AUTOMOBILE/MISSOURI PACIFIC RAILROAD  
FREIGHT TRAIN COLLISION  
WOODLAND DRIVE /  
LAKE VIEW, ARKANSAS

JULY 9, 1982

NTSB-TSR-RHR-83-1

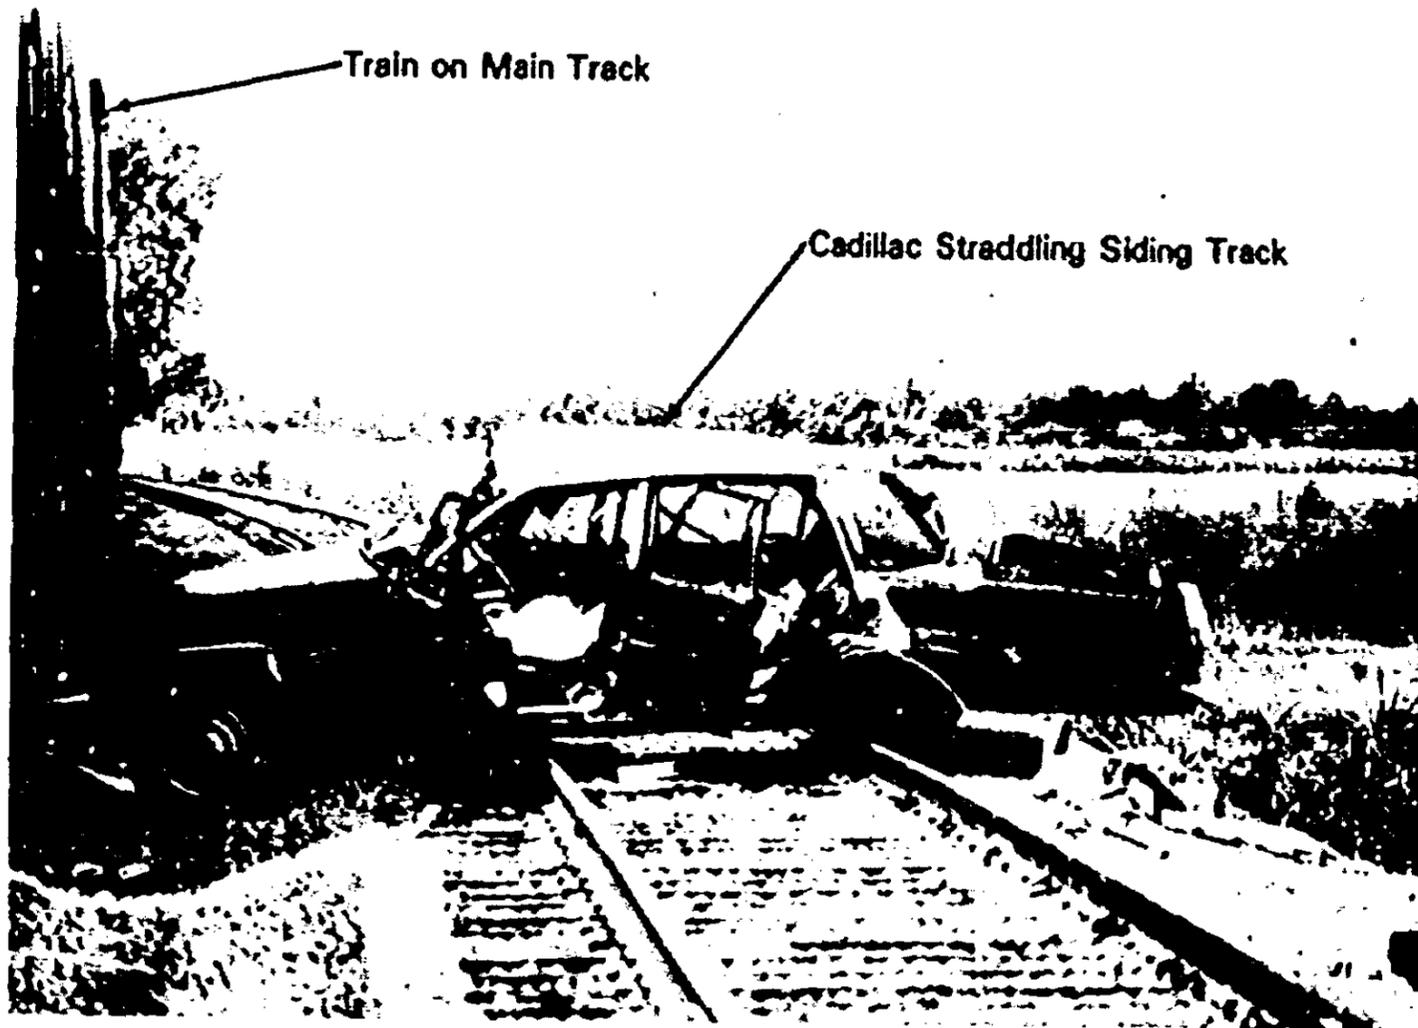
Figure 2.—Left side view of Cadillac in rest position.

Impact damage to the Cadillac was primarily confined to the right side, trunk, and roof. All windows and other glass components on the right side were missing. Both right doors were deformed inward crushing both the front and back seats into an "L" configuration. Maximum penetration of the passenger compartment occurred on the right side just forward of the "B" pillar and was measured to be about 2 feet. Blue paint transfers were observed along the right side in several locations. The trunk lid was severed from its mounting brackets and bent into a "V" shape configuration. The left side doors were buckled slightly, apparently during the rescue operation, and the left door windows were intact and found closed (in the rolled up position).

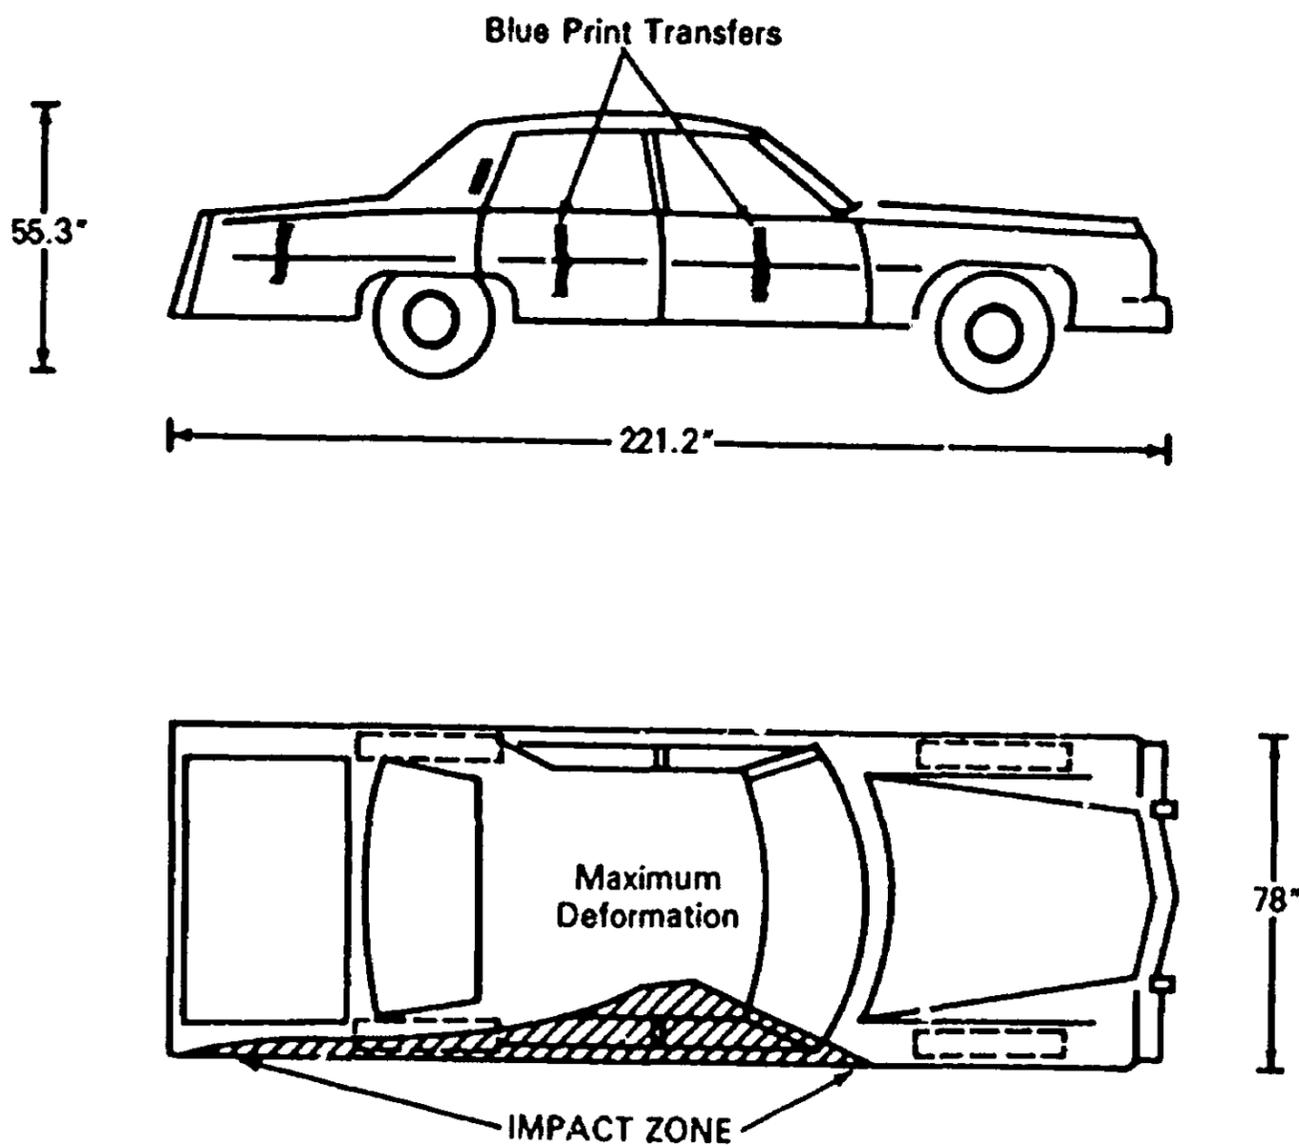
Figure 3.—Schematic of 1978 Cadillac.

The locomotive struck the passenger car about midway on the right side and penetrated the passenger compartment. Three passengers were ejected during the impact sequence. The surviving passenger was seated in the rear of the vehicle, probably out of the immediate impact zone. (See figure 3.)

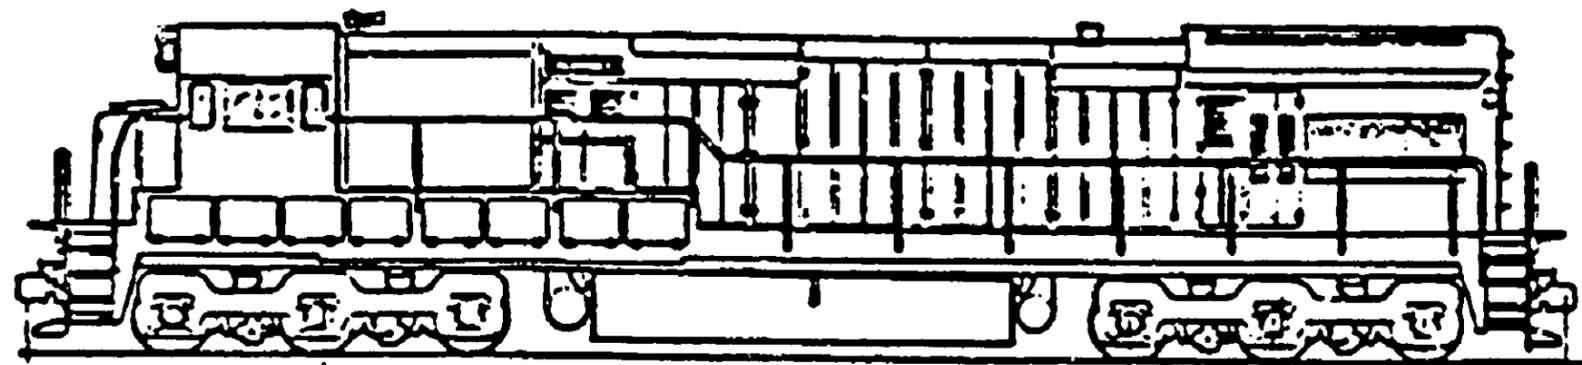
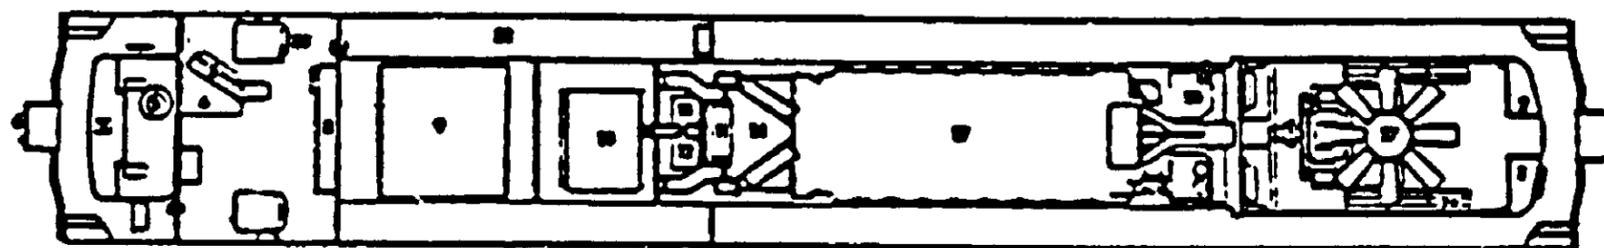
Figure 5.--General Electric Model B30-7A.

As a result of the collision, the right front grabiron, the right front ladder, and the right front pilot on the locomotive were bent. Repair damage was estimated at \$495.60; total cost was for labor, since no materials were needed to make the repairs.

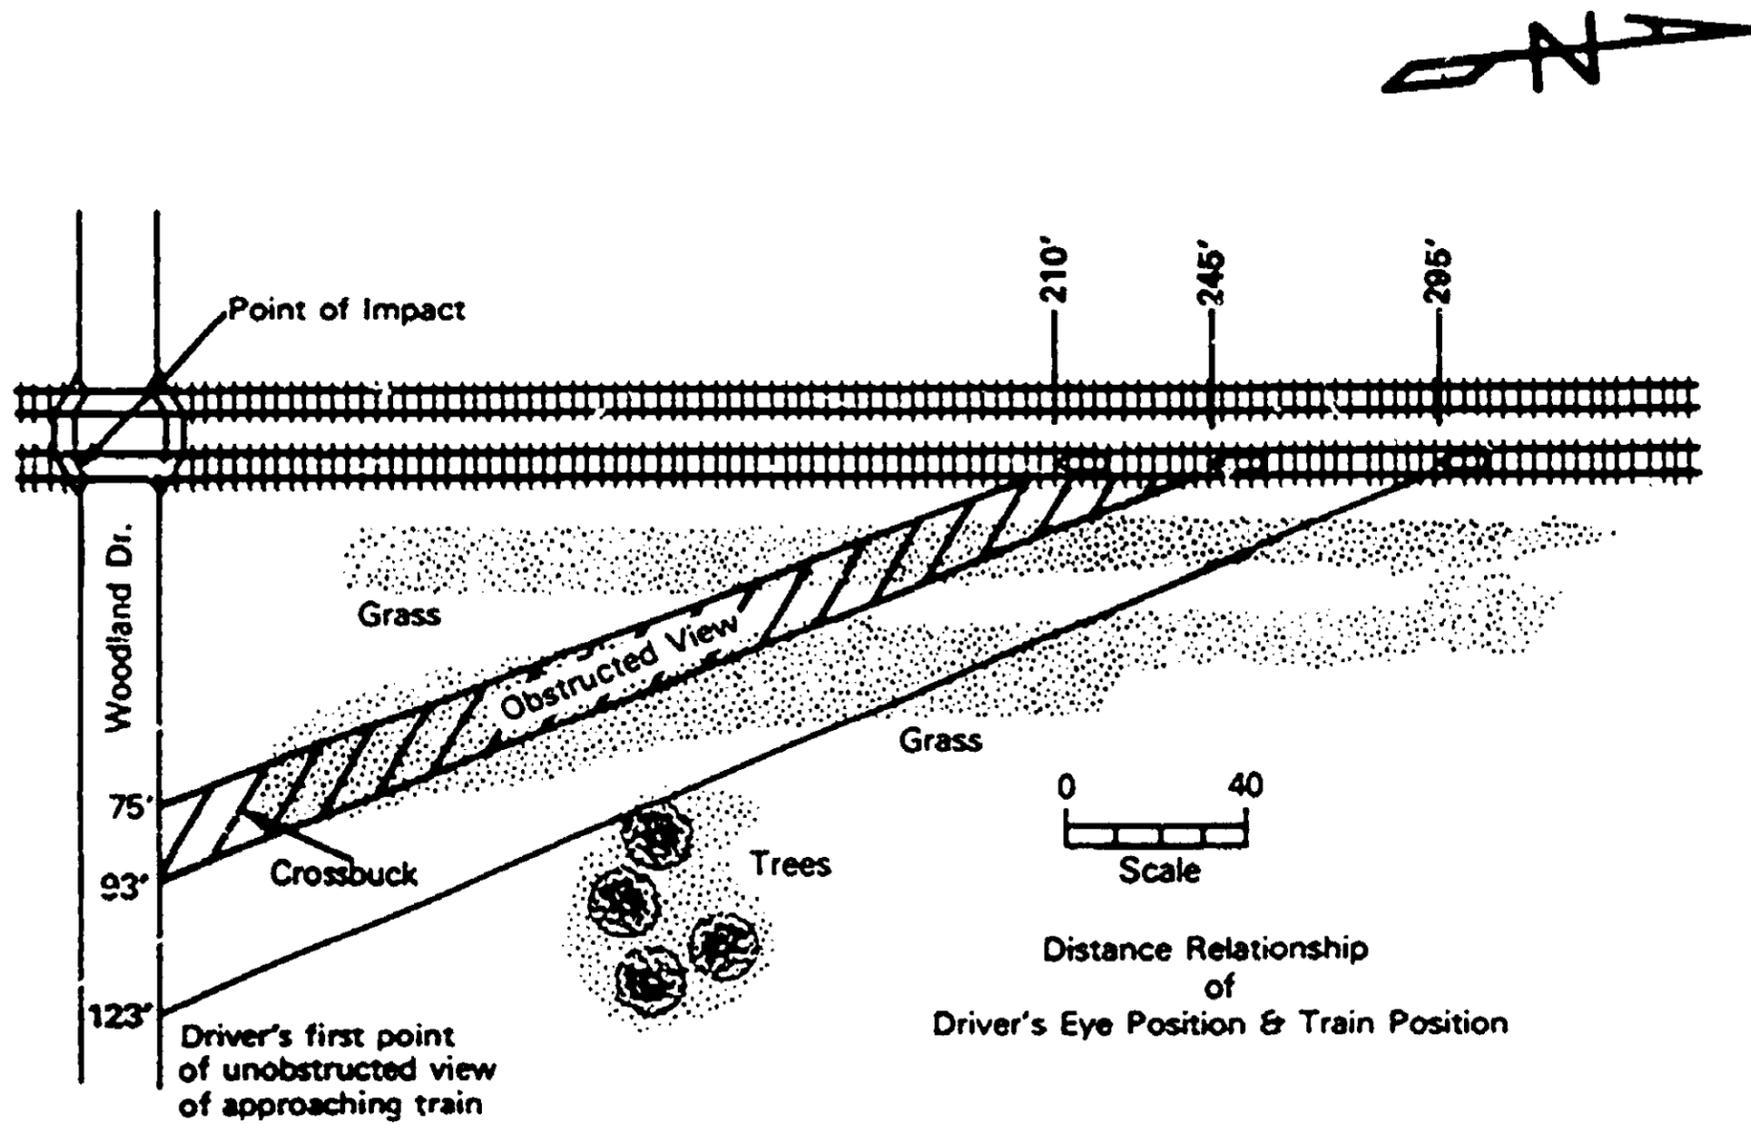
Figure 7.—Sight distance for the Cadillac driver.

about 26 mph at 106 feet from the point of impact, assuming the vehicle was coasting to the crossing while climbing the 6-percent grade on the westbound approach. From a distance of 123 feet to 93 feet from the point of impact, the driver had an unobstructed view of the train. The view obstruction indicated in figure 7 was caused by a combination of high rolling terrain and vegetation. If the driver had been alert, during the initial 17 feet of unobstructed view, she would have had at least 3.7 seconds to react and stop short of the tracks at the crossing. 11/ It is likely that once the car reached the next point where the driver had an unobstructed view (75 feet from the point of impact), she could not have stopped the car in time to avoid the impending danger.
