RAILROAD/HIGHWAY ACCIDENT REPORT

**COLLISION OF AMTRAK TRAIN NO. 88
WITH TRACTOR LOWBOY SEMITRAILER
COMBINATION TRUCK
ROWLAND, NORTH CAROLINA
AUGUST 25, 1983**

NTSB/RHR-84/01

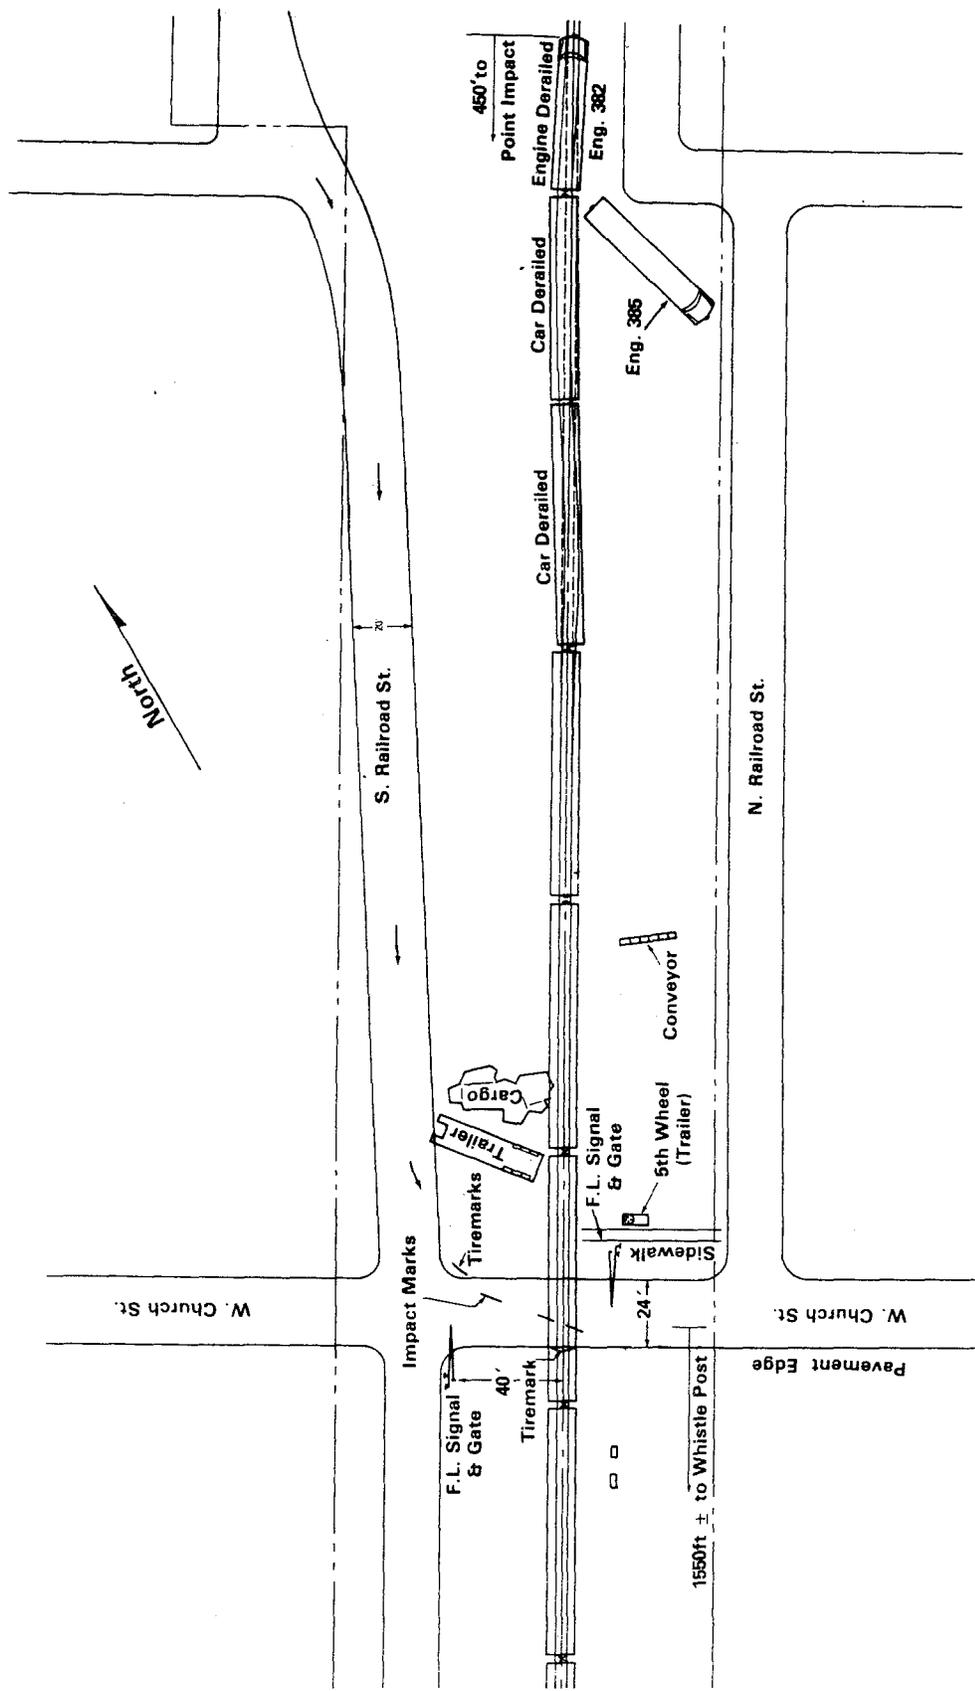
Figure 1.--Plan view of accident site.

When the train struck the truck, the fifth wheel attachment to the truck-tractor frame separated, leaving the tractor relatively undamaged. The goose neck separated from its attachment to the lowboy trailer bed and came to rest in the northeast quadrant of the crossing. The lowboy trailer came to rest upright after being rotated about 180 degrees from its original heading and into the northwest quadrant of the crossing. The piece of construction equipment broke loose of the lowboy trailer and came to rest north of the trailer. (See figure 1.)

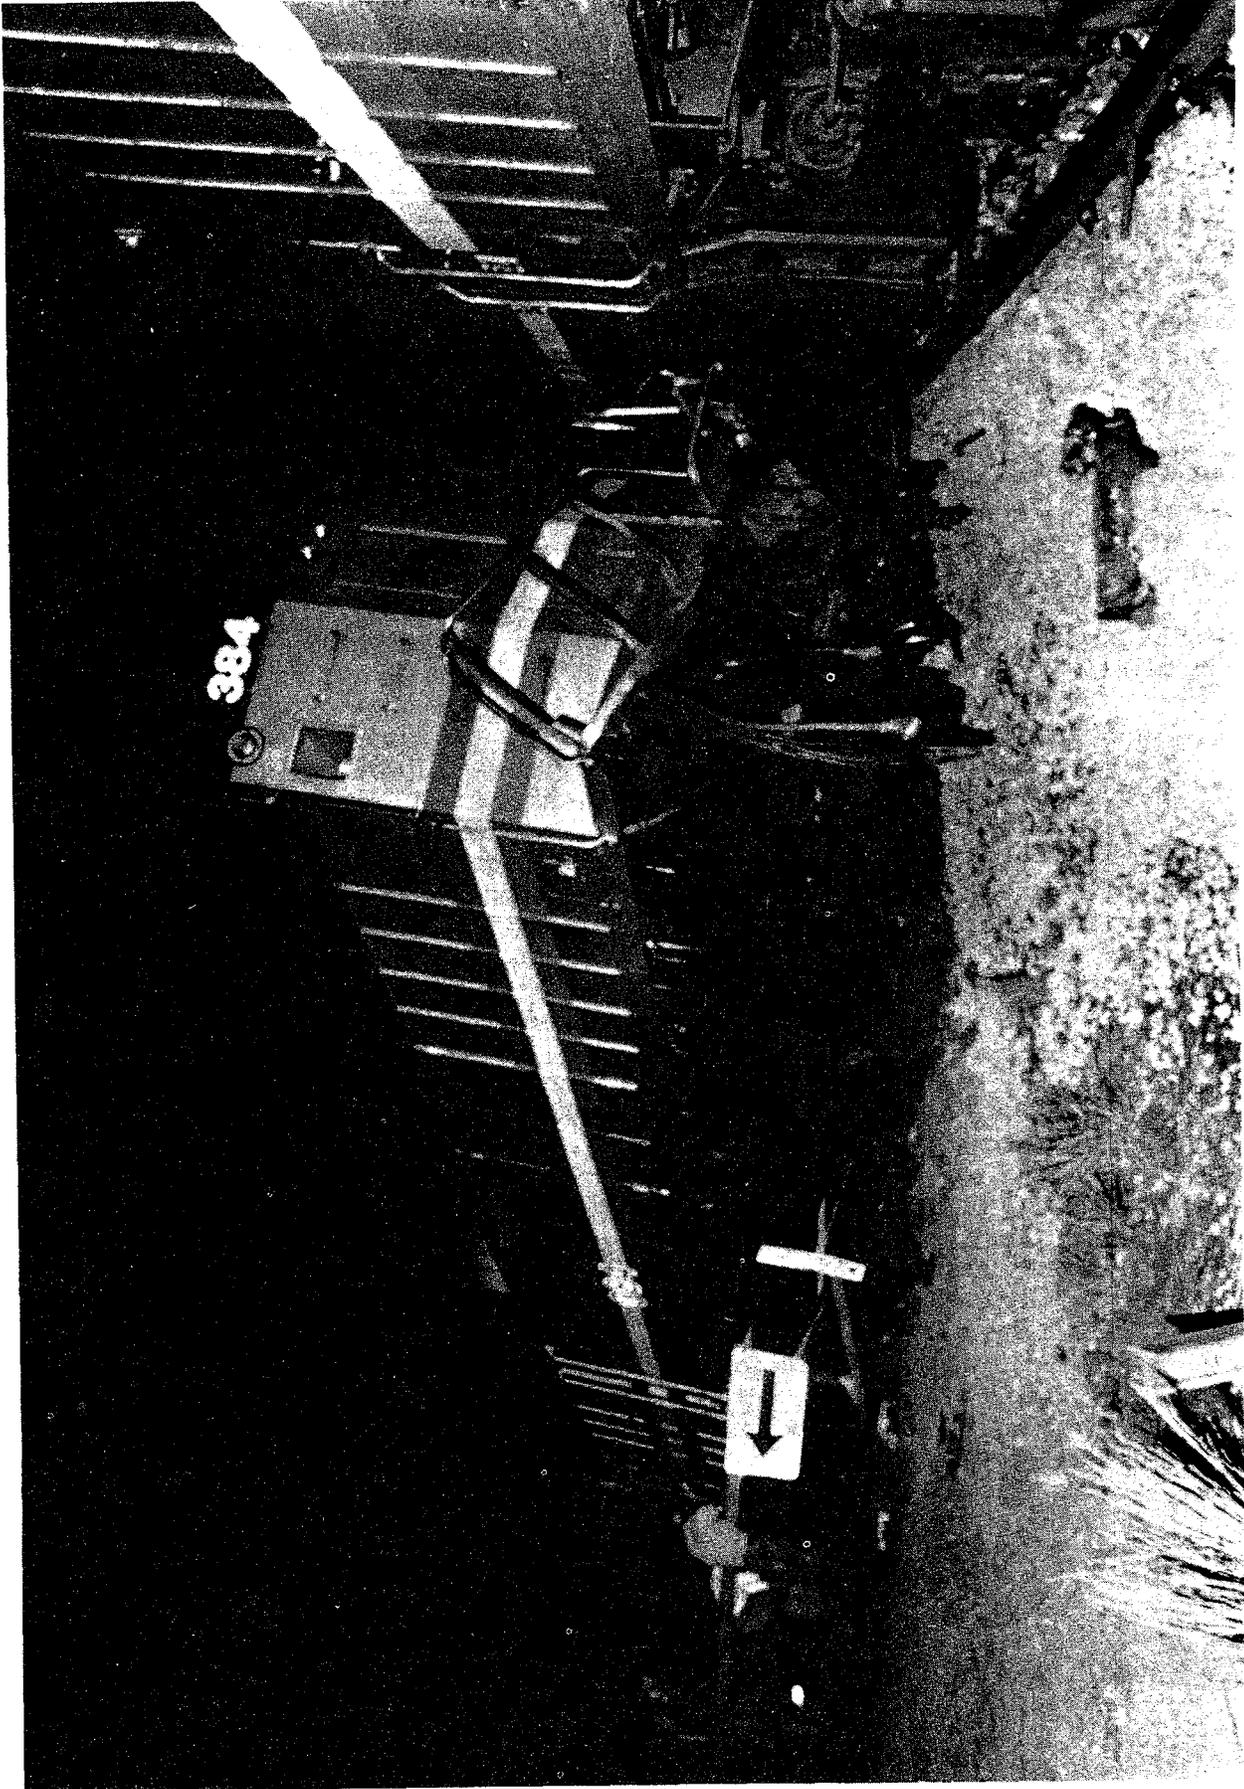
Figure 2.--Lead locomotive unit of train No. 88.

The lead locomotive unit was damaged substantially. The second locomotive unit, the baggage mail car, and the baggage-dormitory car all received minor damage.

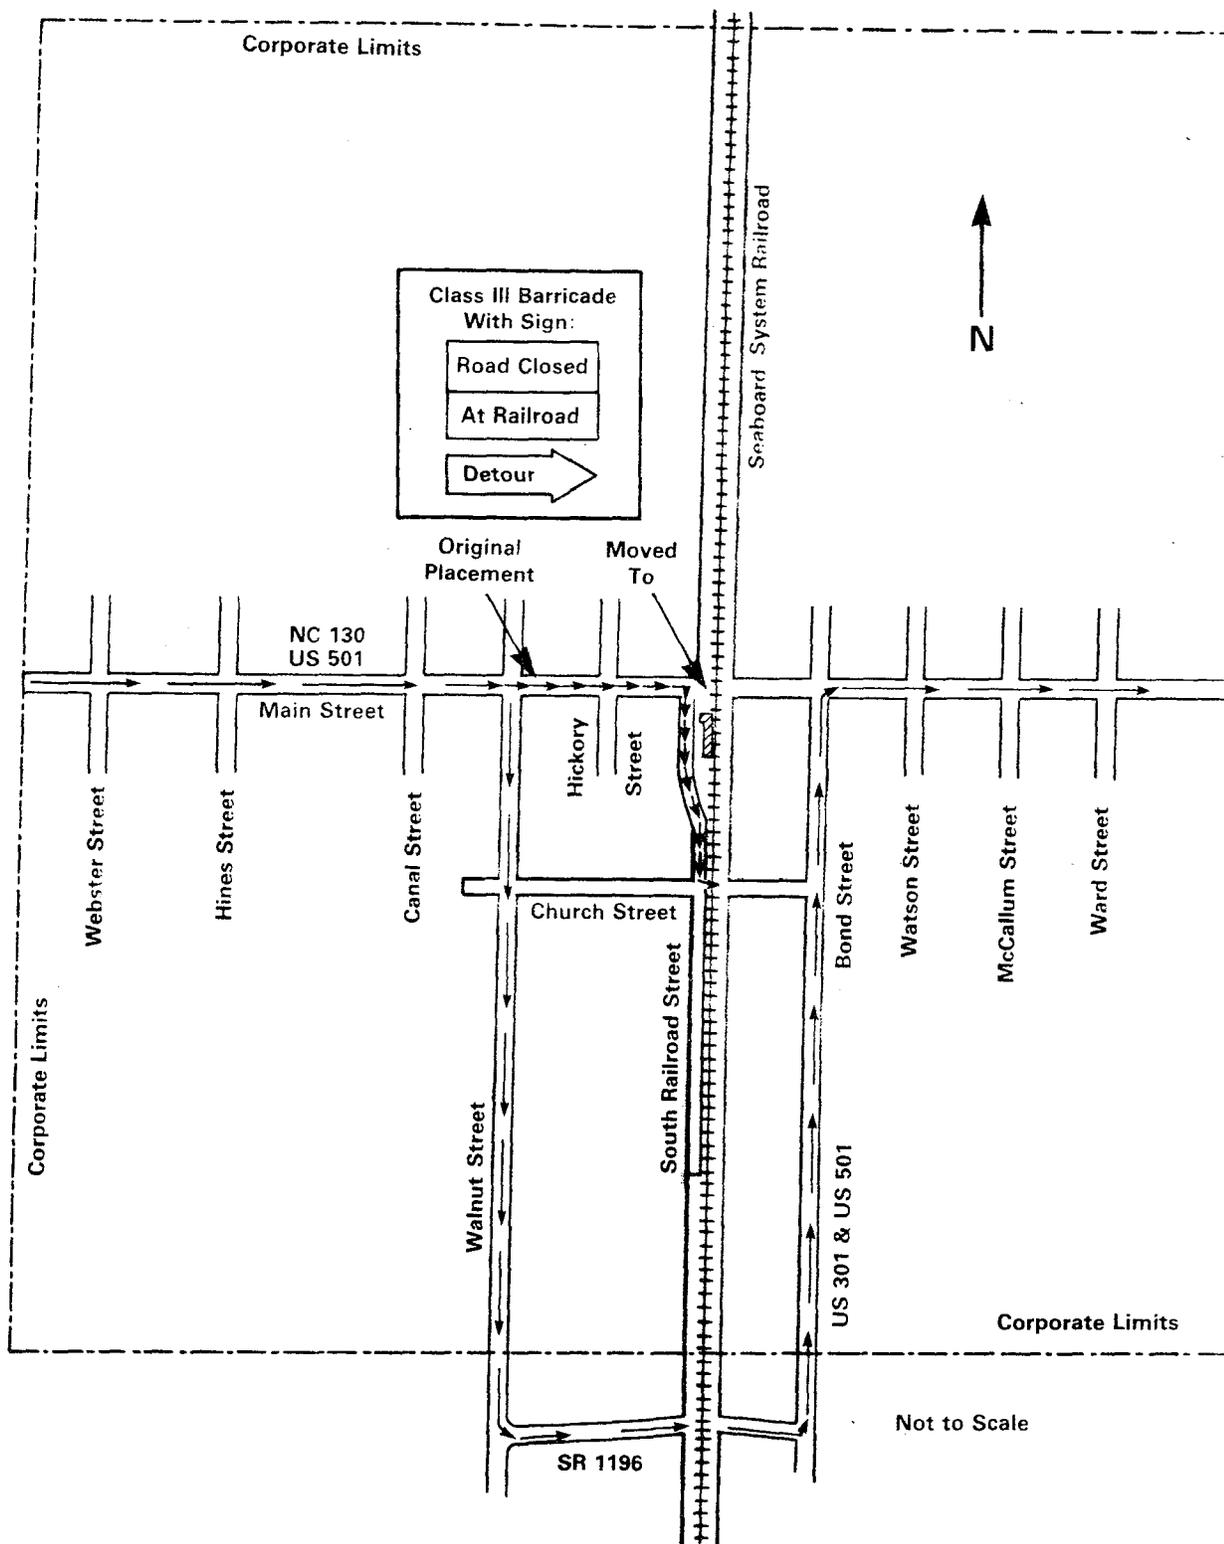
Figure 3.--Plan view of detour route.

The truckdriver continued west on N.C. Route 20 and then on other highways that led him to eastbound N.C. Route 130, which was designated Main Street in Rowland. The truck traveled east on Main Street, and as the truckdriver approached the Main Street grade crossing of the Seaboard's main line, he found the crossing barricaded. Earlier in the day, Seaboard personnel had removed the pavement to resurface the crossing. The truckdriver turned right onto South Railroad Street, which parallels the west side of the railroad right-of-way, and headed south. (See figure 3.) The next grade crossing south of Main Street was at Church Street, where the truckdriver attempted to turn left and move across the railroad track. The truck tractor successfully crossed the track, but the bottom of the semitrailer struck and became lodged on the track. (See figure 4.) Efforts by the truckdriver to drive the semitrailer off the track failed. The driver attempted to raise the semitrailer frame by operating the rams on the semitrailer gooseneck, but the semitrailer remained lodged on the track. The truckdriver did not place flares on the track; he was not carrying any on his vehicle. About 5 to 10 minutes later, the truckdriver saw the headlight of the approaching train, and the warning devices at the crossing activated. He left the truck and ran from the crossing.

Street facing eastbound traffic at intersecting Walnut Street (two blocks west of the grade crossing). (See figure 3.) A series of signs with arrows diverted eastbound traffic southerly on Walnut Street to N.C. Route 1196 (just south of the city limits), eastwardly on N.C. Route 1196 across the same Seaboard track, then northerly on Bond Street (1 block east of the track) to Main Street. A similar barricade was placed in the center of Main Street at the intersection of Bond Street to divert westbound traffic over the same route to the west side of the Main Street crossing. All of the roadways on the 1.36-mile-long detour route were State-maintained.

The NCDOT sign installer, who had erected the detour signs, inspected the route the morning of August 24, 1983. He found all of the signs and barricades in place. Later that day, Seaboard personnel removed the pavement from the N.C. Route 1196 crossing and closed it to motor vehicle traffic. The detour signs were moved 2 blocks east on Main Street to the intersection with South Railroad Street just west of the Main Street crossing. Inquiries failed to determine who moved the signs.

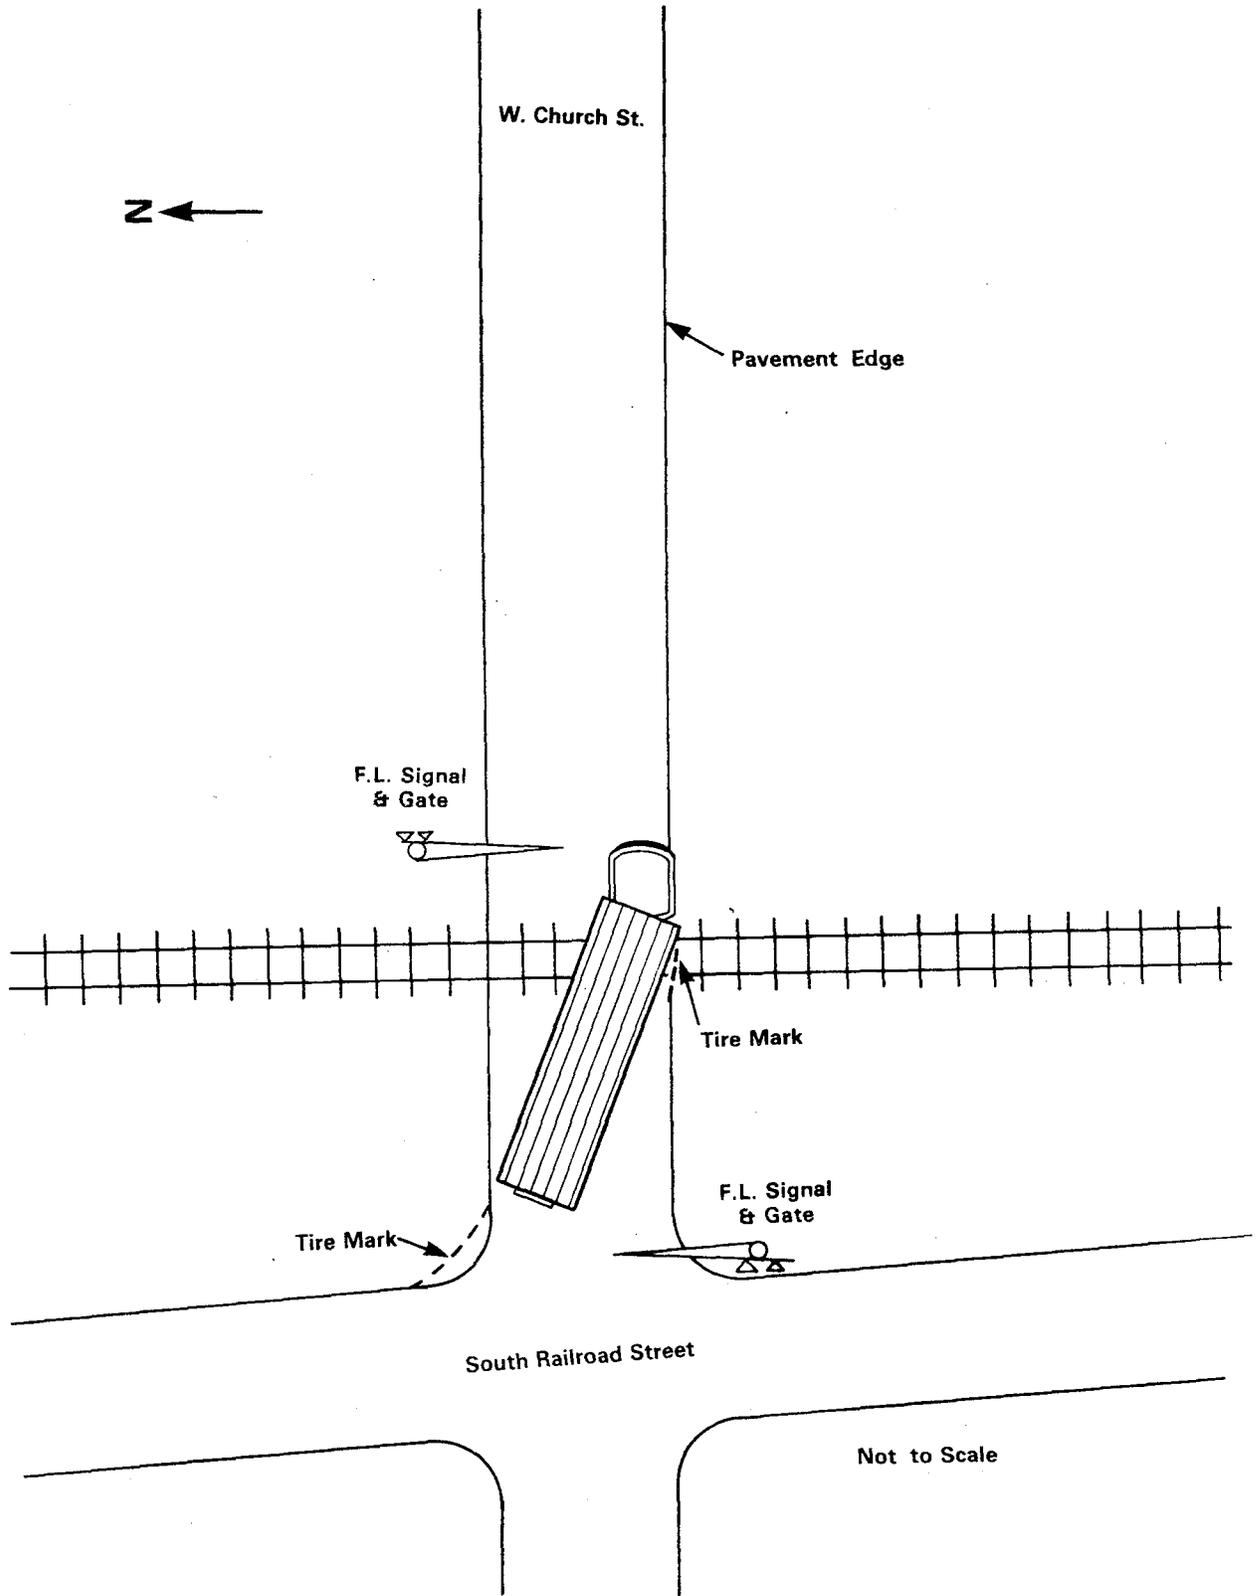
Figure 4.--Truck in lodged position on crossing at accident site.

7. The truck was not being operated in accordance with the requirements of the Federal Motor Carrier Safety Regulations.
8. The low ground clearance of the semitrailer combined with the hump of the grade crossing caused the semitrailer to become lodged on the track.

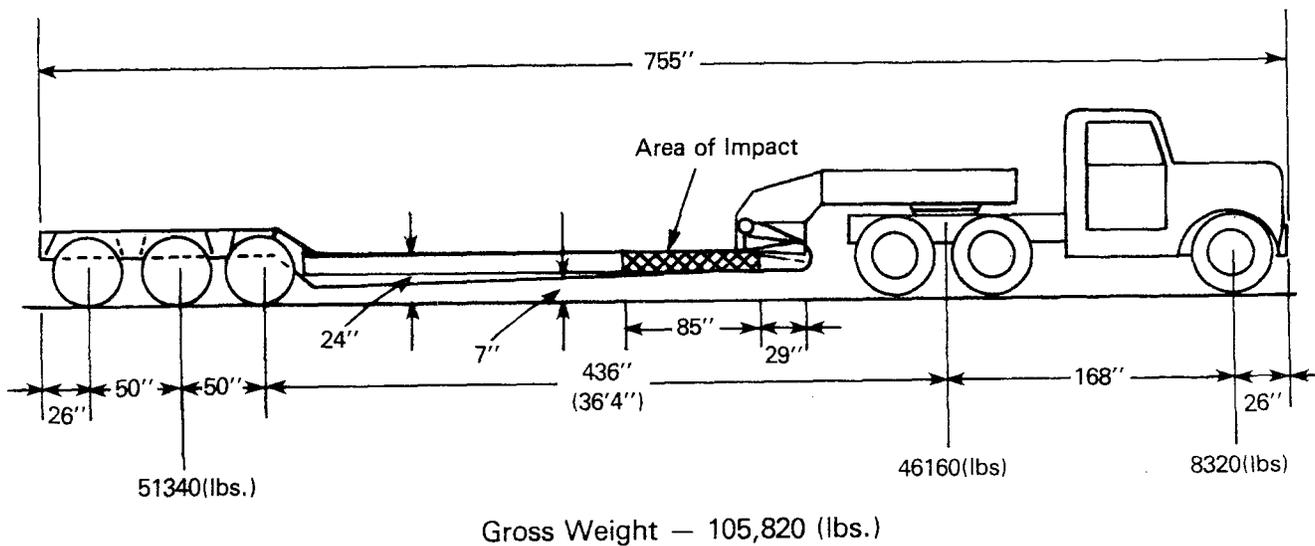
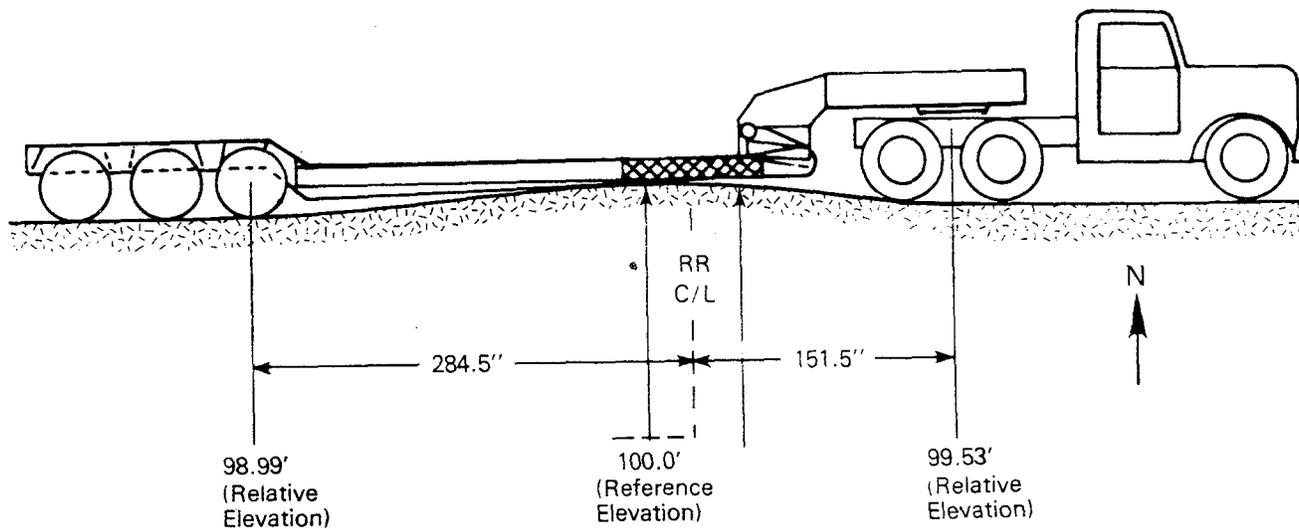
Figure 5.--Measurements and weights of tractor and lowboy semitrailer as loaded (top), and measurements of tractor and lowboy semitrailer in relation to grade crossing at the accident site (bottom).

The tractor-lowboy semitrailer combination (see figure 5) was owned and operated by the S.L. Balogh Trucking Company, Inc., of Ft. Lauderdale, Florida. The 63-foot-long unit with its cargo was weighed in Virginia the day before the accident; the gross

weight was 105,820 pounds. The tractor tandem axle weighed 2,160 pounds more than the weight allowed on the permit issued by Virginia. (See appendix C.) A summons was issued to the driver, and a \$257 fine was paid.

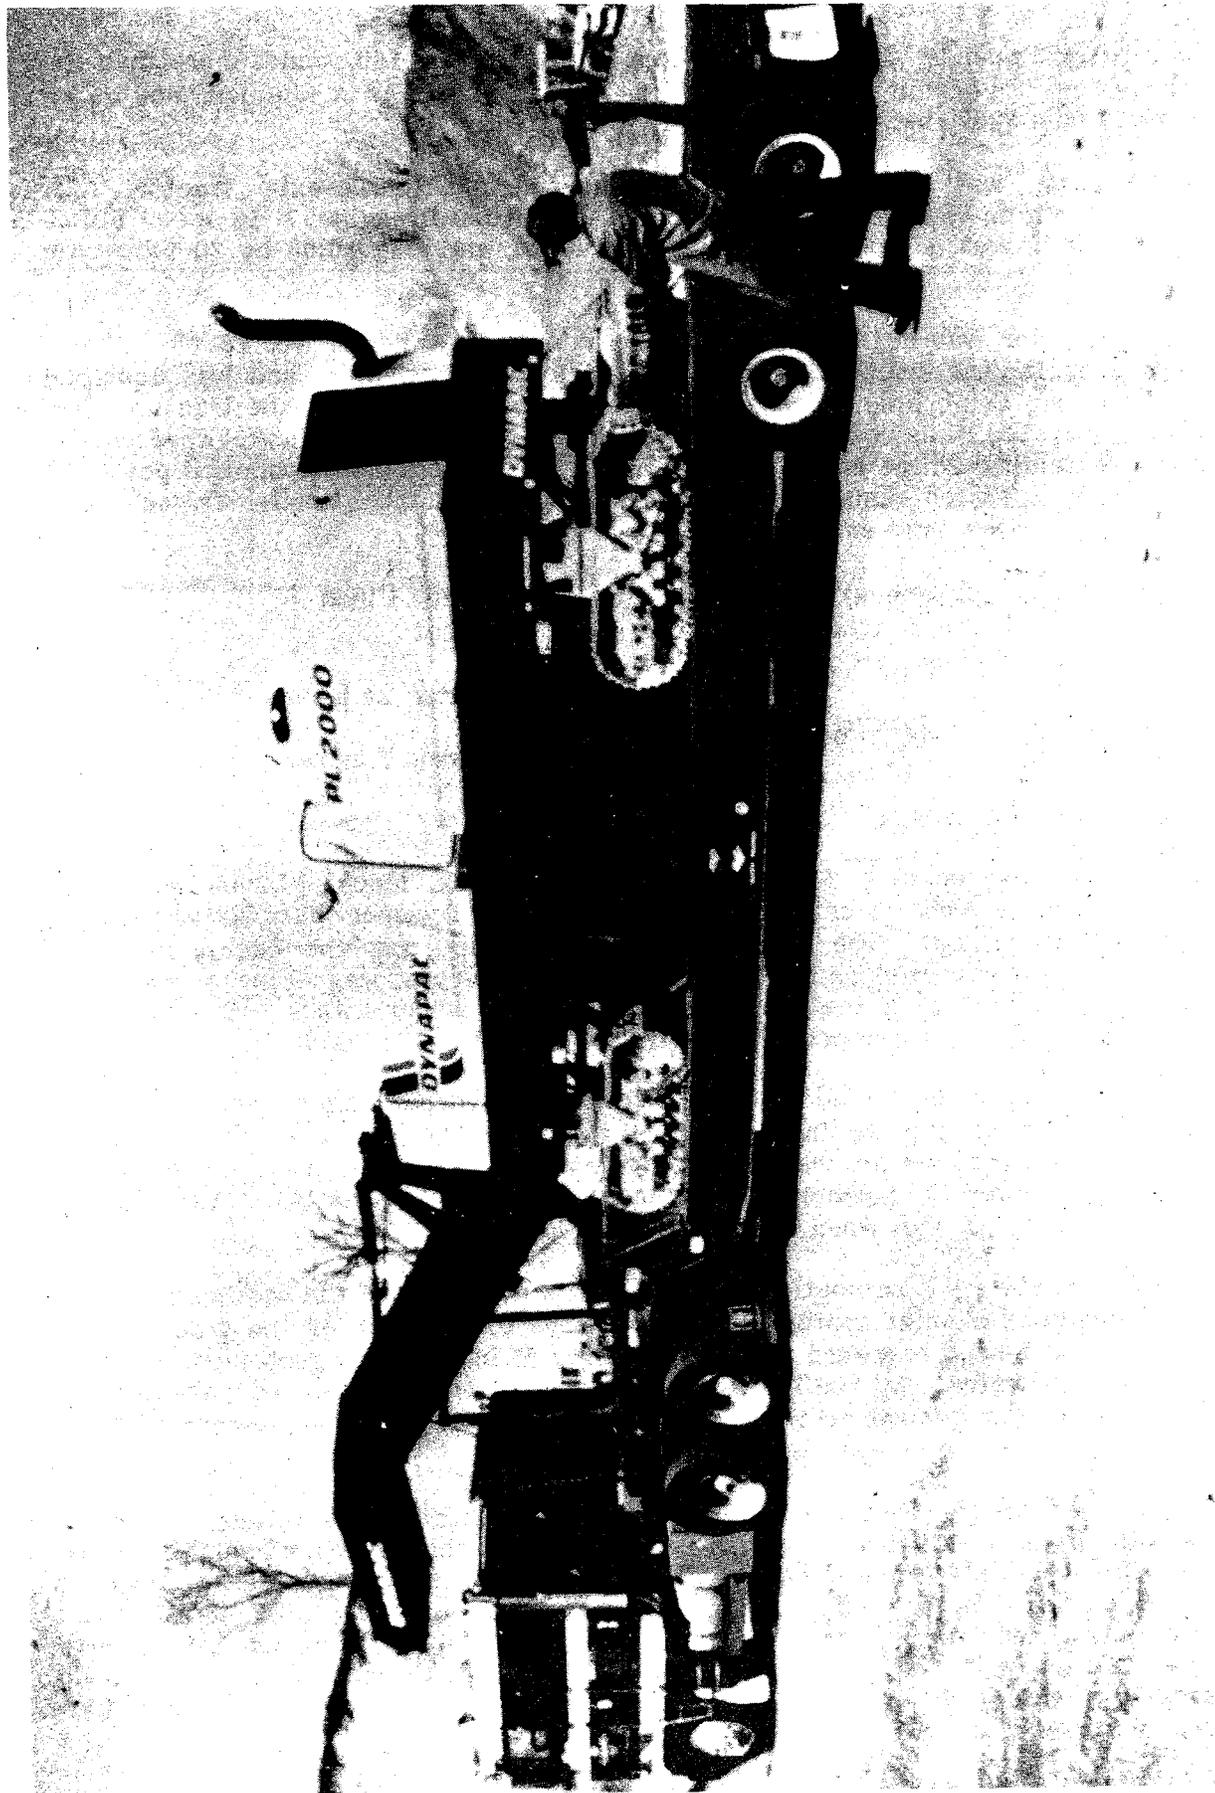
Figure 6.--Dynapac Pavement Profiler machine, similar to the machine involved in this accident, loaded on a lowboy semitrailer.

The cargo consisted of a 61,000-pound, 4-wheel-track, Model PL2000 Pavement Profiler (see figure 6). The machine was manufactured by Dynapac Manufacturing, Inc., of Stanhope, New Jersey. The Balogh truck was transporting the equipment from Stanhope to a customer in Hialeah Gardens, Florida. The machine was 98 inches wide, 117 inches high, and measured 22 feet 11 inches long at the wheel tracks. An adjustable boom-type loading conveyor extended 23 feet from the front of the machine.

The machine had been loaded on the semitrailer by Dynapac employees. The wheel tracks were resting on the loading deck of the semitrailer with the conveyor boom extending forward and above the tractor cab. Only the weight of the machine resting on the loading deck secured the machine to the semitrailer. The conveyor boom was adjusted to a height of 13 feet 6 inches when the machine was loaded.

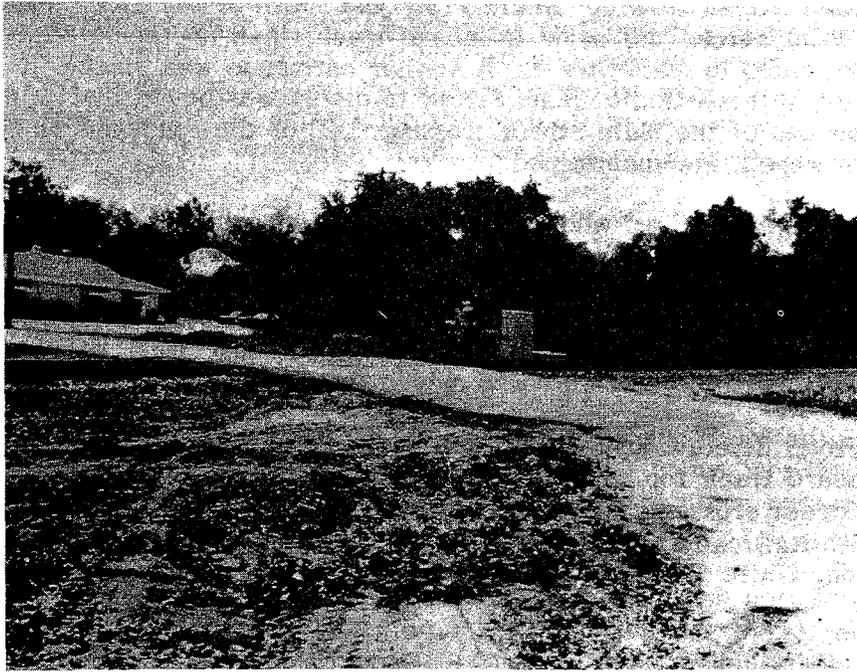
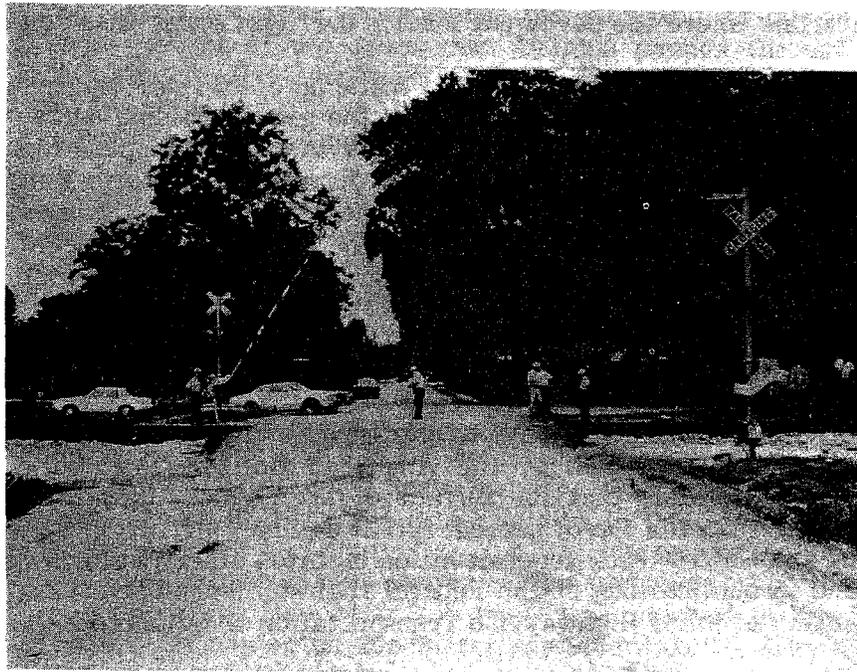
Figure 7.-- West approach to track (above)
and east approach to track (below).

10. Although the American Railway Engineering Association has a recommended practice on the profile and alignment of crossings and approaches stated in its "Manual for Railway Engineering," it was not followed at the Rowland, North Carolina, crossing.
