September 30, 2025

Railroad Investigation Report: RIR-25-12

# Eliminate Fire Risk in the Southeastern Pennsylvania Transportation Authority Silverliner IV Fleet

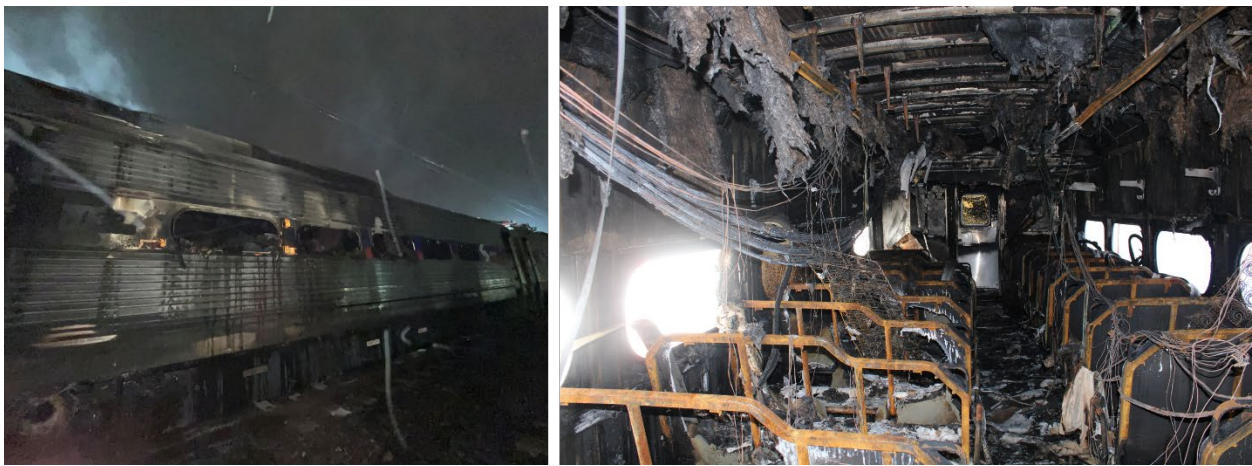
causing slow acceleration, but at the direction of the dispatcher, the train remained in service. The operator also reported a strong burning smell in the lead railcar about 5:07 p.m. The train remained in service until the operator noticed smoke behind the lead railcar while departing Crum Lynne Station, stopped the train to inspect it himself, and saw that the lead railcar was on fire. The fire spread from the railcar's undercarriage to its passenger compartment, igniting seats and paneling before reaching the roof. The railcar was destroyed (see figure 1). Everyone aboard—4 crew and about 325 passengers—was evacuated. Four passengers later reported minor injuries.

The NTSB's investigation is ongoing; however, preliminary findings indicate that the fire started in the railcar's undercarriage when electrical components associated with the train's propulsion system overheated and ignited.

**Figure 1.** External (left) and internal (right) damage to railcar following Ridley Park fire.

Suspend operation of the Silverliner IV fleet until you have determined the root causes of fires, developed and implemented a plan to address these causes, and identified and corrected the organizational factors that have prevented effective risk mitigations. (R-25-12) (Urgent)

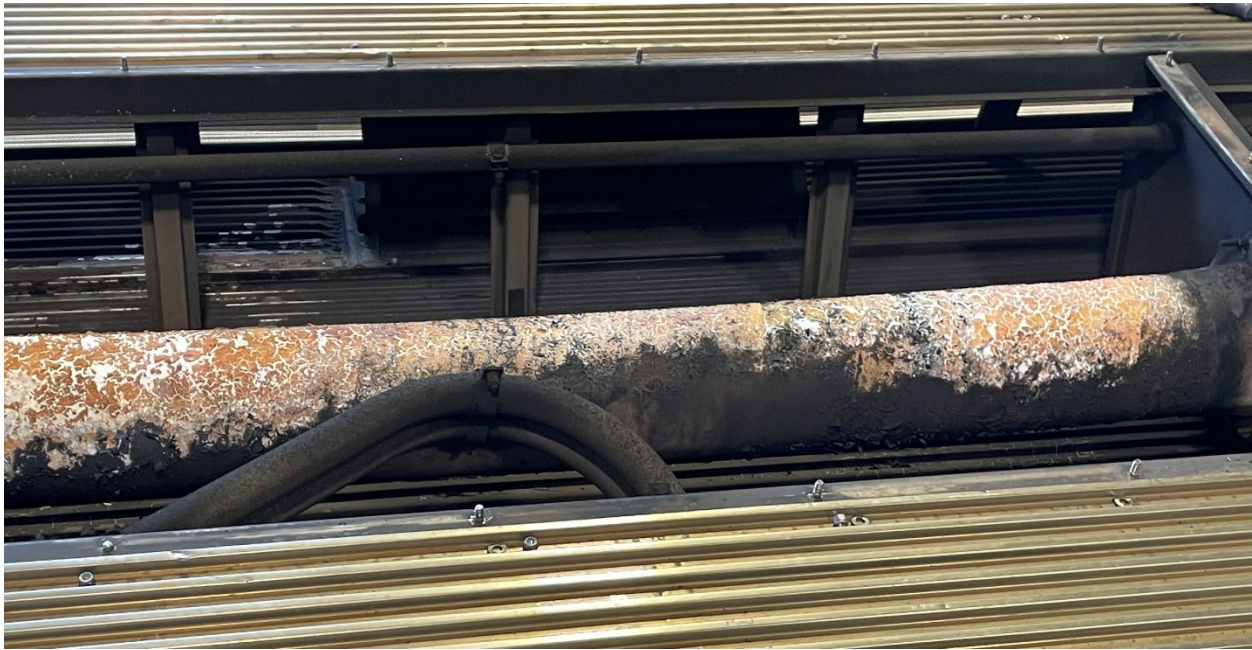
The second incident occurred on June 3, 2025, in Levittown, Pennsylvania, about 7:10 a.m., when the rearmost railcar of SEPTA train 7206 caught fire as the train stopped at Levittown Station. Train 7206 consisted of five Silverliner IV railcars and had about 150 passengers on board. The crew evacuated the train's passengers, and no injuries were reported. The crew did not report a fault light before the fire. The fire was mostly confined to the roof area of the railcar and a rooftop ventilation duct (see figure 2).

As part of the investigation into the earlier Ridley Park fire, the NTSB examined the damaged railcar from Levittown and found signs of overheating on the dynamic brake resistor banks, which normally convert mechanical energy into heat when the dynamic brakes are applied.<sup>3</sup> Preliminary findings indicate that a cam controller pilot motor (part of the system that controls the railcar's dynamic brakes) failed and that the dynamic

braking pressure switch (which engages or cuts out the dynamic brakes during air brake applications) was out of calibration. Together, these two issues allowed this railcar's braking system to become stuck in dynamic braking mode as the train remained in motion and under power, causing the resistor grid to overheat and ignite a fiberglass rooftop ventilation duct.

**Figure 2.** Fire-damaged ventilation duct on railcar following Levittown fire.

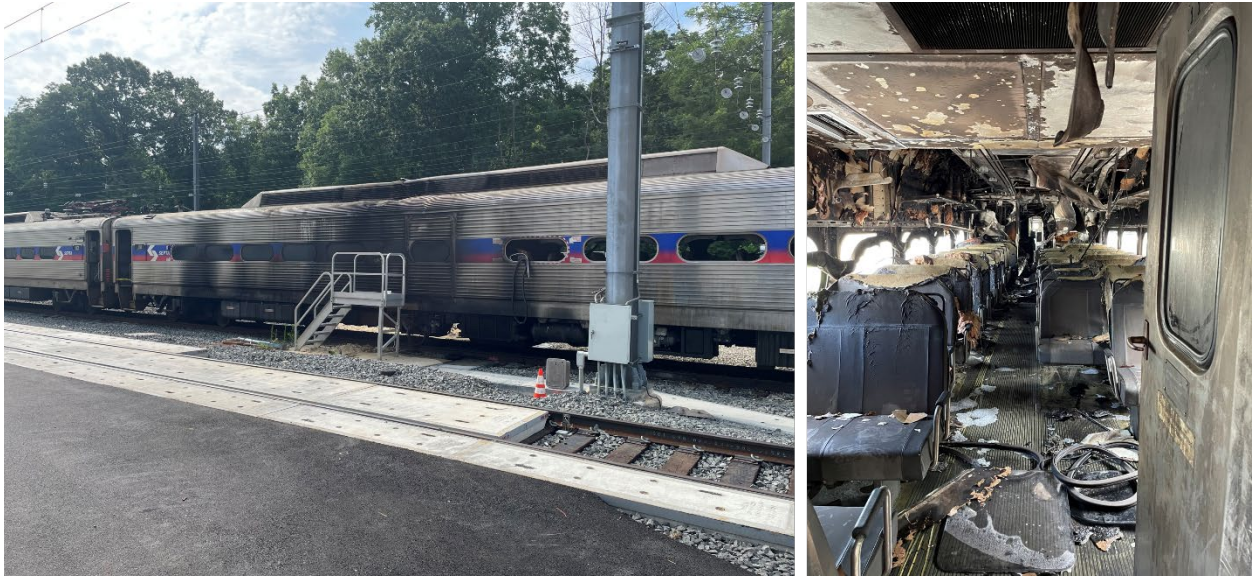
The third incident occurred on July 22, 2025, about 10:53 p.m., when the fifth railcar of SEPTA train 3553 caught fire as the train stopped at Paoli Station in Paoli, Pennsylvania. Train 3553 consisted of six Silverliner IV railcars. Two crews operated the train in the hours before the fire, and both crews reset the fault light at least once. When interviewed by the NTSB, both crews said they reported slow acceleration to the dispatcher, but the train remained in service. The second crew discovered the fire when the train lost motive power and the conductor left a railcar near the front of the train to reset the fault light again, encountering smoke in the rear railcars. The crew evacuated the train's 14 passengers. The conductor was transported to a local hospital for treatment for smoke inhalation; no other injuries were reported. The railcar that caught fire was destroyed (see figure 3). The NTSB examined the involved railcar from train 3553, again as part of the ongoing investigation of the Ridley Park fire. Preliminary findings indicate that the fire began in the undercarriage with electrical components in the train's propulsion system and spread to the passenger compartment, similar to the February 6 fire in Ridley Park.

**Figure 3.** External (left) and internal (right) damage to railcar following Paoli fire.
