Railroad Investigation Report: RIR-25-18

Carolina Coastal Railway Employee Injury

Location	Rocky Mount, North Carolina
Date	November 19, 2024
Accident type	Employee injury
Train	2 railcars
Track	Main track, signalized
Hazardous materials	None
Fatalities	0
Injuries	1

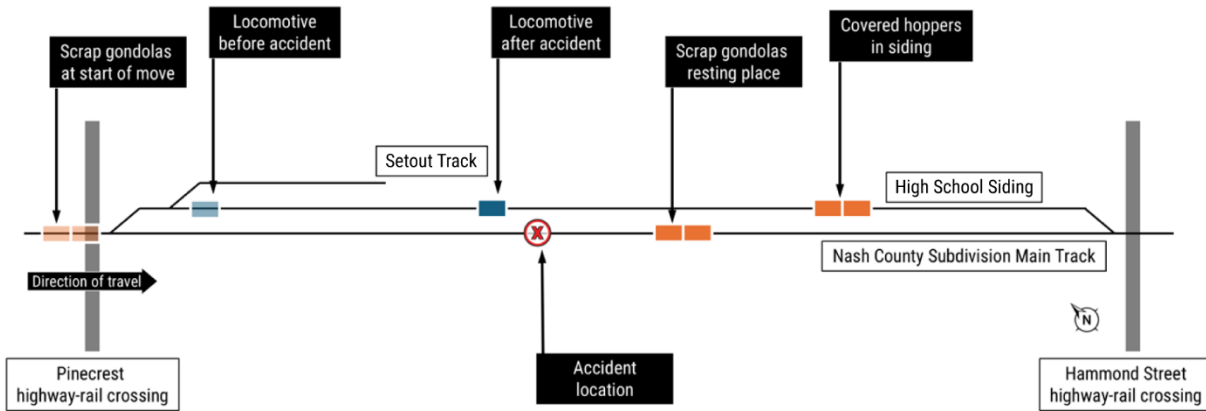
south and where the accident took place), the High School Siding (this set of track ran parallel to the main track on the north side), and a small setout track (this set of track was furthest north and extended just beyond the Pinecrest crossing). (See figure.)

Figure. Diagram of the accident scene.
