September 17, 2026

Railroad Investigation Report RIR-26-15

# Prohibit Riding Railroad Equipment During Shoving Movements

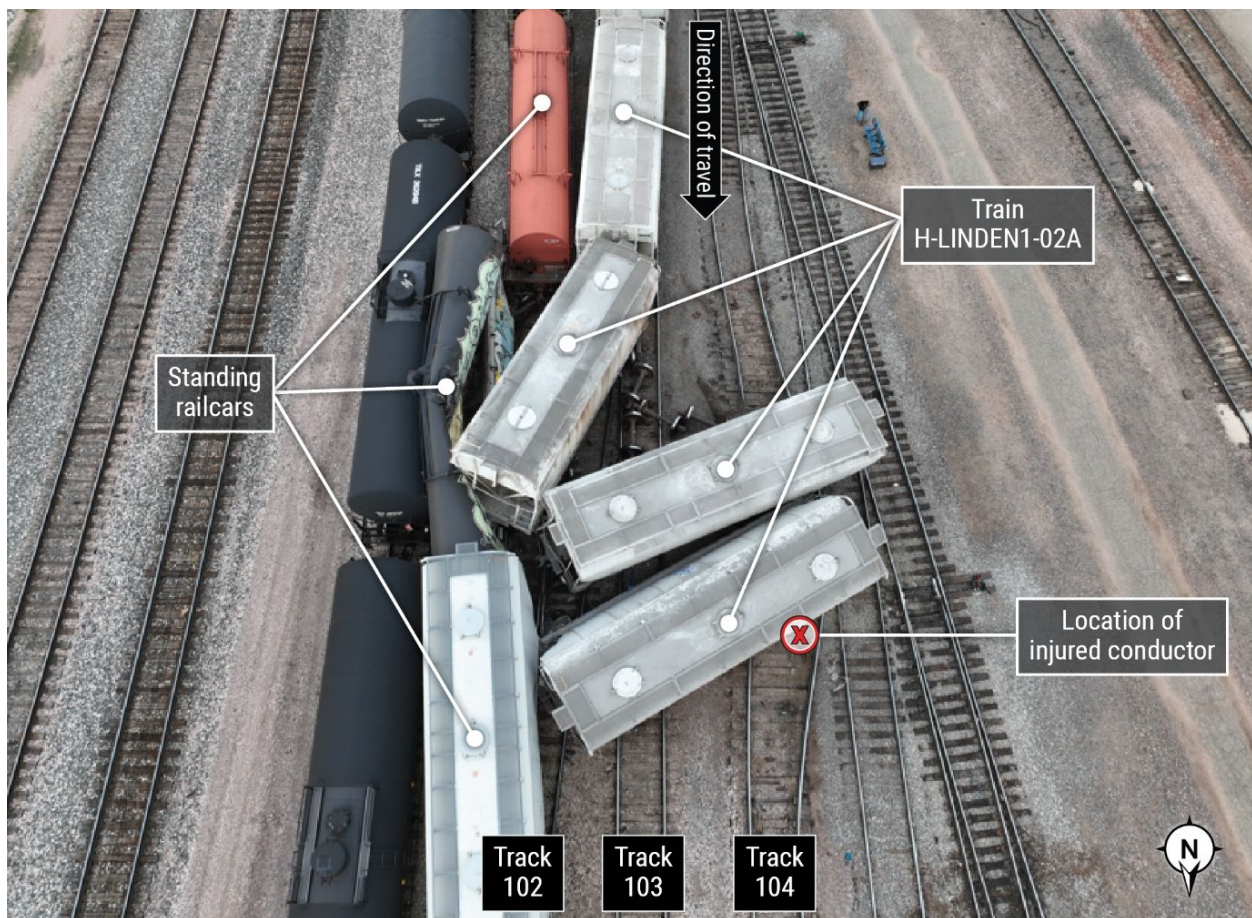
on the ground or in a separate vehicle, as the exterior of a train does not have seatbelts, fall restraints, or enclosures for protection that are federally required for other types of equipment designed to be occupied or ridden (for example, motor vehicles or hi-rail machinery). An employee riding a railcar can lose their grip during a collision or derailment, leading to a fall. Employees can also be caught under an overturning railcar during a derailment. We investigated accidents in which conductors riding railcars during shoving movements were fatally injured when a derailed railcar toppled onto them in El Paso, Texas, in 2022 (UP), and again in Denver, Colorado, in 2025 (BNSF). (See figure 3.) Similarly, a CSX conductor was fatally injured in Calera, Alabama, in December 2025 by a railcar that fell onto him after a collision with standing equipment during a shoving movement.

**Figure 3.** Railcars after the 2025 collision and conductor injury in Denver, Colorado. (Photo: BNSF.)

During our investigation of the Denver accident, which was caused by a misaligned switch on the track into which the BNSF crew was shoving their train, the NTSB interviewed the yardmaster on duty at the time of the derailment. He described the general nature of what BNSF called “job safety briefings” at that location, noting that the average briefing “can happen on the lead, it can happen on a locomotive, it can happen in a crew room, it happens anywhere.” He noted that in general, these briefings address the functions of the job, relevant rules, planned movements and tasks, and conditions to watch for, like water on the track. He further clarified that he
