Railroad Investigation Report: RIR-22/01

# Housatonic Railroad Company

## Employee Fatality

North Canaan, Connecticut

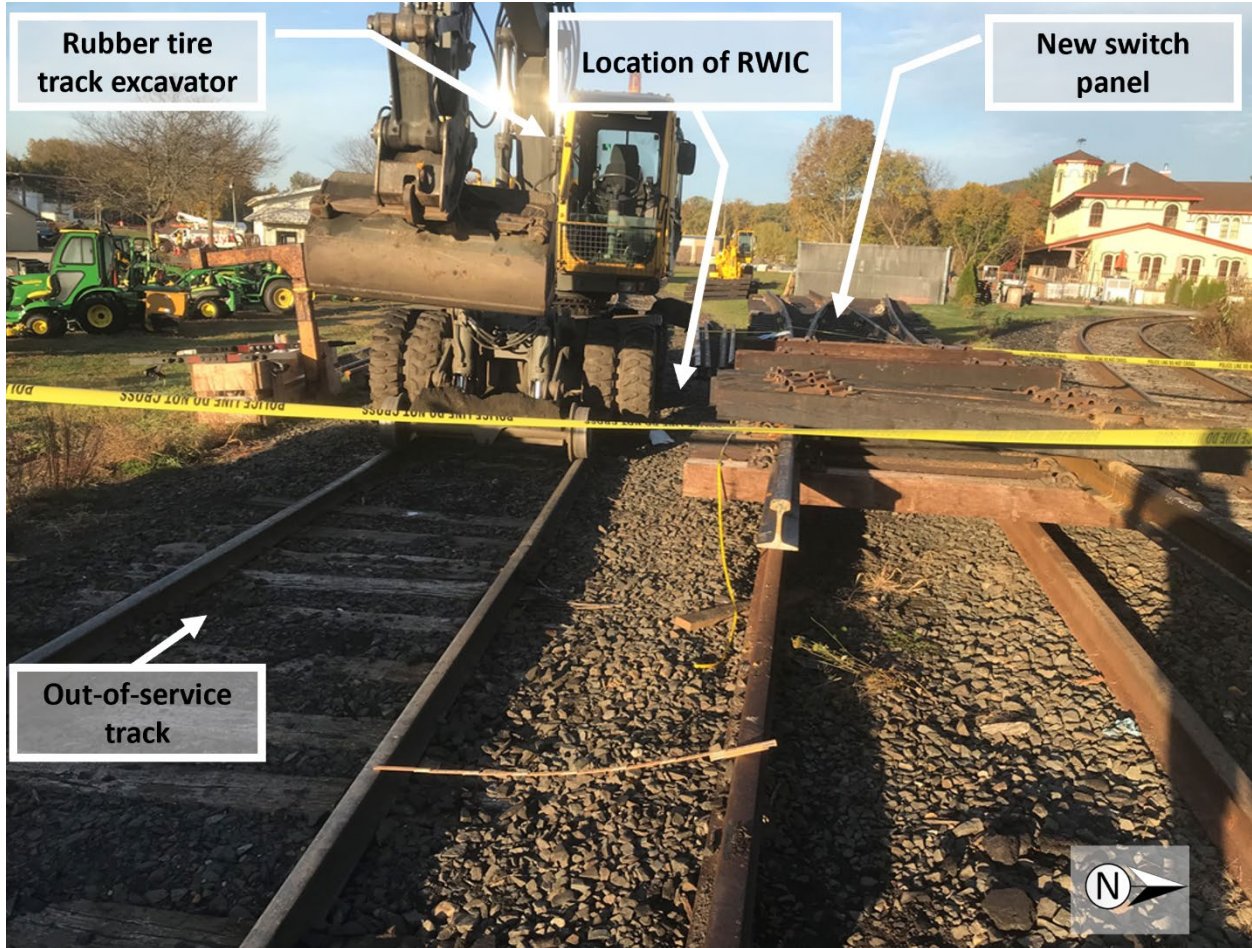
On October 14, 2020, about 2:50 p.m. local time, a Housatonic Railroad Company (HRRC) employee working as the roadway worker-in-charge (RWIC) of a group of track workers was struck and killed by a rail-mounted track excavator that was traveling on an out-of-service track in North Canaan, Connecticut.<sup>1</sup> Figure 1 shows the accident scene.

**Figure 1.** Photograph of the accident scene. (Photograph courtesy of the Federal Railroad Administration.)

The RWIC and a track worker were working on the out-of-service track and had recently completed measurements of a new switch panel that was located along the north side of the out-of-service track. The new switch panel was scheduled for installation the next day. The RWIC was standing clear of the out-of-service track at the west end of the new switch panel when the track excavator operator moved the excavator near the RWIC's location to discuss the measurement. After the conversation, the track excavator operator moved the machine forward (east). Based on evidence recovered from the accident scene and unbeknownst to the track excavator operator, as the machine was moving forward, the RWIC began rolling up his measuring tape while walking along the left side of the out-of-service track, placing himself between the new switch panel and the moving track excavator. The clearance between the new switch panel and the track excavator gradually reduced to about 2 feet as the track excavator continued to move. Eventually, the track excavator's rubber tire struck the RWIC, causing fatal injuries.

The National Transportation Safety Board determines that the probable cause of the roadway worker-in-charge's fatal injuries was his walking into a close-clearance location between the switch panel and the moving track excavator where he was struck.
