Railroad Investigation Report: RIR-22/02

# Decatur & Eastern Illinois Railroad Conductor Fatality

Tuscola, IL  
November 11, 2020

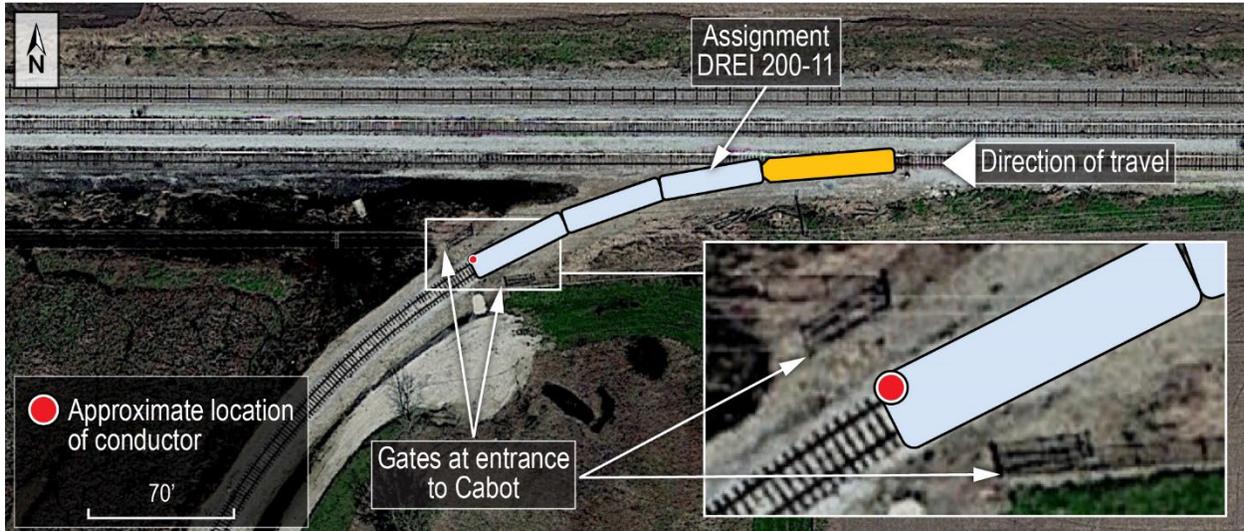
**Figure 1.** Location of conductor and train DREI 200-11.

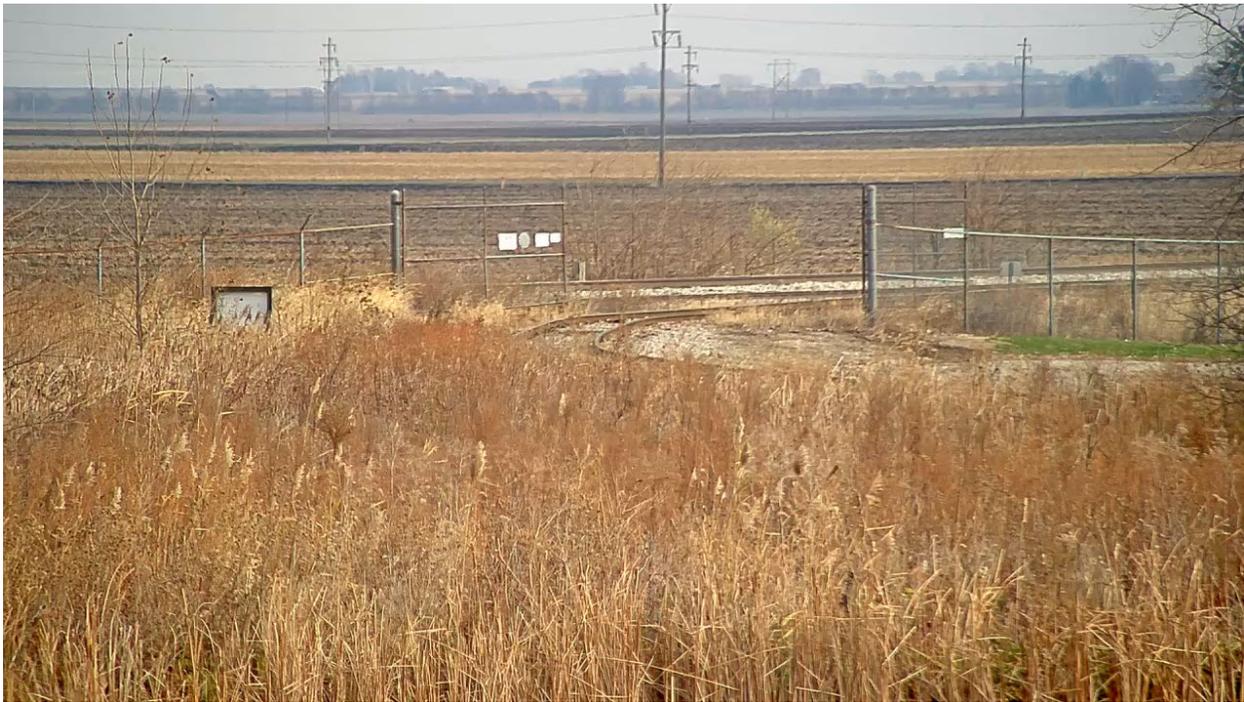
Investigators were able to obtain and review surveillance video of the Cabot facility and observed the actions of the conductor. About 9:42 a.m., as the crew was shoving into the Cabot industrial facility, the conductor positioned himself on the end ladder of the lead railcar in the direction of movement and attempted to open the entrance gate fouling the track. (See figure 2.) As the conductor's hand made contact with the gate, he was pulled from the railcar onto the track where he was struck by the moving train.

**Figure 2.** Gate fouling the track at the Cabot industrial facility.

Surveillance video footage reviewed by investigators showed that the conductor was aware that the gate was fouling the track and repositioned himself on the end ladder of the railcar to open the gate while the train was in motion. Operating rules require crews to stop and dismount to make sure gates are completely open and secure. As a result of his attempt to open the gate while riding a moving railcar, the conductor was pulled from the railcar onto the track and struck by the moving train.

The National Transportation Safety Board determines that the probable cause of the conductor's fatality was a result of his attempt to open the entrance gate at Cabot industrial facility fouling the track and being pulled from the end ladder of the moving railcar onto the track where he was subsequently struck by the train and killed.

Within a week after the conductor's fatality, DREI management conducted safety briefings for DREI employees emphasizing GCOR rules on shoving movements and movement through gates or doors, and safety rules on riding on moving equipment. Additionally, DREI management increased efficiency testing for employees. Efficiency testing evaluates a worker's skills and overall ability to perform a task safely and correctly, and reinforces compliance with rules.

Following the conductor's death, DREI management conducted safety briefings for DREI employees on the rules associated with train movement. DREI also increased the efficiency testing of employees to reinforce safety rules and to evaluate skills and ability. Further, SOFA issued an alert reminding employees to avoid close or no-clearance hazards and to hold job briefings whenever a job or situation changes.
