Railroad Investigation Report: RIR-22/003

# Southeastern Pennsylvania Transportation Authority Fatality at Spring Garden Station

Philadelphia, Pennsylvania July 28, 2021

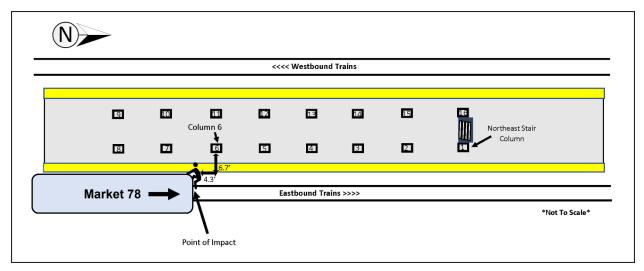
On Wednesday, July 28, 2021, about 2:28 p.m. local time, a man was struck and killed by a train at the Spring Garden Station platform in Philadelphia, Pennsylvania.<sup>1</sup> As the Southeastern Pennsylvania Transportation Authority (SEPTA) Market-Frankford Line (MFL) passenger train number 78 entered the station for a normal station stop, the man fell from the platform into the path of the eastbound train and was struck and killed.<sup>2</sup> (See figure 1.) At the time of the accident, the weather was mostly cloudy skies.

#### Figure 1. Sketch of the accident scene. (Source: SEPTA.)

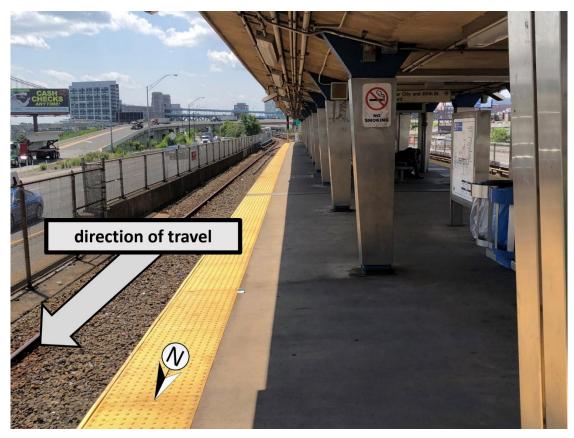
Simultaneously, MFL train 78 entered the station for a scheduled station stop. (See figure 2.) The train operator was using normal braking to slow the train and was looking forward and toward the man as the man approached the platform edge. At the platform edge, the man took an additional step, which landed his foot halfway off the edge, causing him to lose his balance and fall into the path of the train. The train struck the man as he fell, and he was killed.

Figure 2. Spring Garden Station. (Photo courtesy of Pennsylvania Department of Transportation.)

Investigators inspected Spring Garden Station and found the area consisted of tangent track and platform areas with no physical obstructions. The platform provided adequate sight distance for approaching trains. Walking surfaces were dry, regular, even and free of debris and obstructions. The yellow tactile warning strip was present, dry, secure, clean and properly installed.
