Railroad Investigation Report: RIR-22/05

# Alabama Export Railroad Fatal Collision with Maintenance-of-Way Equipment

Prichard, Alabama  
November 17, 2020

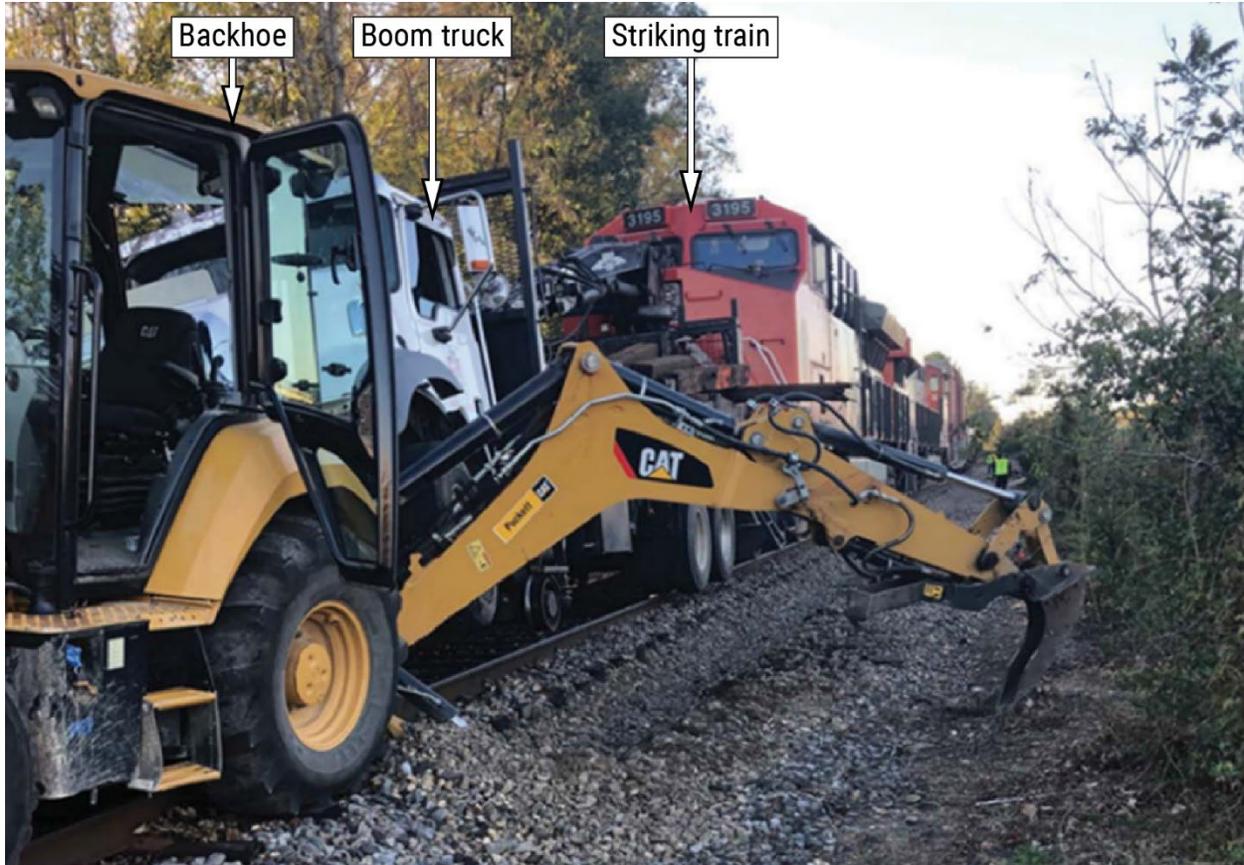
**Figure.** On-track maintenance equipment and striking train after the collision.

About 2:26 p.m., while traveling at a recorded speed of 19 mph through a right-hand curve, the train struck the boom truck. The collision shoved the truck, causing it to strike the backhoe, and the displaced equipment struck a group of contractors performing track maintenance at MP 3.7, killing one contractor and injuring three others. The engineer did not apply brakes before the collision and the throttle was in position 2 (low power). The contractors told National Transportation Safety Board (NTSB) investigators that they did not hear a train horn before the collision.

In response to this collision, ALE implemented over 25 managerial and operational changes, including updating and implementing safety plans that corrected issues related to on-track safety, operational communication, and internal oversight for electronic device usage and train operations. Additionally, ALE will no longer use contractors for track maintenance. The ALE employee who was operating the train was decertified as an engineer and terminated.
