NTSB/RIR-22/06

# Norfolk Southern Corporation Employee Fatality

Baltimore, Maryland

February 7, 2019

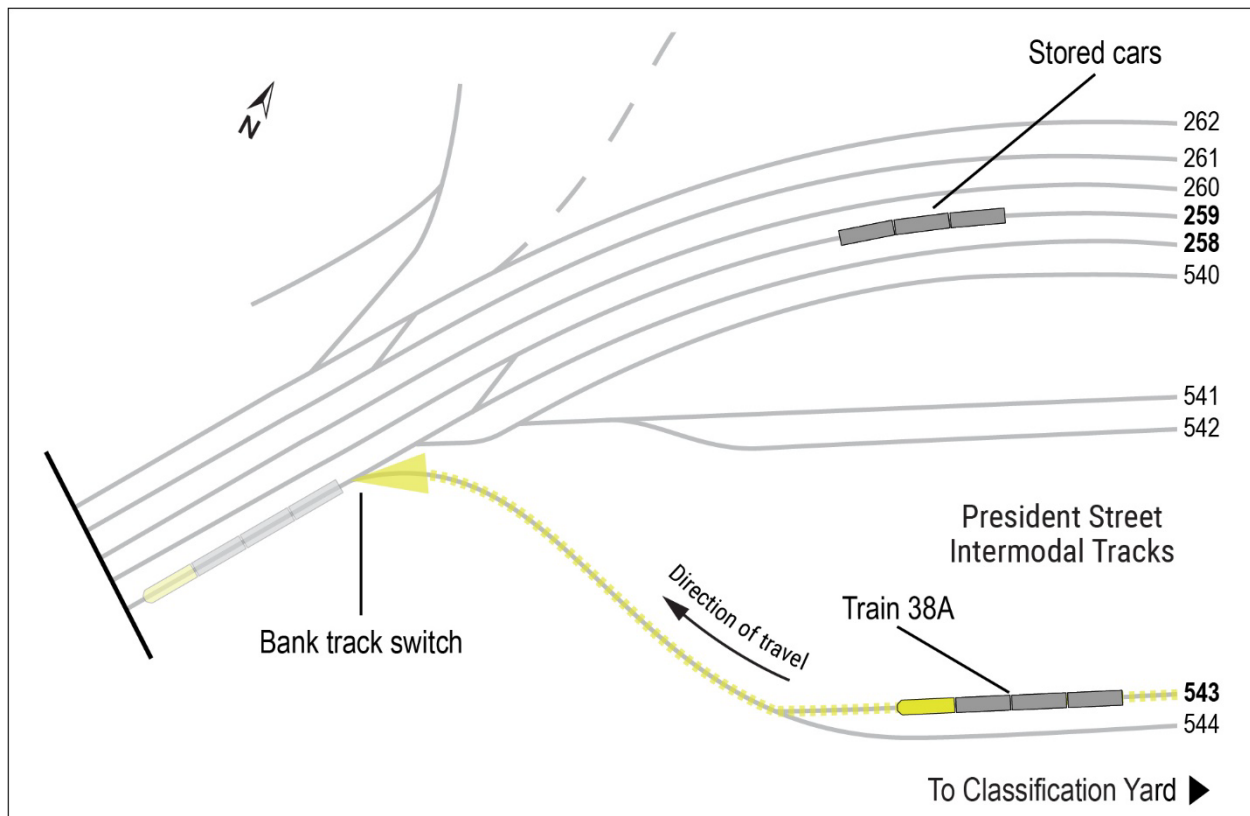
**Figure 2.** Train 38A movement south through President Street intermodal tracks.

Note: The yellow line and arrow at the bottom of the graphic show the movement of train 38A south after it aligned with track 543 and headed toward the Bank track switch to drop off four railcars and continue south.

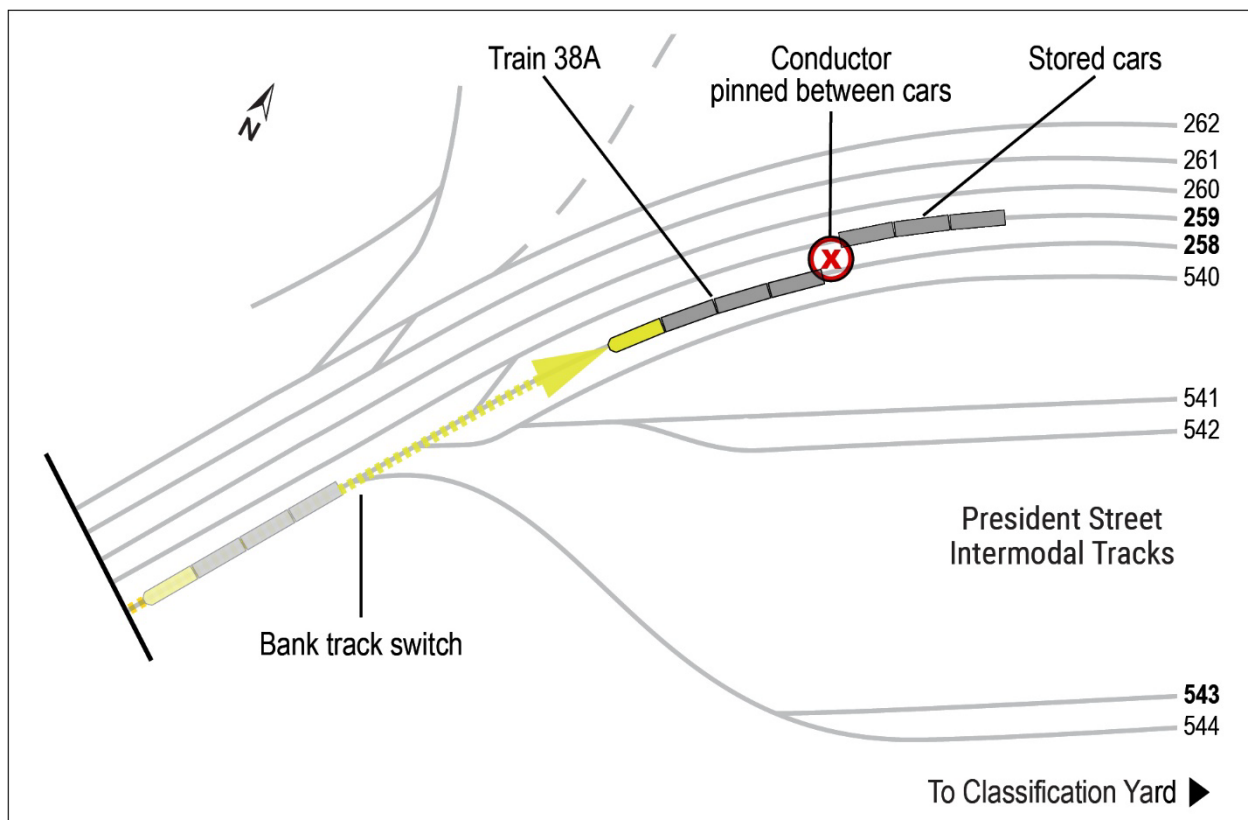
**Figure 3.** Train 38A movement north on track 258 and accident site.

Note: A yellow arrow on track 258 shows the reverse movement north of train 38A, starting at the Bank track switch, to the stored railcars on track 259 and the accident site.

At the accident location, six tracks are in a right-hand curve used for railcar storage. These tracks have close-clearance restrictions due to the limited space between the tracks. The track centers measured at the accident location were between 11 feet 9 inches and 12 feet 1 inch. *NS Maintenance-of-Way Standard*
