Railroad Investigation Report NTSB/RIR-22/07

Collision Between Sacramento Regional Transit District Light Rail Vehicles

Sacramento, California
August 22, 2019

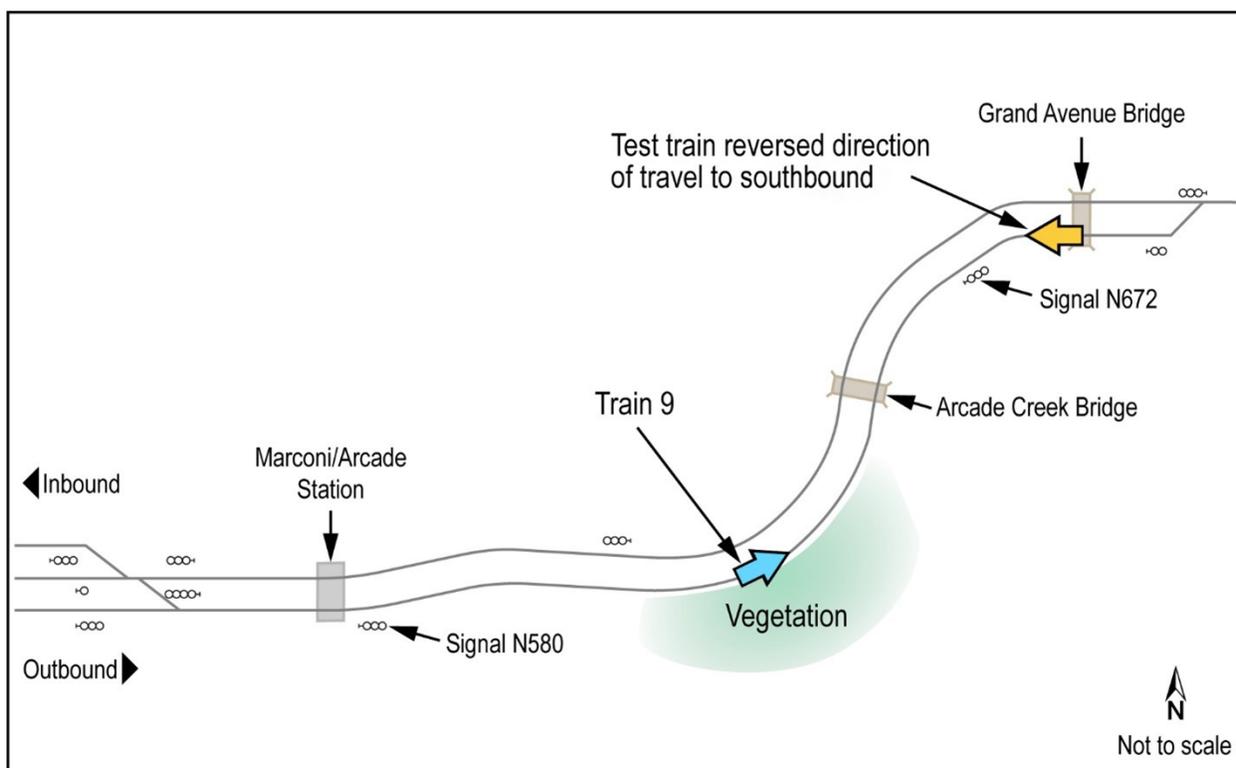
Figure 2. Train positions before the collision.

He could not determine if the headlight he saw ahead of his train was on the same track until the opposing train, train 9, traveled around the curve and cleared the trees. (See figure 2.) At 9:38 p.m., while operating about 28 mph, the test train operator applied dynamic braking to slow his train.¹⁰ Soon thereafter, he applied the emergency brakes, stopped the train, and evacuated the control cab into the passenger area before impact.

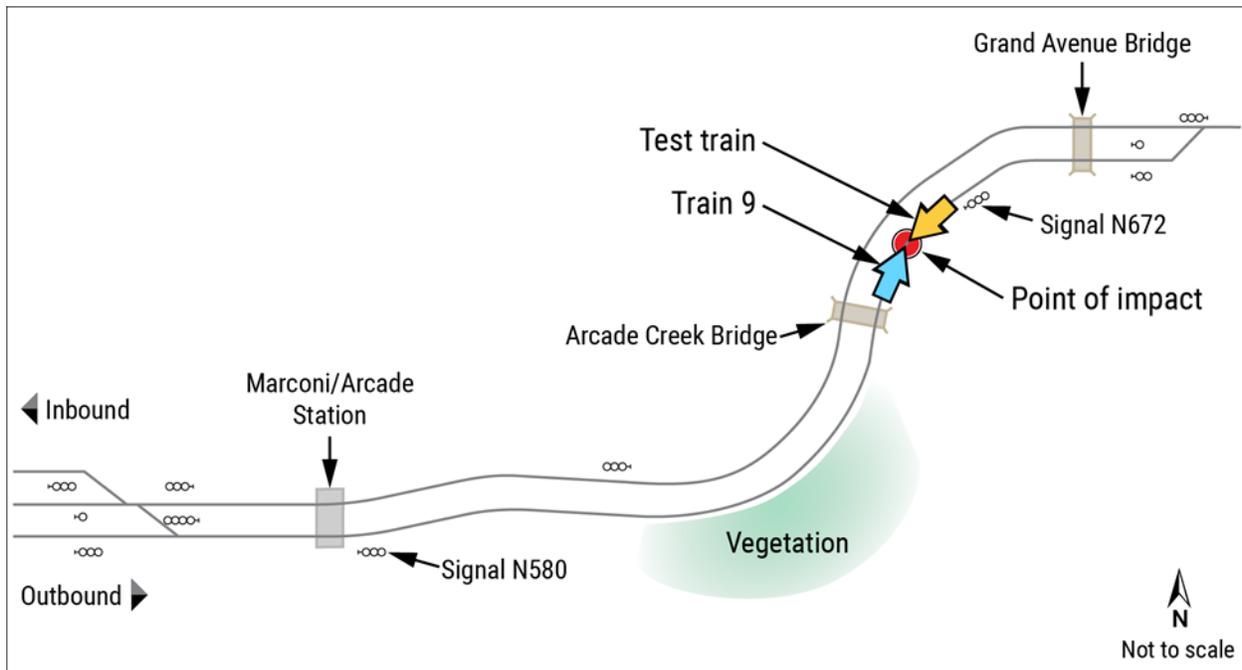
Figure 3. Movement of test train (LRV 310) and train 9 leading to the collision.

later, 50 yards south of the intermediate signal N672. Train 9 was traveling 32 mph when it collided with the stopped test train. (See figure 3.)

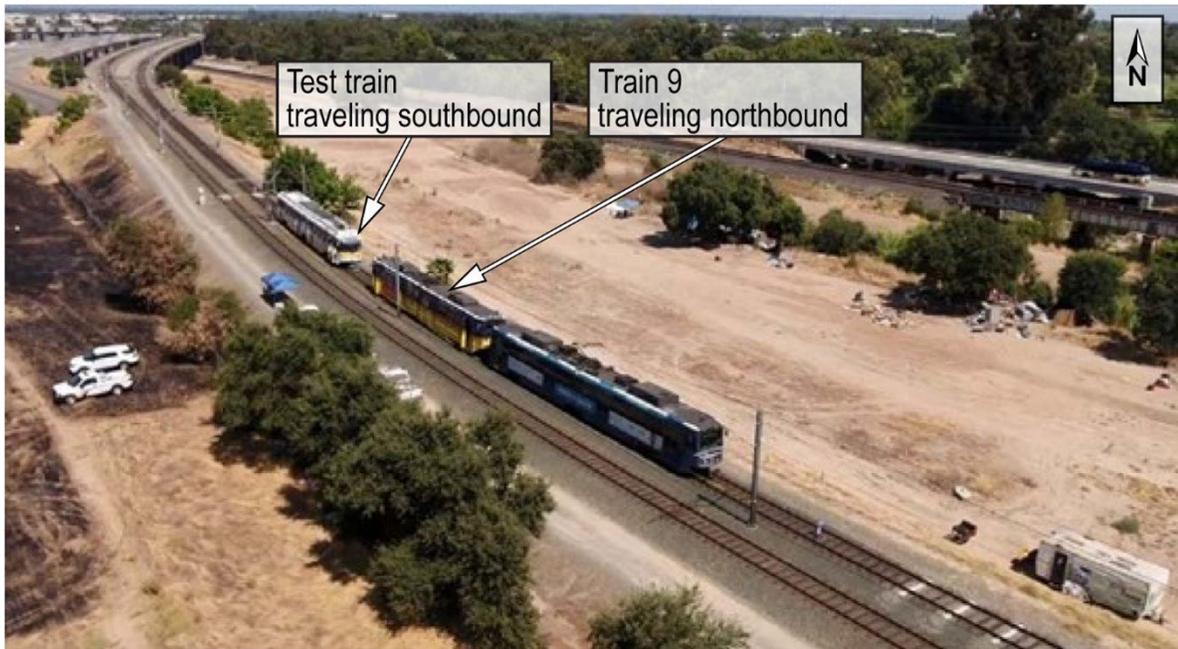
Figure 4. Aerial view of collision site. (Source: Associated Press.)

After the collision (See figure 4.), both operators radioed Metro Control to report the collision. The Sacramento police and fire departments, along with SacRT officials, responded to the collision. At the time of the collision, most passengers had been seated and many were thrown to the floor. Thirteen people were transported to area hospitals with non-life-threatening injuries.

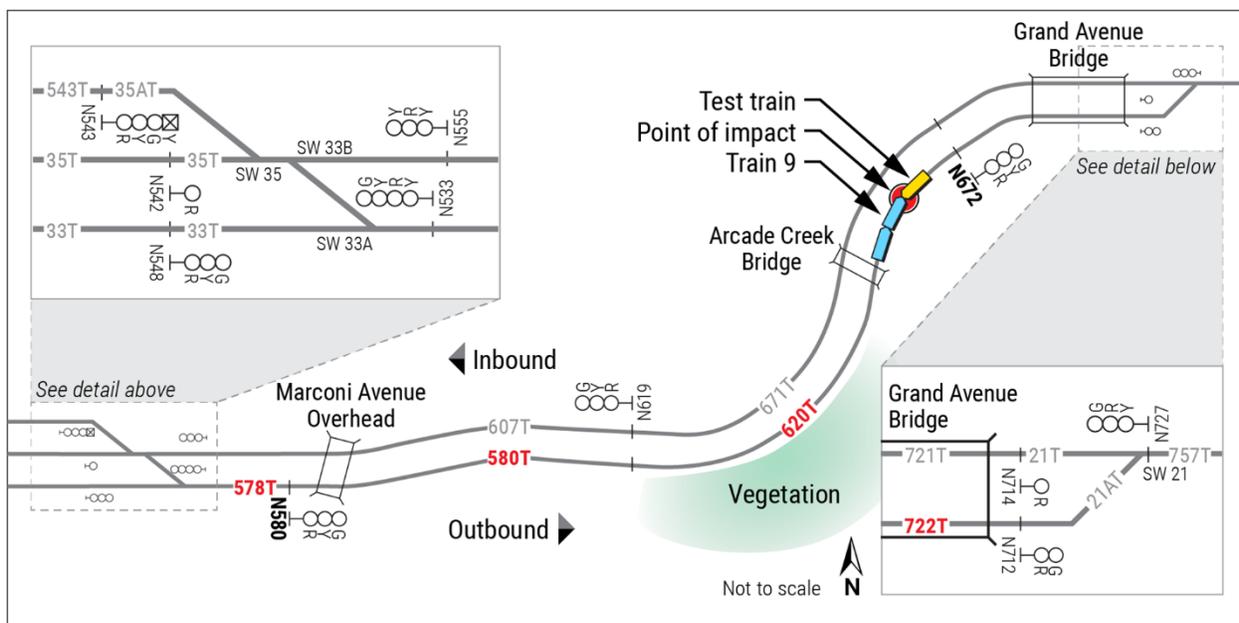
Figure 5. SacRT collision area depicting track circuits and signaling system.

Train movements on the segment of track where the collision occurred were governed by operating rules, general orders, and the signal indications of an automatic block signal system. An automatic block system is a series of consecutive blocks along the track in which signals are controlled by the trains themselves. Entry to each block is governed by block signals. The presence or absence of a train is determined by track circuits, which are activated by a train or by certain conditions affecting the use of the block. Signals are arranged for train movements in a specified direction on the inbound and outbound mainline tracks. (See figure 5.) For example, signal N580 has two track circuits in it, 580T and 620T, which end near signal N672. Track circuit 722T is the only track circuit for signal N672.

The NTSB verified the track circuits for 578T, 580T, 620T and 722T.¹⁷ After verifying the track circuits operated as the system was designed, investigators simulated train movements in both directions on the outbound track observing signal N672 to see how the signal aspects were displayed. During the simulation, signal personnel were stationed by signal N580 and signal N672. Investigators confirmed

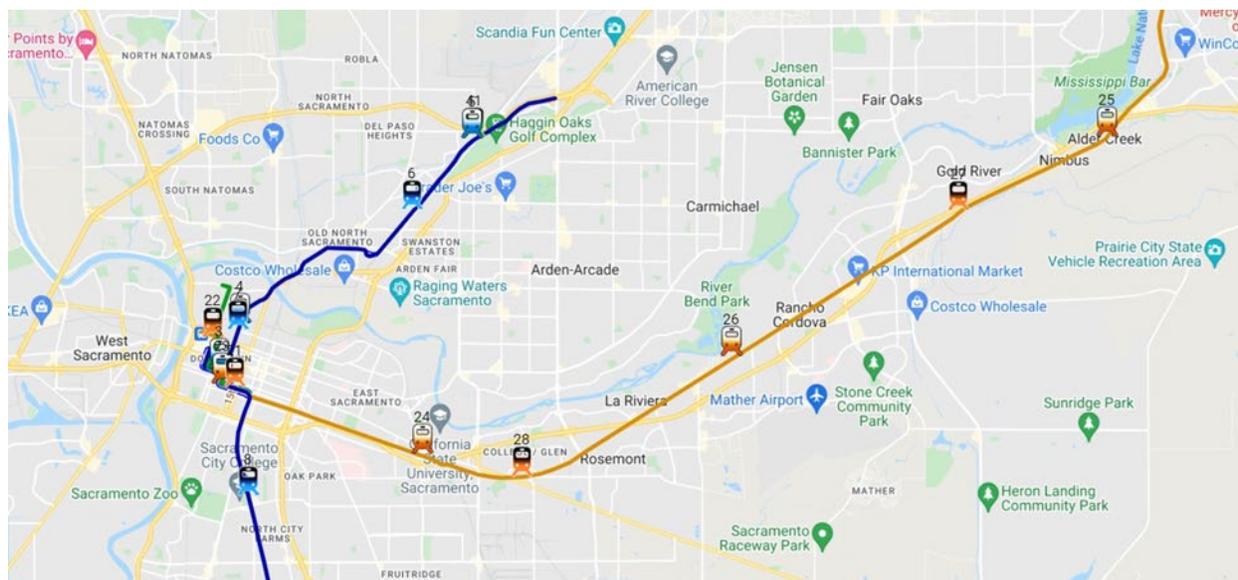
Figure 6. Example of the SacRT consist manager display.

SacRT's consist manager is a computer program accessible on the transportation supervisors' workstation that tracks the location of trains by using global positioning system technology. Figure 6 shows an example graphic displayed on the consist manager.

The transportation supervisor who was on duty at the time of the collision told the NTSB that he routinely used the consist manager during the day and had the program pulled up on one of the computer screens in the control center.²¹ However, he also told the NTSB that in the evening, he rarely used the consist manager because he was occupied with radio and phone communications and paperwork.
