Kansas City Southern Railway Conductor Fatality

Tupelo, Mississippi
December 23, 2020

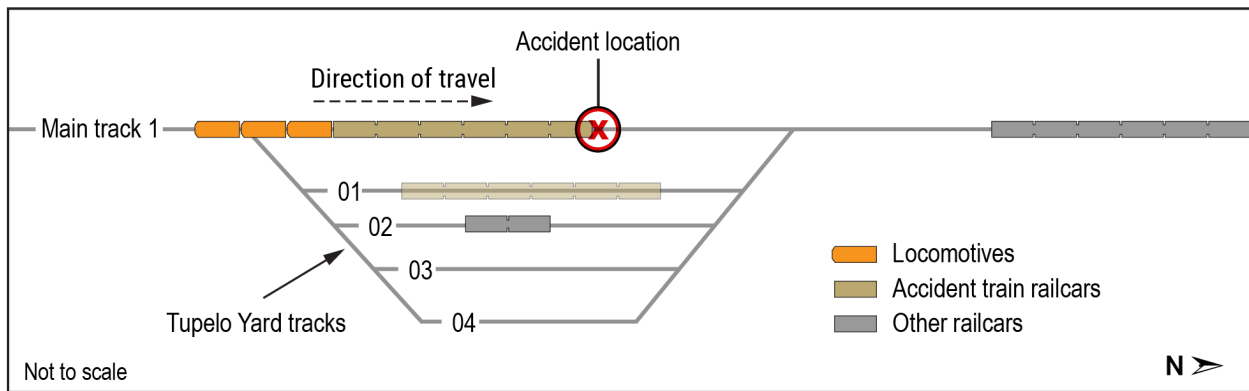
On December 23, 2020, about 6:55 a.m. local time, the conductor of Kansas City Southern Railway Company (KCS) train L-CO302-22 was struck and fatally injured by the train in the Tupelo Rail Yard in Tupelo, Mississippi.¹ The accident occurred on main track 1 at milepost 278.0 on KCS’s Artesia Subdivision. (See figure 1.) At the time of the accident, the train consisted of 3 locomotives and 22 railcars. It was dawn, the sky was clear, and the temperature was 44°F with light winds from the south.

Figure 1. Diagram of accident location.

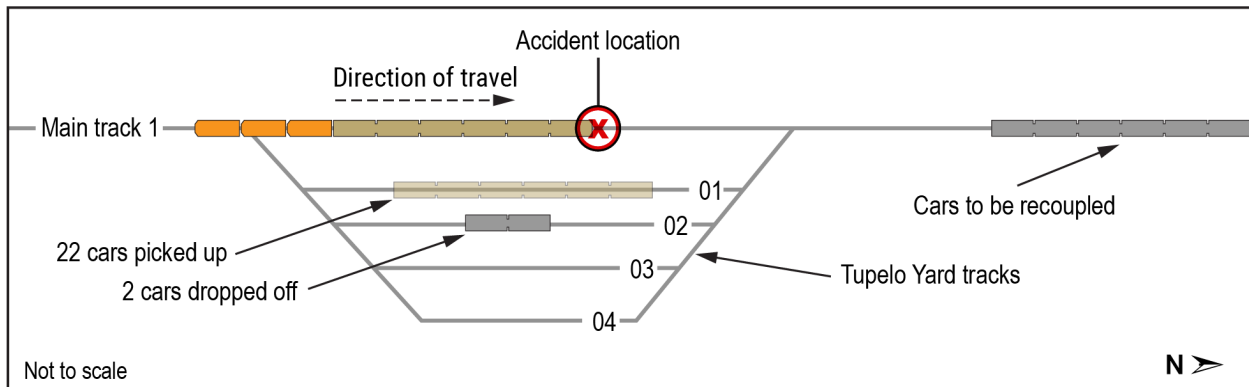
After arriving at the north end of Tupelo Rail Yard, the crew uncoupled and secured railcars 3 through 46 on main track 1, leaving two railcars connected to the locomotives. The crew then proceeded to the south end of Tupelo Rail Yard where they uncoupled and secured the remaining two railcars on yard track 2. The crew then picked up 22 railcars from yard track 1 and returned to main track 1 to recouple with the cars left on main track 1. The accident occurred on main track 1. (See figure 2.)

Figure 2. Diagram of accident location and switching operation.

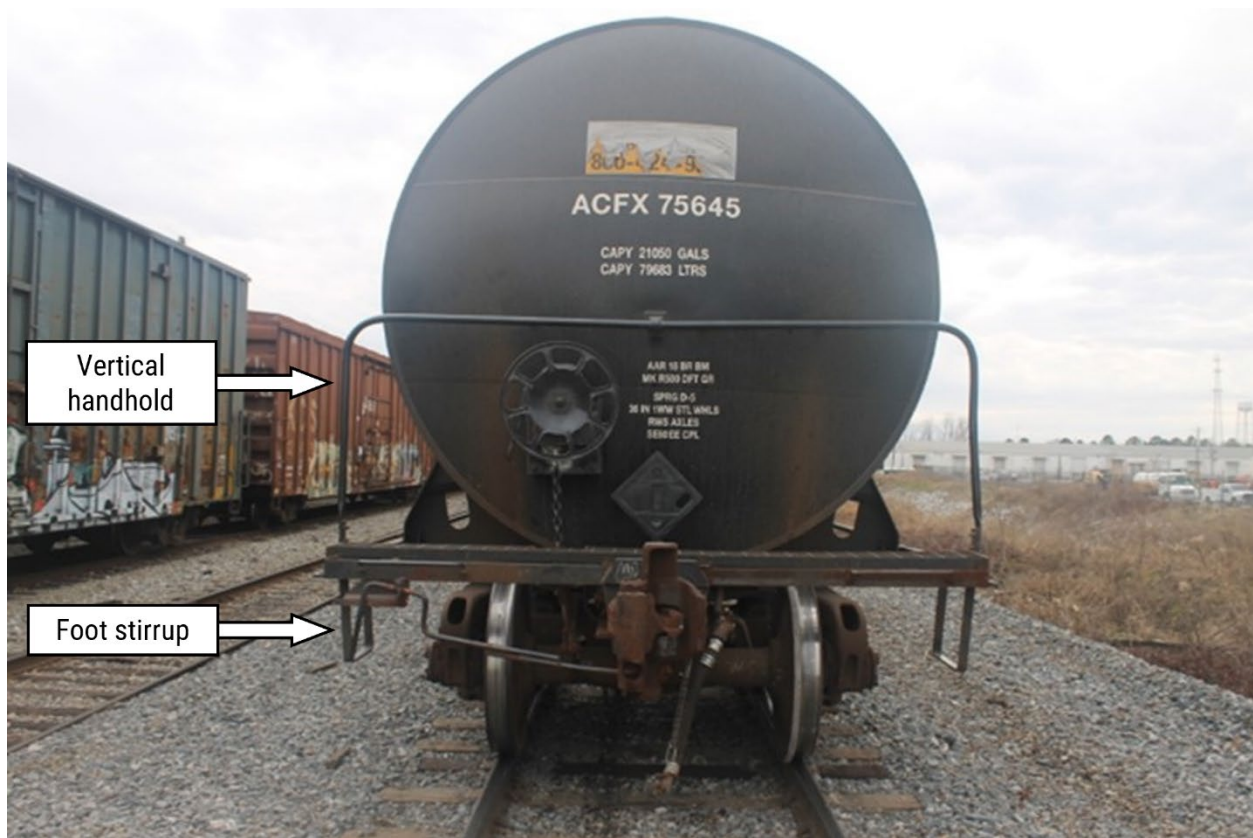
The railcar that the conductor was riding was a DOT-111 tank car. The railcar was equipped with a foot stirrup and vertical handhold at each corner. (See figure 3.)

Figure 3. The end of the railcar where the conductor was riding.

NTSB investigators could not determine the conductor's stance while riding the northeast corner of the railcar, including how he was using the handrail and stirrup and whether he was maintaining three points of contact.⁸ None of the KCS employees interviewed during the investigation witnessed the accident, and the train's forward- and rear-facing locomotive image recorders did not have a view of the conductor.

The conductor was likely holding on to a vertical handhold while operating a handheld radio and may have been in an unstable position while preparing to make the coupling. If slack action occurred unexpectedly, the conductor could have fallen into the path of the moving train.
