Railroad Investigation Report: RIR-22/09

Union Pacific Railroad Derailment with Bridge Strike and Fire

Tempe, Arizona
July 29, 2020

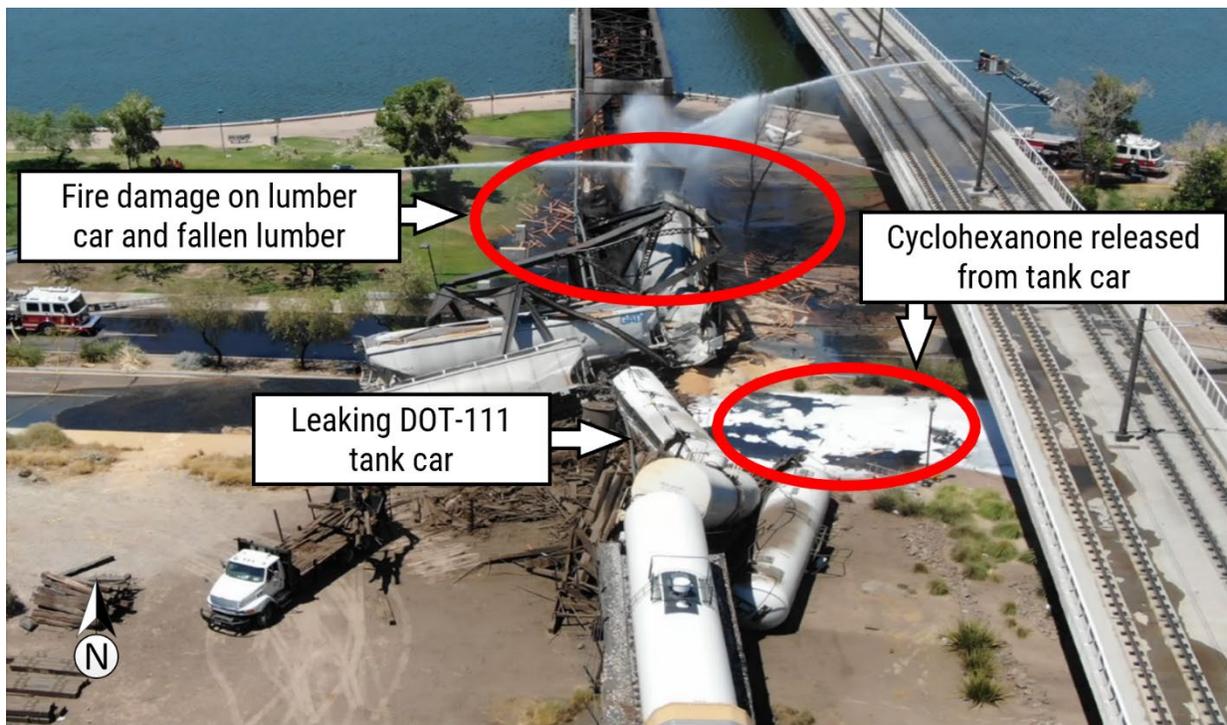
On July 29, 2020, about 6:06 a.m. local time, a northbound Union Pacific Railroad (UP) freight train, MTUPX-29, derailed 12 railcars at the south end of the railroad bridge over Tempe Town Lake on UP's Phoenix Subdivision in Tempe, Arizona.¹ At the time of the derailment, train MTUPX-29 was a mixed freight train consisting of 3 locomotives and 97 railcars. One of the derailed railcars struck the bridge structure, and part of the bridge collapsed, dropping railcars and bridge structure onto Rio Salado Parkway below and temporarily shutting down the road. Five of the derailed railcars were DOT-111 tank cars carrying various hazardous materials.² Two of these tank cars, both carrying UN1915 cyclohexanone, a flammable hazardous material, fell from the bridge during the derailment; the rest remained in-line with the track.³ One of the fallen DOT-111 tank cars

released about 2,200 gallons of cyclohexanone, creating a pool of hazardous material below the damaged bridge. The cyclohexanone did not ignite, and no other tank cars were breached. Derailed lumber cars, which remained on the bridge, caught fire during the derailment. Some lumber fell onto and near the road, where it burned for several hours. (See figure 1.) There were no fatalities; one firefighter was treated for smoke inhalation at the scene. UP estimated the damage costs to be about \$485,000 for railroad equipment, \$435,000 for track and structures, and \$10 million for the bridge. On the morning of the derailment, the sky was clear, and the temperature was 90°F with north-by-northwest winds at 5-8 mph.

Figure 1. Aerial view of the derailment scene. (Photo courtesy of Union Pacific Railroad.)

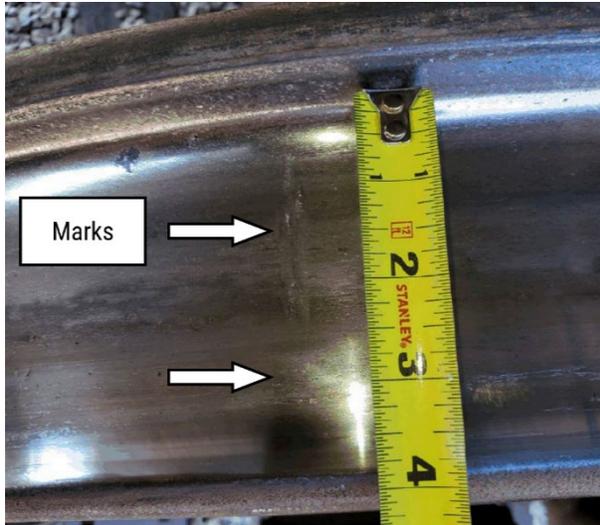
Railcars 49-60 (counting backward from the head of the train) derailed. While inspecting the derailed railcars, investigators discovered that railcars 48 and 49 had marks on their wheels consistent with having traversed a broken or damaged rail head.⁸ (See figure 2.) Railcar 48 had a mark on the trailing axle and railcar 49 had marks on the leading two axles; the marks were on three consecutive axles across two railcars. The marks were all on the east wheels. Investigators found no other marks of this kind on the train's other wheels.

Figure 2. Marks from railcar 49. (Photo courtesy of the Federal Railroad Administration.)

The first physical evidence of abnormal operation is a mark on the rearmost east-side wheel of railcar 48, which indicates that it traversed a broken rail end. The lack of marks on wheels up-train of railcar 48 indicates that the first 47 cars traversed the rails normally, without encountering any rail breaks.

Marks on the first two east-side wheels of railcar 49 show that they too rolled over the broken rail end. Subsequent wheels did not exhibit similar marks, indicating that the train had derailed far enough that wheels were no longer traversing the broken rail end.

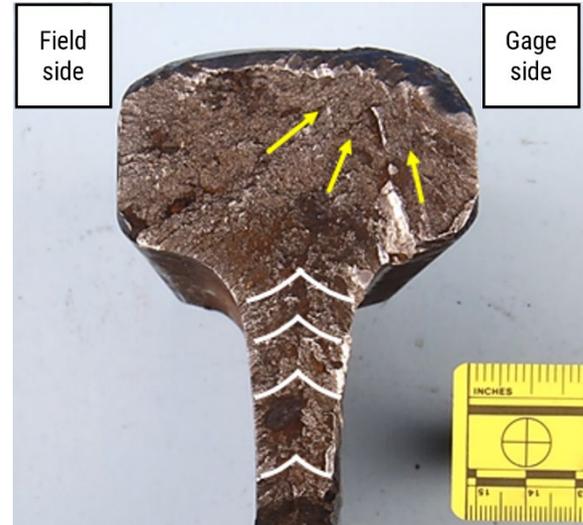
In reconstructing the damaged rails, investigators found rail-end batter on a rail segment from the eastern rail about 30 feet south of the first steel span, where the track was supported by a ballast deck over a wooden trestle.⁹ (See figure 3.) The segment exhibited departing-end batter, and no other recovered segments exhibited rail batter of any kind. The NTSB's metallurgical analysis of the rail segment found no signs of rail fatigue or defects, but examination of the fracture face revealed a chevron pattern (shown in white in the figure) and micro features (marked with yellow arrows) consistent with overstress.¹⁰

Figure 3. The fracture face of a recovered rail segment.

Rail reconstruction identified a single segment of rail, about 30 feet from the bridge's first steel span, that showed rail-end batter, a type of damage inflicted by wheels traversing a broken rail end. Given the wheel marks and the single rail segment exhibiting rail-end batter, physical evidence places the initial point of derailment at this broken rail. Forty-seven railcars traversed the rail normally before it broke under the 48th. The final two east-side wheels of railcar 49 (and all the wheels of 11 subsequent cars) derailed far enough that they were no longer traversing the broken rail end, as shown by their lack of marks.

Metallurgical analysis of the rail near the derailment point did not identify any signs of fatigue or flaws. The fracture pattern is consistent with overstress, suggesting that the rail broke due to forces applied immediately before the derailment.
