Railroad Investigation Report: NTSB/RIR-22/11

Pan Am Railways Employee Fatality

Newington, New Hampshire

May 19, 2021

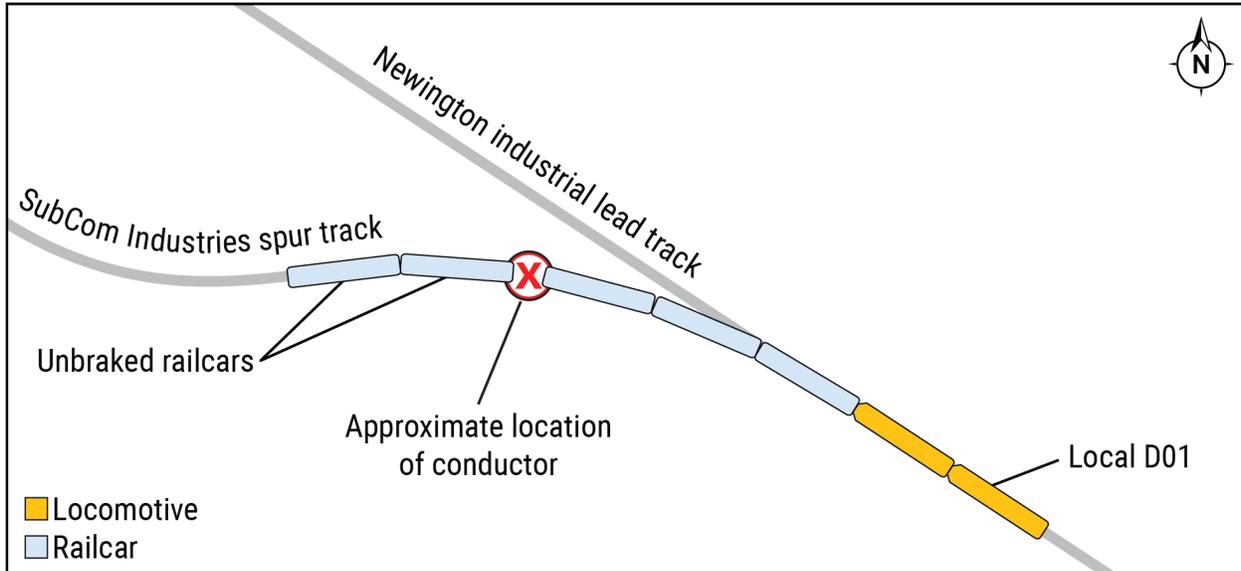
Figure 1. Diagram of accident location.

On the day of the accident, the train crew (comprising an engineer and a conductor) was picking up three empty railcars and delivering two loaded railcars to the SubCom facility. The three empty railcars were positioned on the SubCom spur track linking the Newington industrial lead track to the SubCom facility. The empty railcar nearest the industrial lead track needed to be coupled to the second and third empty railcars, which were already coupled together as shown in figure 1.³

During the sixth attempt, the conductor stepped into the gap between the stationary train and the unbraked pair of railcars. As the unbraked railcars rolled downhill towards the train, the conductor was pinned between the couplers of the stationary train's last railcar and the nearer of the pair of unbraked railcars. (See figure 1.)

The conductor of PAR train Local D01 was pinned between a pair of unbraked railcars that rolled east along a descending grade toward the last railcar of the stationary train during switching operations. The crew was attempting to finish assembling the train using gravity coupling.

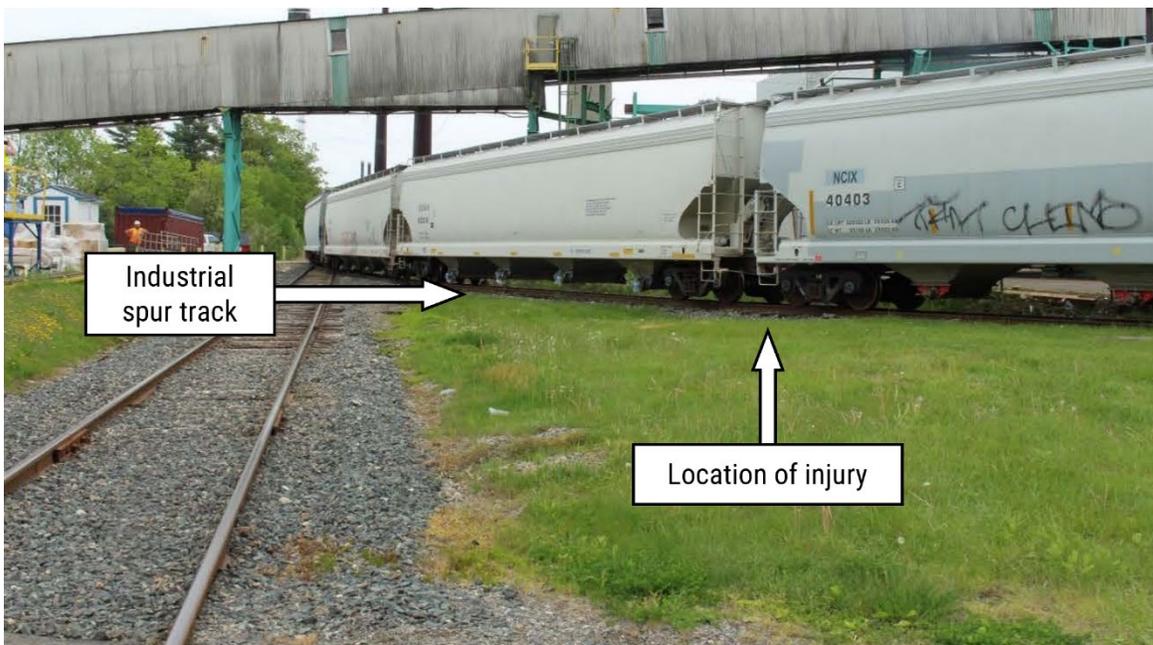
Figure 2. Reconstructed accident scene.

The conductor radioed his injury to the engineer and asked him to move the train forward. This movement allowed the conductor to extricate himself from between the railcars and lie down on the grass nearby. (See figure 2.) The engineer called 911. The Newington Fire Department and Newington Police Department both responded, and police and an ambulance arrived on the scene within 5 minutes. The conductor was transported to a local hospital where he later died from his injuries.
