Railroad Investigation Report: NTSB/RIR-22/12

# CSX Transportation Remote-Control Operator Fatality

Richmond, Virginia  
October 12, 2020

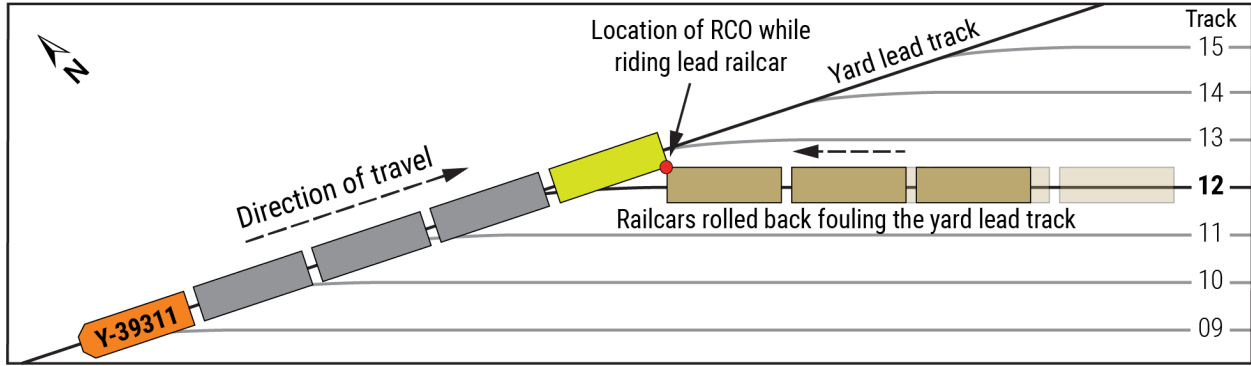
On October 12, 2020, about 2:17 a.m. local time, the remote-control operator (RCO) of CSX Transportation (CSX) train Y-39311 was killed in the Acca Rail Yard in Richmond, Virginia.<sup>1</sup> The RCO was riding on the right side of the lead railcar during a shoving movement when the train he was riding struck a set of three railcars that had rolled back from track 12 fouling the yard lead track.<sup>2</sup> (See figure 1.) At the time of the accident, the sky was dark, but the location was illuminated with commercial light-emitting diode lights mounted on poles, there was light-to-moderate rainfall, and the temperature was 65°F.

**Figure 1.** Overhead illustration of the accident location.

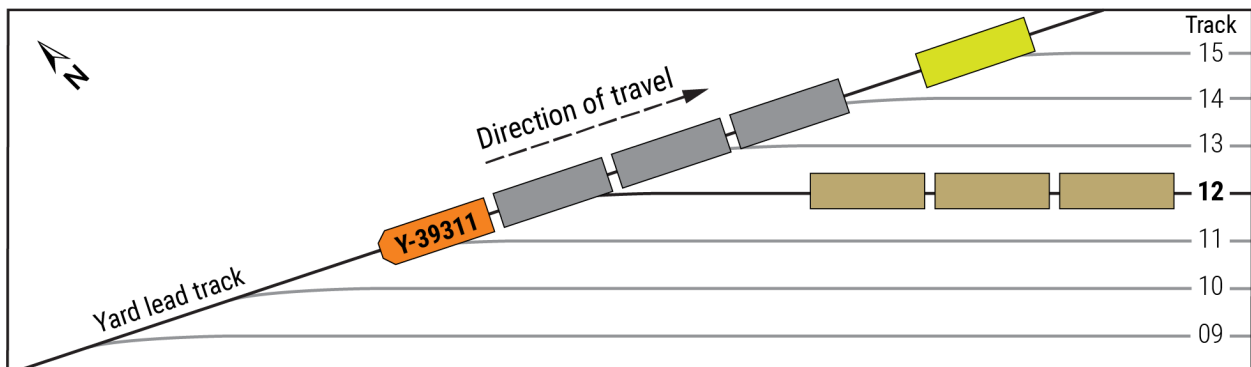
The RCO was working alone at the time of the accident and operating train Y-39311, which consisted of one locomotive and 18 railcars.<sup>3</sup> After the RCO finished kicking three railcars onto track 12, he operated the train southeast on the yard lead track to pick up a railcar he had dropped off past the switch for track 14.<sup>4</sup> Figure 2 shows train Y-39311's movement to pick up the railcar past track 14, and the approximate position of the three railcars after being kicked onto track 12.

**Figure 2.** Train Y-39311's movement and the position of the three railcars on track 12.

After picking up the railcar past track 14, the RCO operated northwest, past the switch for track 12. The RCO then reversed movement and began operating southeast at a speed of about 4 mph on the yard lead track, intending to drop off the additional railcar on track 12. The RCO had not lined the switch for track 12, as the job required, after kicking the three railcars onto the track, and the three railcars had rolled back and fouled the yard lead track. As the RCO operated train Y-39311 southeast toward track

12, there was no longer adequate clearance, and the right (south) side of the lead railcar that the RCO was riding struck the corner of a railcar fouling the track.<sup>5</sup>
