Railroad Investigation Report: RIR-22/14

Canadian Pacific Railway Raking Collision and Impact with Standing Train

St. Paul, Minnesota
August 25, 2021

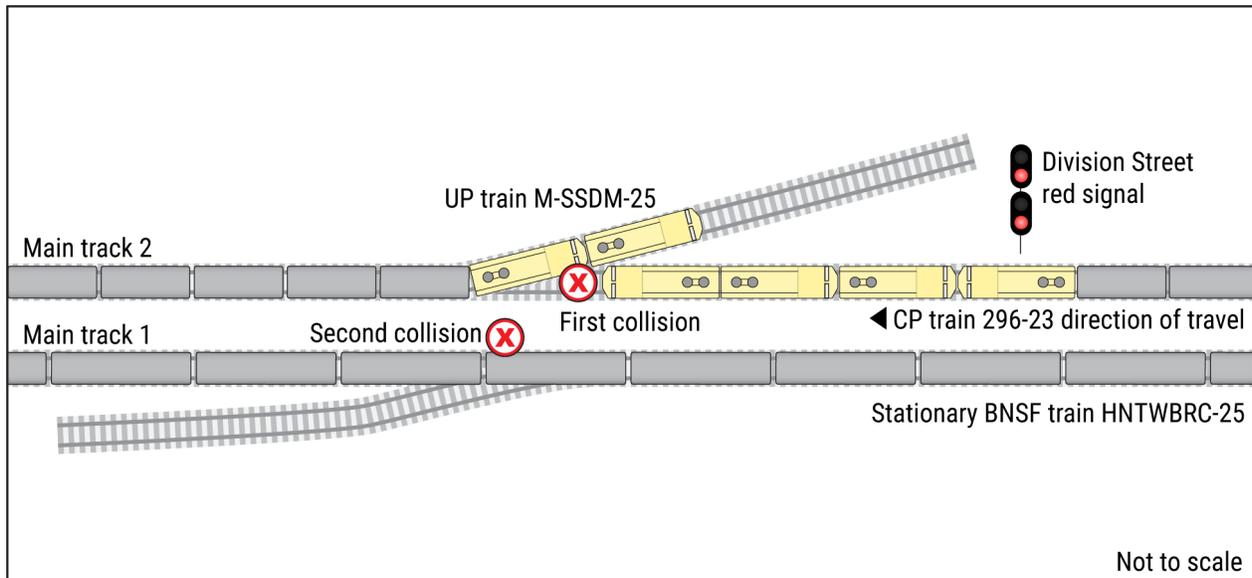
Figure 1. Diagram of collision.

released the brakes and started to descend the grade with the throttle in the idle position, moving toward control point Division Street, which displayed a red signal.³ (See figure 1.) The distance between the two control points was about 3,560 feet.

CP train 296-23 was traveling to St. Paul, Minnesota, on BNSF tracks. The train passed a red (stop) signal at control point Division Street at a speed of about 19 mph and collided with a standing UP train on the same main track, derailing one CP locomotive and two UP locomotives. The derailed CP locomotive then collided with a railcar of a BNSF train that was stopped on the adjacent main track.
