Railroad Investigation Report: NTSB/RIR-22-15

# Massachusetts Bay Transportation Authority Trolley Collision with Derailment

Brookline, Massachusetts  
July 30, 2021

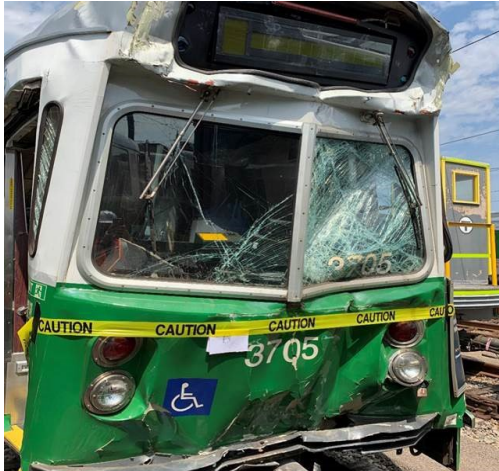
The NTSB's review of event recorder data from both trolleys showed that the striking trolley accelerated under full power for about 500 feet between the passenger stop at St. Paul Street Station and the point of impact near Harry Agganis Street, reaching a speed of about 33 mph when it struck the other westbound trolley, which was traveling about 10 mph. The impact accelerated the struck trolley to about 24 mph and caused it to derail. The struck trolley traveled about 240 feet westward before coming to rest east of the railroad-highway grade crossing at Crowninshield Road. Figure 2 shows the damage to the rear railcar of the struck trolley, railcar 3705. Figure 3 shows damage to the lead railcar of the striking trolley, railcar 3894.

**Figure 2.** Damage to the rear of railcar 3705 (rear railcar of struck trolley).

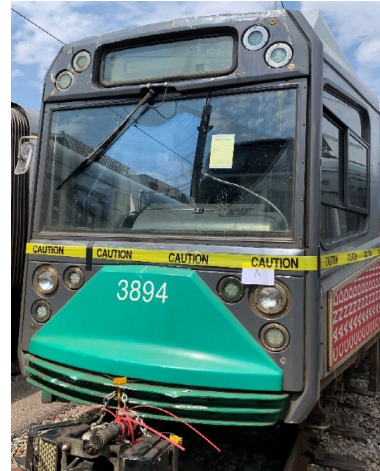
**Figure 3.** Damage to the front of railcar 3894 (lead railcar of striking trolley).
