Railroad Investigation Report: RIR-23/02

Passenger Fatality

Bay Area Rapid Transit

San Francisco, California
September 13, 2021

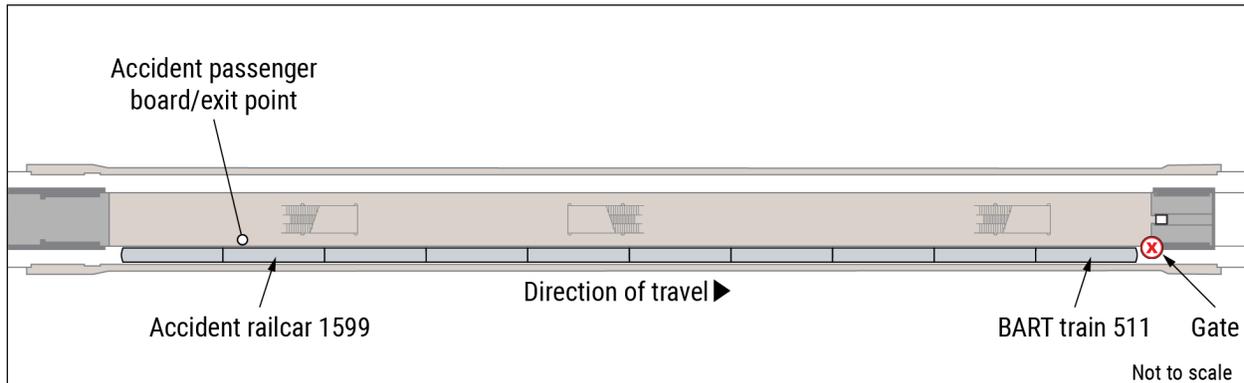
On September 13, 2021, about 3:13 p.m. local time, a Bay Area Rapid Transit (BART) passenger was dragged and killed as BART train 511 was departing the Powell St. Station in San Francisco, California.¹ About 3:12 p.m., the passenger and a leashed canine boarded railcar 1599, the ninth railcar of the 10-railcar train, at the Powell St. Station. The canine's leash was attached to a backpack the passenger was wearing. Seconds before the train's departure, the passenger exited the railcar onto the platform while the leashed canine remained on the train. The side passenger train doors (doors) closed on and pinched the canine's leash.² The train then departed the Powell St. Station. Surveillance video reviewed by National Transportation Safety Board (NTSB) investigators showed that the accident passenger attempted to open the railcar door and then attempted to free herself from the leash. Both attempts were unsuccessful, and the passenger, still attached to the leash, was dragged along the platform by the train

and collided with the gate at the end of the platform. (See figure 1.) The canine was not injured.

Figure 1. Diagram of BART Powell St. Station platform at the time of the accident.

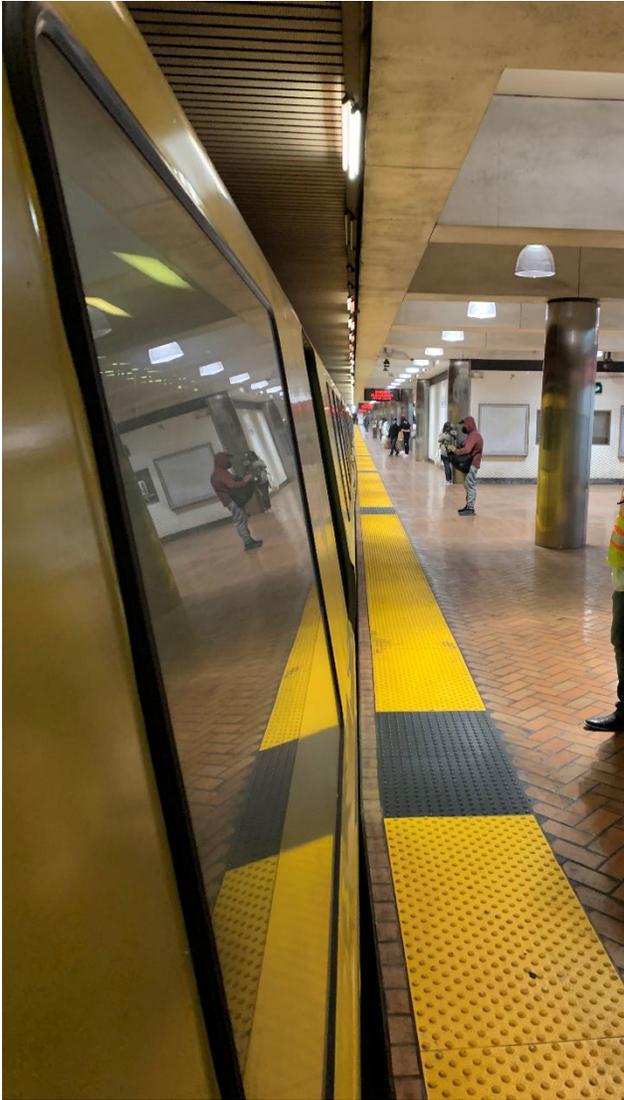
NTSB investigators also observed that ambient lighting conditions at the Powell St. Station at the time of the accident reduced the conspicuity of activity toward the far end of the platform.

Figure 2. Powell St. Station platform before completion of lighting improvements.

Postaccident sight distance observations conducted by NTSB investigators at the Powell St. Station revealed that dim ambient lighting conditions present in the station platform area at the time of the accident reduced the conspicuity of passenger activities toward the far end of the station platform. Specifically, the lighting conditions likely made it difficult for the train operator to reliably monitor and evaluate passengers exiting and entering the rear of the train at the platform when the operator performed his look-back procedure. BART has since completed lighting and painting improvements at the Powell St. Station and other nearby stations, increasing visibility for train operators. BART also has widely distributed an awareness campaign to educate passengers on safe travel practices with service animals and pets.

At the time of the accident, BART was in the process of replacing the platform lighting at the Embarcadero, Montgomery, Civic Center, and Powell St. stations with LED lighting, an upgrade from the original lighting. BART was also in the process of repainting the walls of the station platform areas a brighter color. The lighting and painting improvements at the Powell St. Station were completed in July 2022. These actions increased the illumination of the environment, improving visibility for operators performing the look-back procedure at their stations. (See figures 2 and 3.) BART is procuring more replacement lights and expects to complete lighting improvements at the 16th St. and 24th St. stations by spring 2023.

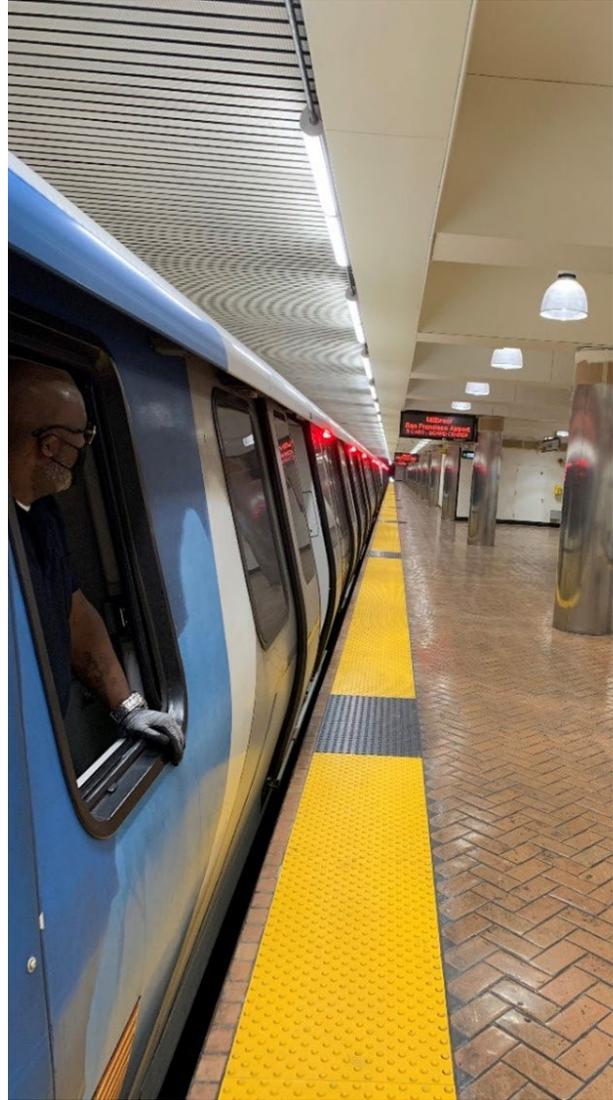
Figure 3. Powell St. Station platform after completion of lighting improvements.
