Railroad Investigation Report: RIR-23-03

Employee Fatality

Amtrak Train 163-15

Westerly, Rhode Island
January 15, 2022

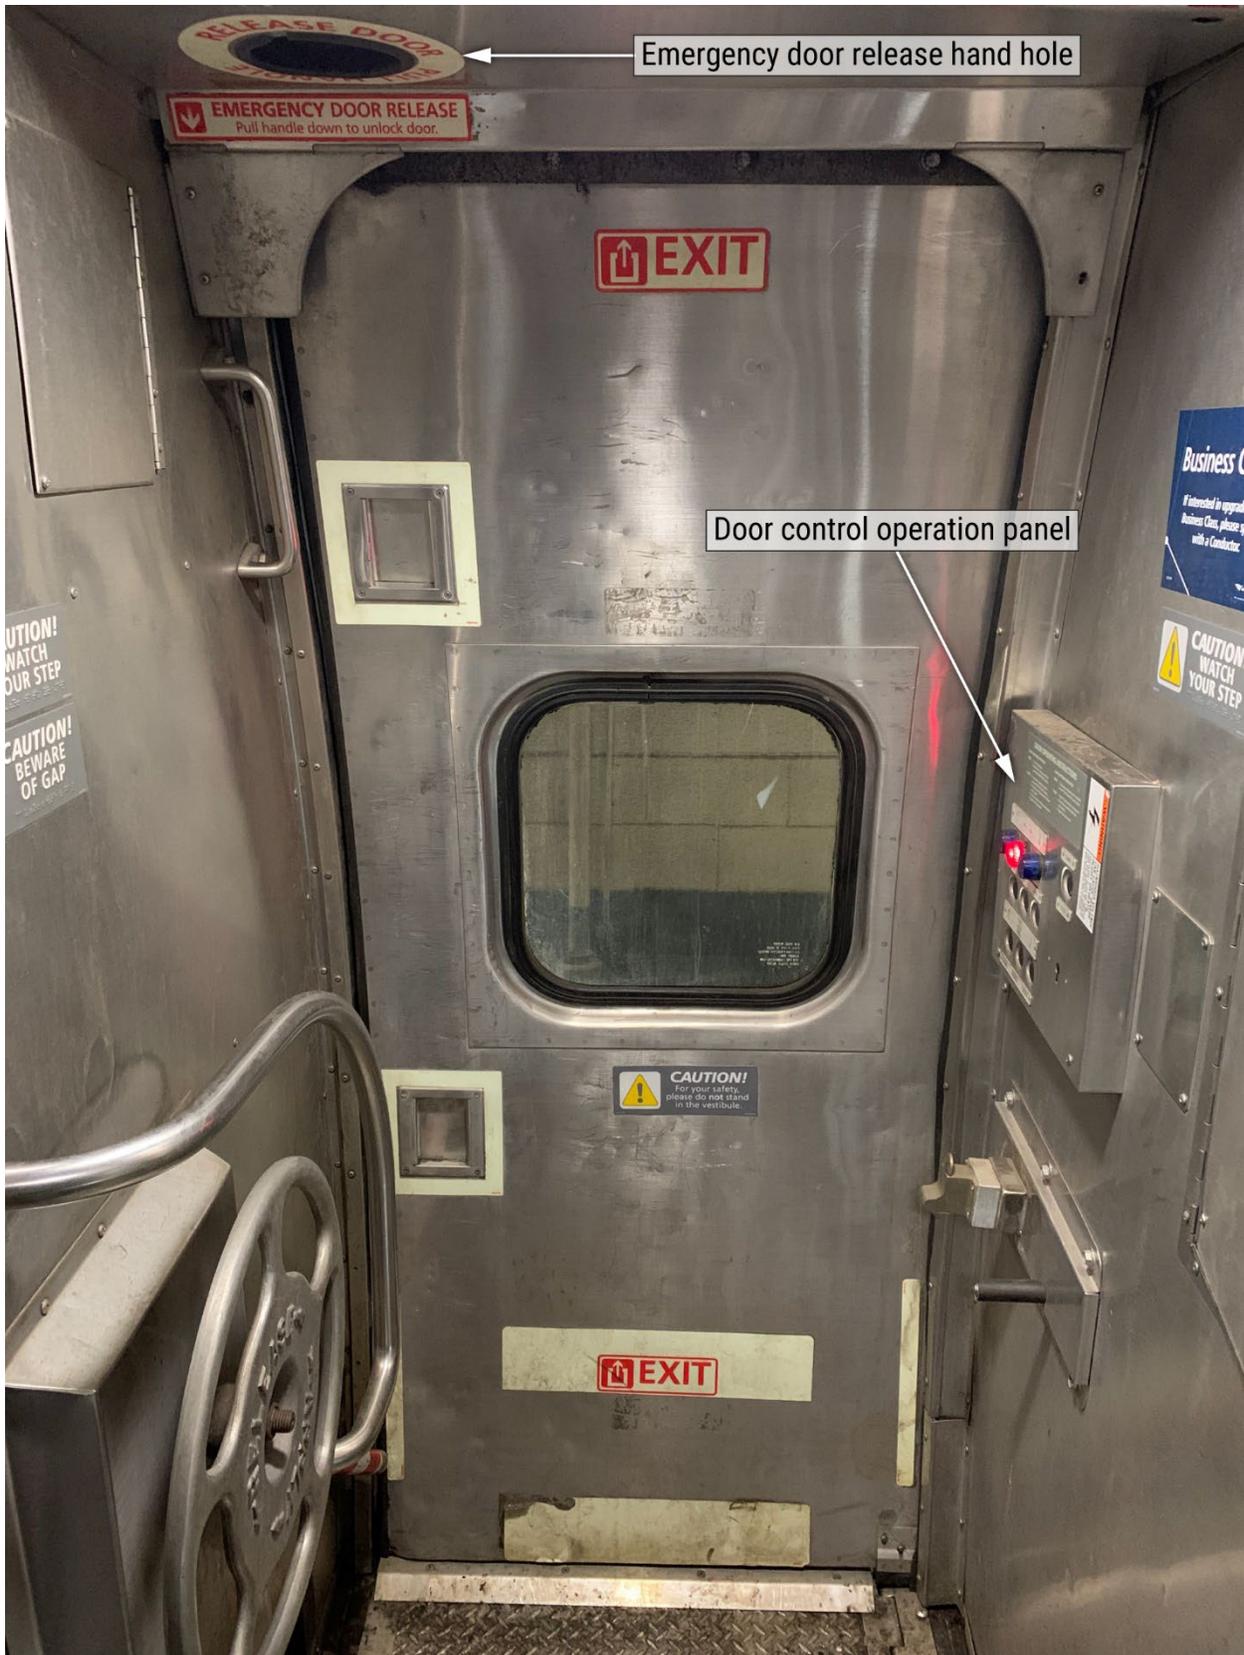
Another method, referred to as emergency opening, allows the door to be opened manually at any speed through the use of an emergency door release handle that is accessible through a hand hole in the side-door motor cover, located above the side door. When the emergency door release handle is completely down, the door mechanism will disengage, bypassing the safety interlock relay and allowing the door to be opened manually at any speed. Figure 2 shows an example of an Amfleet 1 side passenger door, such as the one in this accident.

Figure 2. Example of an Amfleet 1 exterior side door. (Photograph courtesy of Amtrak.)

accepted field practice intended for the use of monitoring the arrival or departure of trains from station platforms when necessary. Because train 163-15 was traveling at 40 mph, which is greater than the 3-mph threshold for the operation of the safety interlock relay that powers the side passenger doors, the emergency door release was most likely used by the conductor and assistant conductor to open the side passenger doors before arriving at Westerly Passenger Station. An open door on a moving train creates a fall hazard. After the accident, Amtrak issued a rule and amended special instructions to prohibit employees on the Northeast Corridor from opening side passenger doors while the train is in motion.

On March 14, 2022, Amtrak, through the issuance of a bulletin order, *Rule 3.21 Amendment, Amendment to Special Instruction 34-S10 and Special Instruction 940-S1 (Northeast Corridor from New York to Washington)*, modified its employee safety rules and operational procedures to be more restrictive and prohibited the opening of side doors until after the train has stopped (Amtrak 2022, 2022a).⁶
