Railroad Investigation Report: RIR-23/04

W.T. Byler Company Equipment Operator Fatality

Castroville, Texas
September 22, 2021

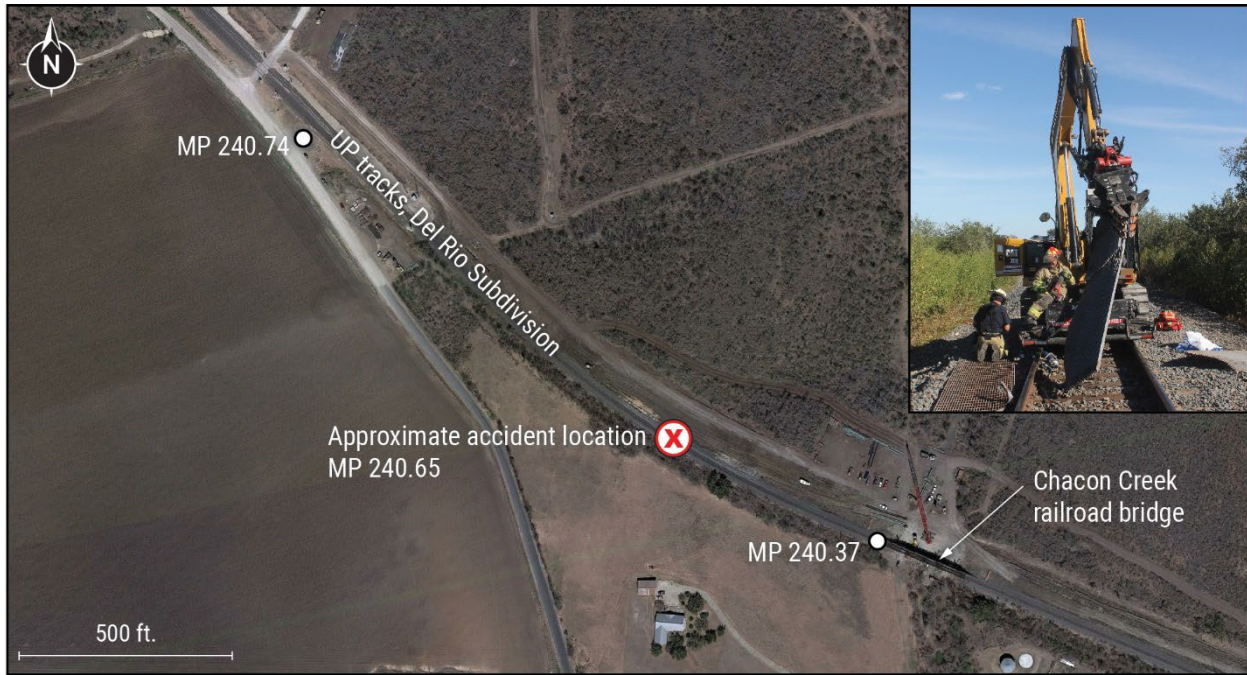
Figure 1. Overhead of accident location with a postaccident inset of the RMM. (Source: Google Earth.)

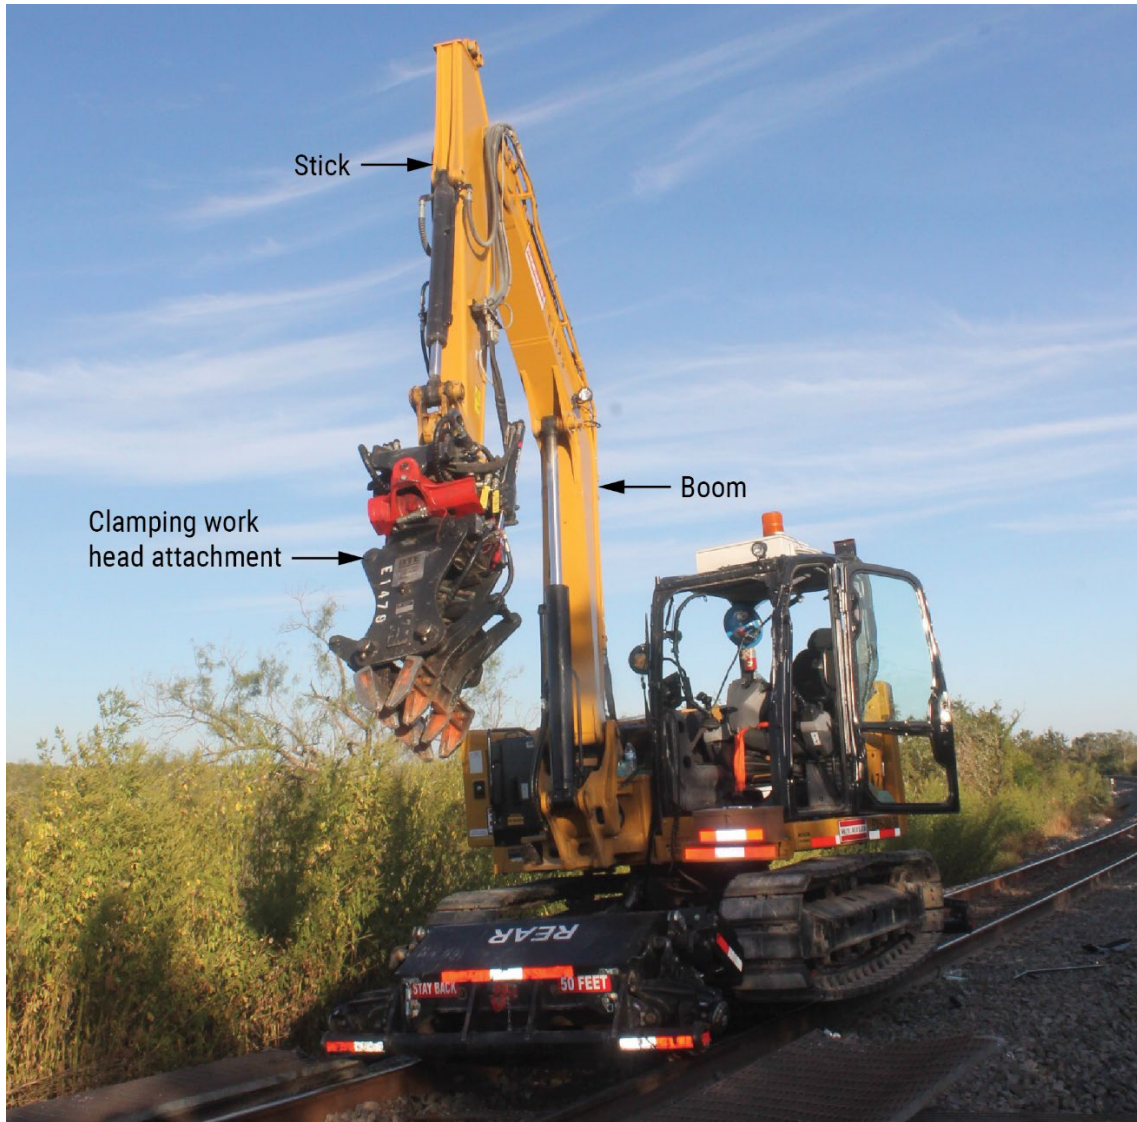
The accident RMM was a Caterpillar mini hydraulic excavator that had been outfitted with retractable railroad wheels by Ballast Tools Equipment (BTE) so that it could operate as a rail-mounted RMM.² The machine was equipped with a standard boom and stick for lifting materials over the front of the machine and had a lifting capacity rating of 6,549 pounds. Various work heads could be attached to the stick, such as grapples, digging buckets, and clamping attachments; a clamping work head attachment was selected for this job. (See figure 2.)

Figure 2. Accident RMM with clamping work head attachment. (Source: UP.)

head, which state that the attachment is designed for use with single crossties. The specification does not discuss other uses of this attachment.

Equipment specifications for the clamping work head attachment indicated that the attachment was specifically designed for use with single crossties, not steel grating panels. By using the clamping work head to move steel grating panels, the operator was not performing the work in accordance with equipment specifications. W.T. Byler now

As a result of this accident, W.T. Byler prohibited the use of the clamping work head attachment to move steel grating panels. Employees must use a grapple truck to move these panels.⁷ W.T. Byler also added rules to their safety program that prohibit workers from transporting materials suspended in front of RMM equipment above the

prohibits the use of the clamping work head attachment to move the panels and has hired two safety professionals dedicated to railroad projects.

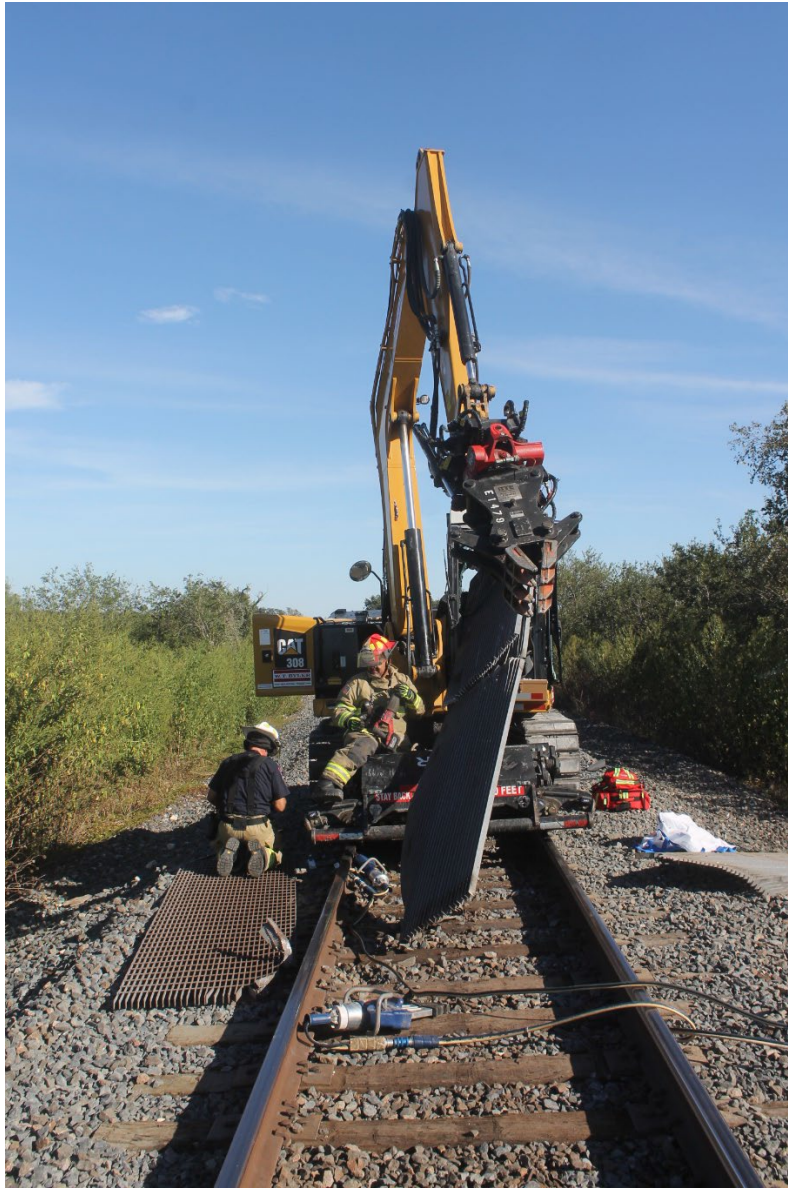
On September 24, 2021, NTSB investigators examined impact markings in the center of the track gauge. Gouges and scrapes in the crossties and ballast in front of the accident RMM indicated where the steel grating panels had fallen from the clamping work head attachment.

The final resting position of the RMM on the track was such that the steel grating panel, still gripped by the clamping work head attachment, was positioned with one end of the panel stuck in the ground directly in front of the RMM, in the center of the track gauge, and the other end extending through the broken front windshield of the RMM. (See figure 3.)

Figure 3. Postaccident position of steel grating panels and RMM. (Photo: UP.)

The National Transportation Safety Board determines that the probable cause of the September 22, 2021, equipment operator fatality was the use of a roadway maintenance machine to move a load of steel grating panels suspended in front of the machine with a clamping work head attachment that was not designed for use with such a load.

centerline of the track. These rules specify that operators using RMMs to transport suspended loads must position the loads over the field side of the track and must use tag lines (ropes attached to the lifted load) to stabilize the loads. Rail carts must be used when railroad clearance issues obstruct the movement of materials.
