Railroad Investigation Report: RIR-23/06

# BNSF Railway Employee Fatality

Denver, Colorado  
February 9, 2022

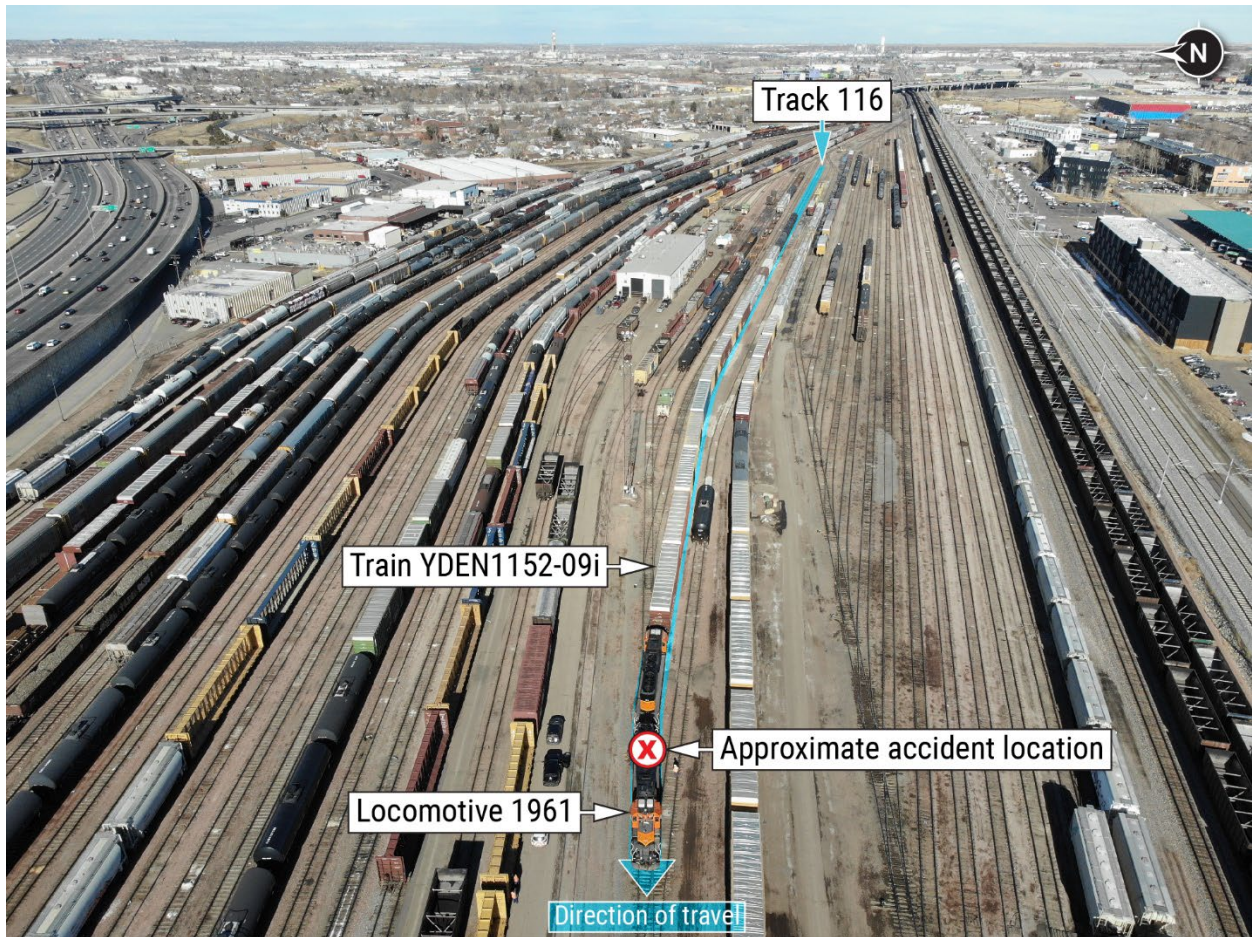
On February 9, 2022, about 10:57 a.m. local time, a BNSF Railway (BNSF) switchman was struck and killed by BNSF train YDEN1152-09i during a switching movement on Track 116 in the BNSF Globeville Yard in Denver, Colorado.<sup>1</sup> The switchman, working as a remote control operator (RCO) helper, was riding on the front center platform of the lead locomotive he was controlling remotely, BNSF 1961. The train suddenly decelerated, and the RCO helper fell forward onto Track 116, where he was struck by the locomotive he was riding. (See figure 1.) Visibility conditions at the time of the accident were daylight and clear, and the weather was 45°F with south-by-southeast winds at 15 mph.

**Figure 1.** Overhead of accident location. (Source: BNSF Railway.)

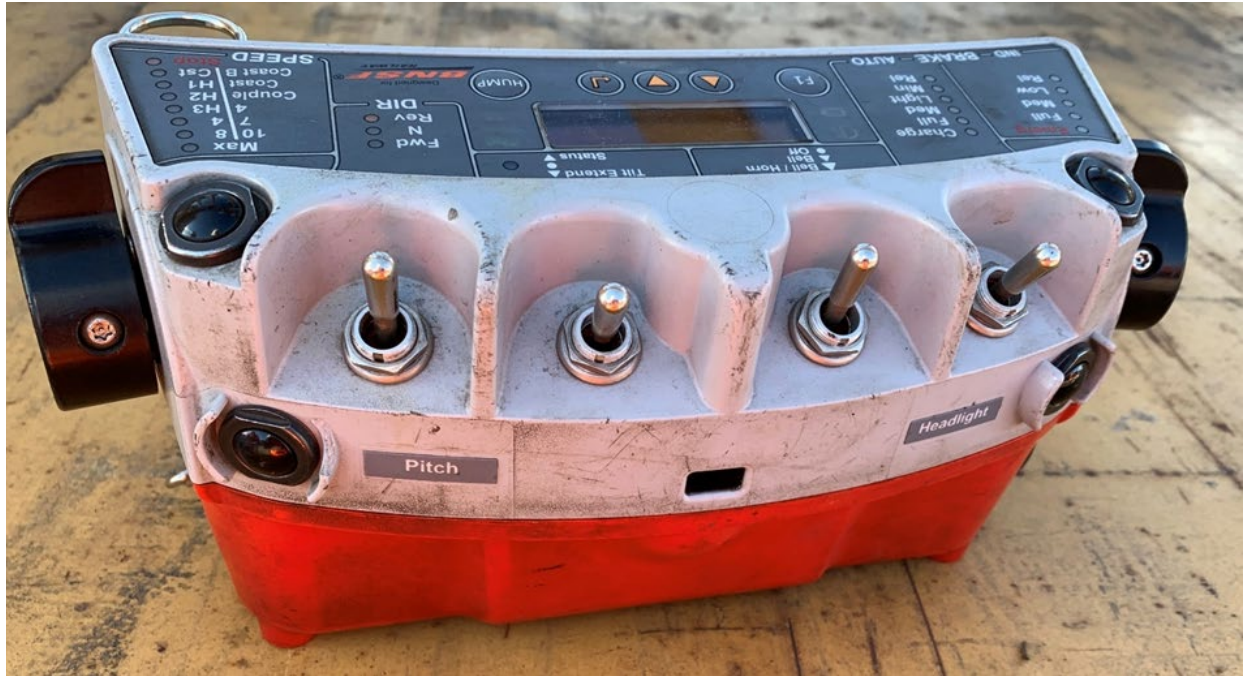
The crew of train YDEN1152-09i consisted of an RCO foreman and the RCO helper; each had one operator control unit (OCU), a handheld device that enables a train operator to control the train remotely.<sup>2</sup> (See figure 2.) Train YDEN1152-09i was composed of two lead locomotives and 21 freight railcars.<sup>3</sup>

**Figure 2.** The accident OCU.

At 10:57:14 a.m., the tilt timeout feature on the RCO helper's OCU broadcasted the first of three radio messages indicating the tilt timeout and initiated an emergency application of the train's air brakes.<sup>5</sup> BNSF 1961 traveled an additional 8 feet before coming to a stop.

Also during the accident re-creation, investigators observed that the OCU units and locomotive BNSF 1961 functioned as designed. NTSB investigators also re-created the OCU tilt timeout feature; the feature functioned as designed.
