Railroad Investigation Report: RIR-23-09

# Grade Crossing Collision Between MS Contracting LLC Dump Truck and Amtrak Passenger Train

Mendon, Missouri  
June 27, 2022

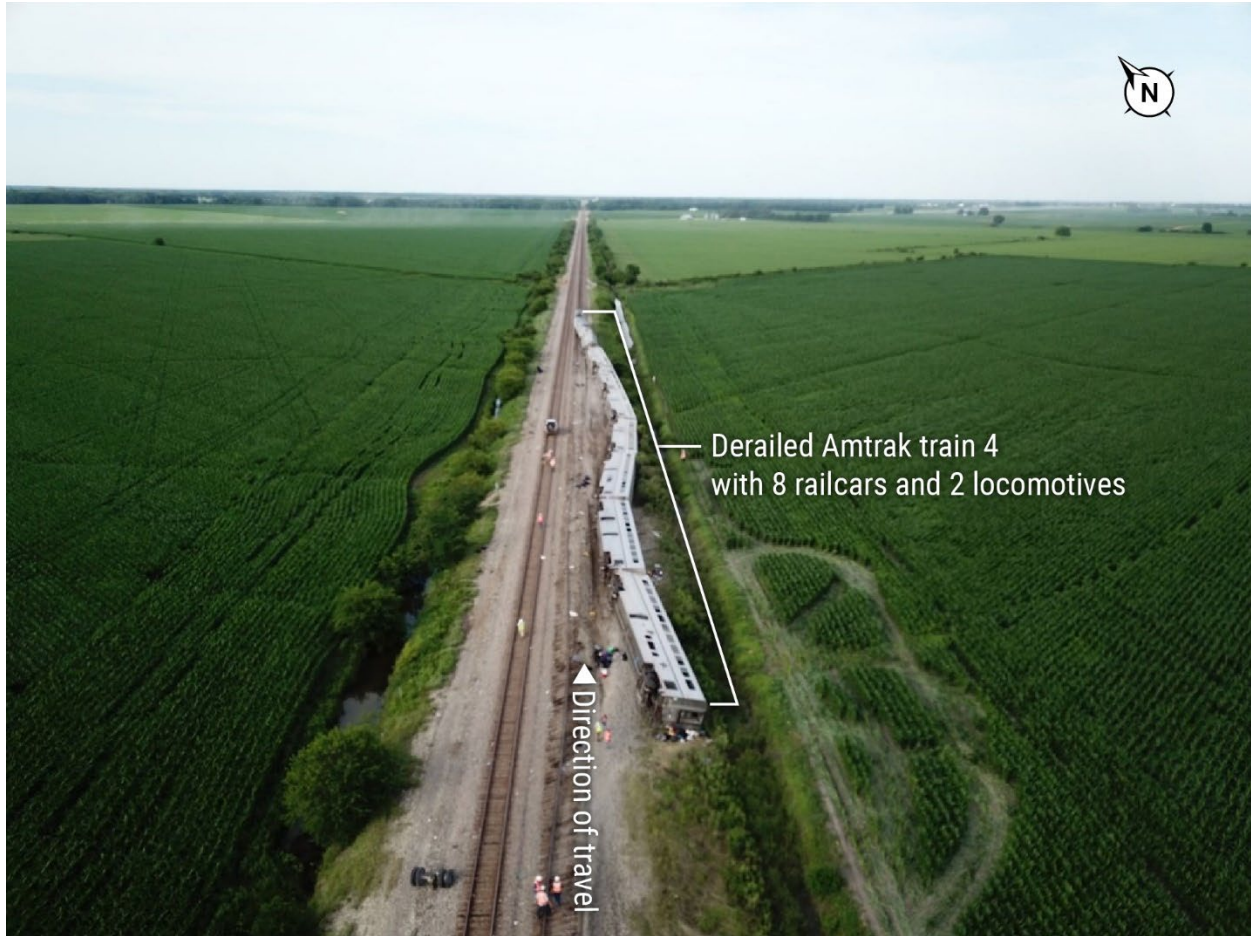
On June 27, 2022, about 12:42 p.m. local time, eastbound National Railroad Passenger Corporation (Amtrak) train 4 (also known as the *Southwest Chief*), derailed both locomotives and all eight railcars in Mendon, Missouri, after colliding with an MS Contracting LLC dump truck that was fouling a highway-railroad grade crossing.<sup>1</sup> (See figure 1.) Three train passengers and the truck driver were killed, and 146 passengers and Amtrak crewmembers were transported to local hospitals with injuries. Amtrak and the BNSF Railway Company (BNSF) estimated damage to track and equipment to be about \$4 million. Visibility conditions at the time of the collision were daylight and clear; the temperature was 81°F with no precipitation.

**Figure 1.** Amtrak train 4 after the collision. (Courtesy of BNSF.)

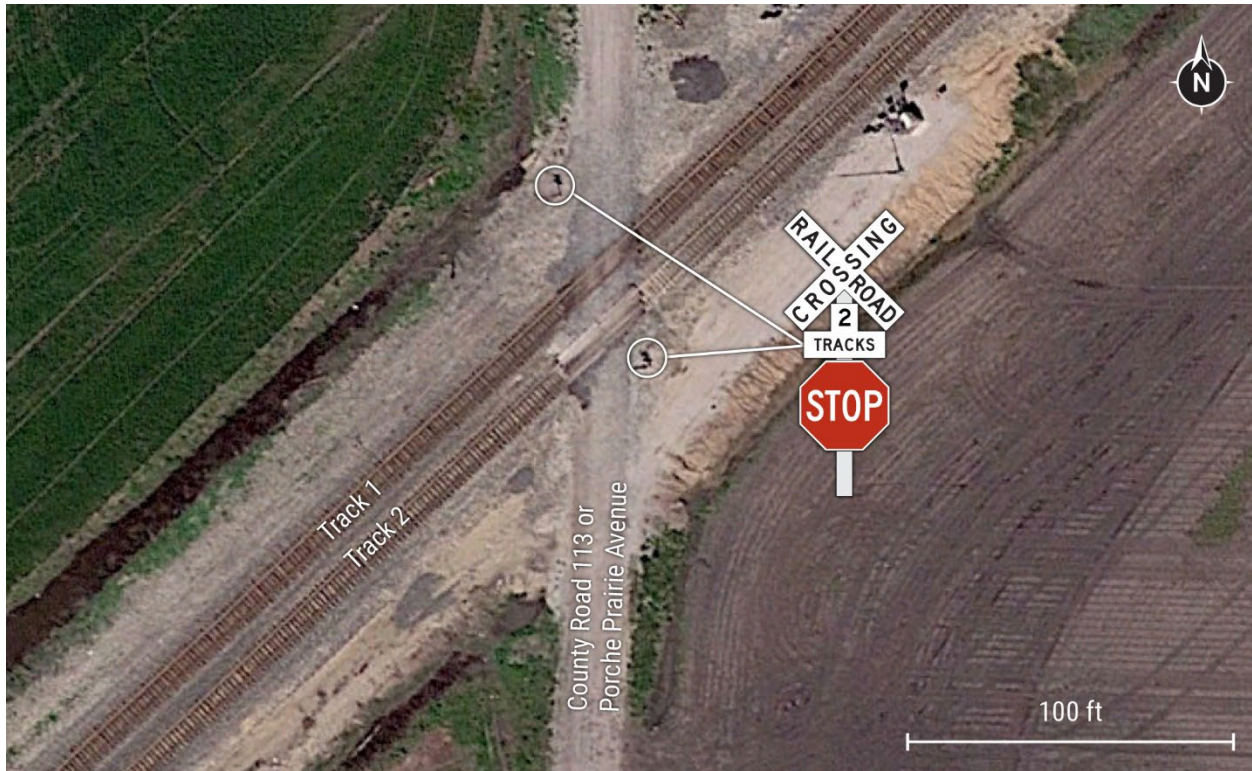
The highway-railroad grade crossing involved in the collision (hereafter the crossing) was number 005284Y in the US Department of Transportation Crossing Inventory.<sup>4</sup> The crossing was at milepost 363.876 on the Marceline Subdivision where both tracks 1 and 2 (Amtrak train 4 was on track 2) of the rail line intersected County Road 113, a gravel road also known as Porche Prairie Avenue. (See figure 2.) The crossing was a *passive crossing*, meaning that it was not equipped with active warning or barrier systems such as flashing lights or gates.<sup>5</sup> Instead, it was equipped with crossbucks and stop signs for both north- and southbound highway traffic.

**Figure 2.** The crossing. (Source: Google Earth.)

The crossing where the collision occurred was a passive skew intersection equipped with crossbucks and stop signs.<sup>11</sup> County Road 113 intersected the rail line's two tracks at a 45° angle and ran north to south; the rail line ran northeast to southwest.

After the collision, Chariton County closed the involved crossing. In collaboration with the City of Chillicothe and the Missouri Department of Transportation, Chariton County has developed a plan to close several other passive crossings and redesign local roads to direct traffic through active crossings. Chariton County proposed its plan during a public meeting in April 2023 and is in the process of obtaining state or federal funding to make the planned changes. As of July 2023, the Missouri state budget includes \$50 million for improving grade crossing safety, and the Missouri Department of Transportation plans to use a portion of those funds to address passive grade crossings.

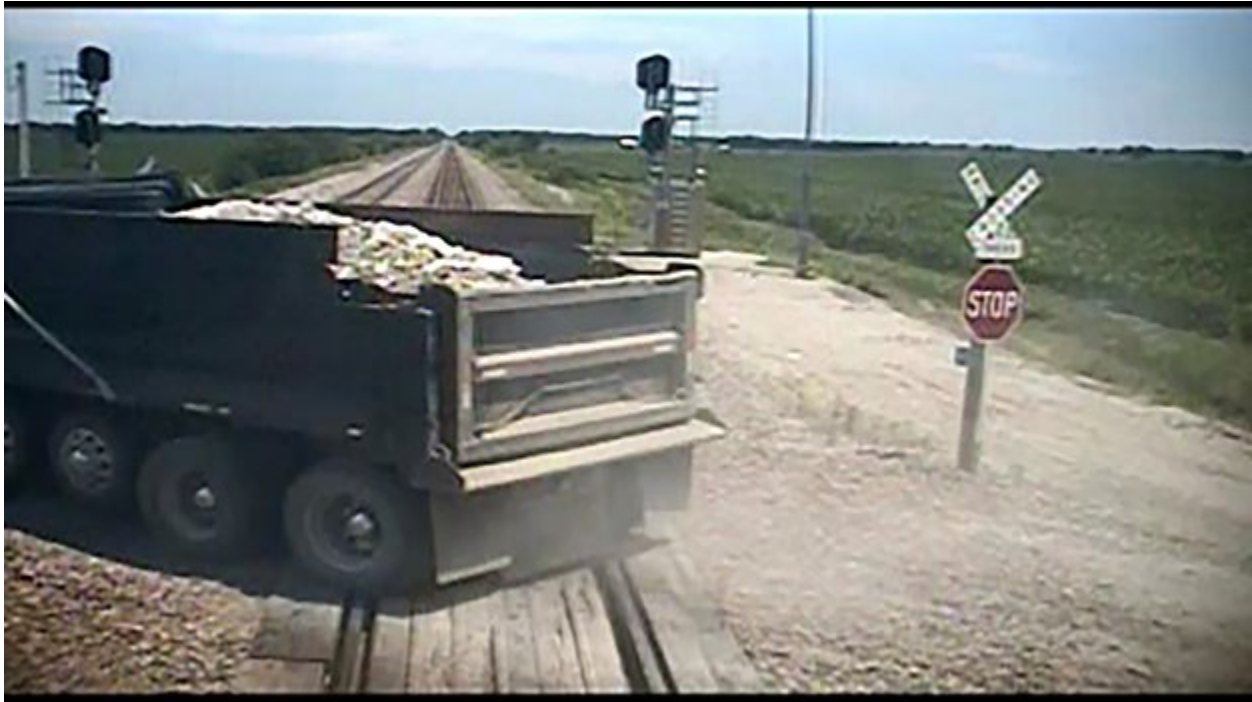
Locomotive event recorder data, along with the engineer's interview with the NTSB, show that the train engineer sounded the locomotive horn at 12:42:36 p.m. near the whistle board positioned 1,328 feet west of the crossing with County Road 113.<sup>6</sup> While the lead locomotive was near the whistle board, the engineer saw a truck approaching the crossing from the south on County Road 113. The train engineer sounded the horn four more times over the next 10 seconds as the train approached the crossing at 89 mph with the throttle in position T1.<sup>7</sup> Data from the lead locomotive's forward-facing onboard image recorder showed the truck traveling about 5–6 mph as it reached and traversed the crossing without stopping.<sup>8</sup> (See figure 3.)<sup>9</sup> When the Missouri State Highway Patrol (MSHP) recovered and examined the truck after the collision, the speedometer needle was stopped about 5 mph and the tachometer was displaying 1,100 rpm. At 12:42:44, the engineer initiated an emergency application of the train's air brakes. The train decelerated to 87 mph before striking the truck within the crossing at 12:42:46 p.m. and derailling.

**Figure 3.** Truck in the crossing shortly before collision. (Source: Amtrak.)

The NTSB's review of forward-facing image recorder data from the lead locomotive showed that the truck proceeded into the crossing without stopping. Missouri state law requires highway traffic to stop between 15 and 50 feet from a highway-railroad grade crossing if the crossing is equipped with a stop sign or if a train is within hazardous proximity—conditions that were both present as the truck neared the crossing before the collision. However, the truck driver maintained a speed of about 5–6 mph through the crossing as shown by image recorder data. The stopped tachometer and speedometer recovered after the collision showed values of about 1,100 rpm and 5 mph, which were consistent with the image recorder data. A driver of a similar dump truck who was familiar with the crossing and saw the collision (the witness driver) characterized this speed and rpm as typical for crossing the tracks. The witness driver also said that he did not usually stop at the crossing as required by Missouri law because the steep grade made starting again difficult. The collision truck driver's movement through the crossing was therefore consistent with how the witness driver would proceed with no train present. This suggests that the driver involved in the collision did not see the train as he approached and entered the crossing.

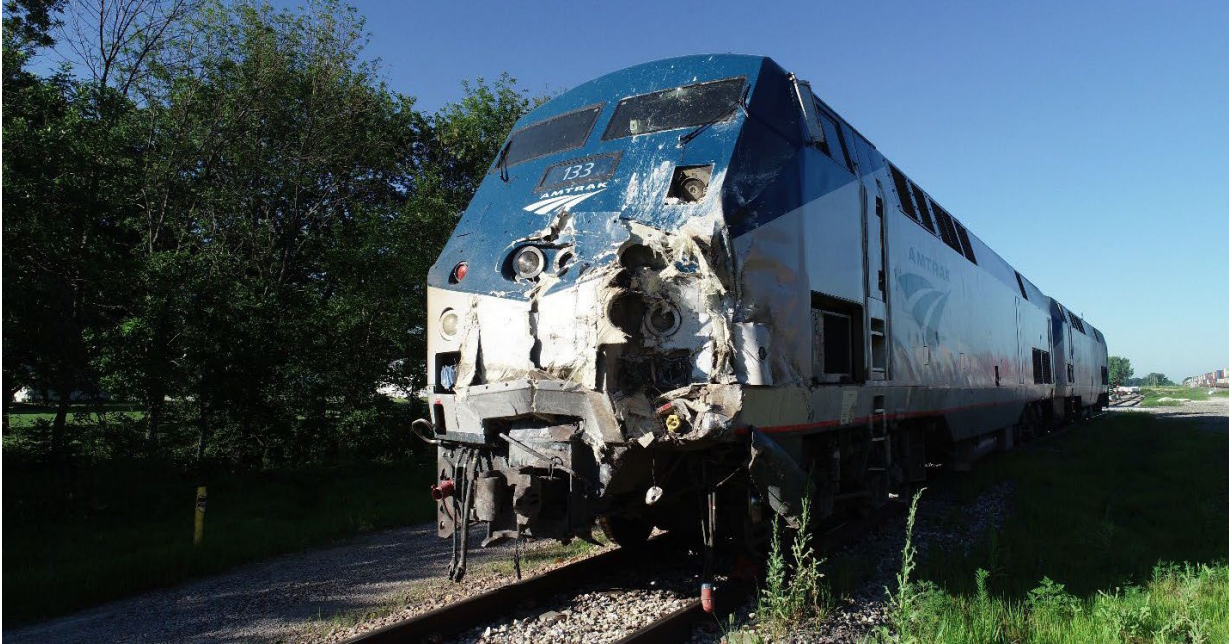
The NTSB performed on-scene examinations of derailed equipment on June 28-29, 2022. The NTSB found collision damage to the lead locomotive's left-front bulkhead. (See figure 4.) Distance measurements showed that the train continued moving east after the collision, and the front of the lead locomotive came to rest 1,286 feet east of the crossing. Both locomotives and all eight railcars derailed; seven railcars overturned and came to rest on their right sides.

**Figure 4.** Damage to the front-left bulkhead of the lead locomotive.

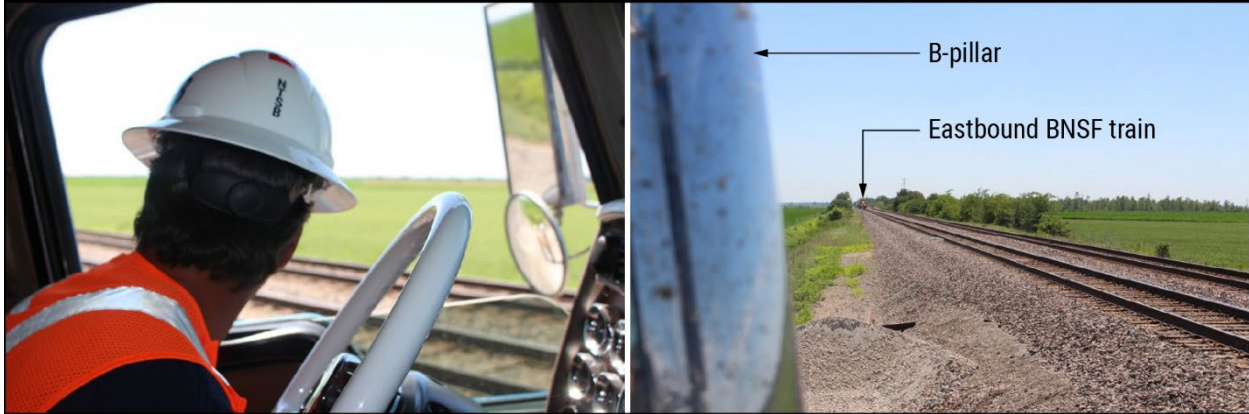
While conducting sight distance observations on July 1, 2022, the NTSB evaluated the effect of the crossing angle on visibility by positioning an exemplar truck near the crossing and observing approaching eastbound rail traffic. The NTSB found that an observer in the driver's seat had to lean forward and look over their left shoulder to see down the track without the B-pillar obstructing their view.<sup>14</sup> From this position, the observer could see an eastbound freight train near the whistle board. (See figure 5.)

**Figure 5.** An NTSB investigator (left) leans forward to see an eastbound BNSF train (right).

constructing intersections as close as practicable to 90° and no less than 75°, or 30° more than the crossing involved in the collision. The NTSB's on-site observations with an exemplar truck found that the angle of the crossing caused the B-pillar of the truck to interfere with the driver's vision; the driver had to lean forward and twist far to the left to see an approaching train when near the crossing. Whether the driver of the collision truck used this method or any other to look for approaching trains is unknown. However, the NTSB's observations indicate that the driver's B-pillar would have posed a greater obstacle to the driver seeing an approaching train than it would have at a 90° crossing.
