# CSX Transportation Freight Train and Southeastern Pennsylvania Transportation Authority Trolley Collision

Darby, Pennsylvania  
December 9, 2021

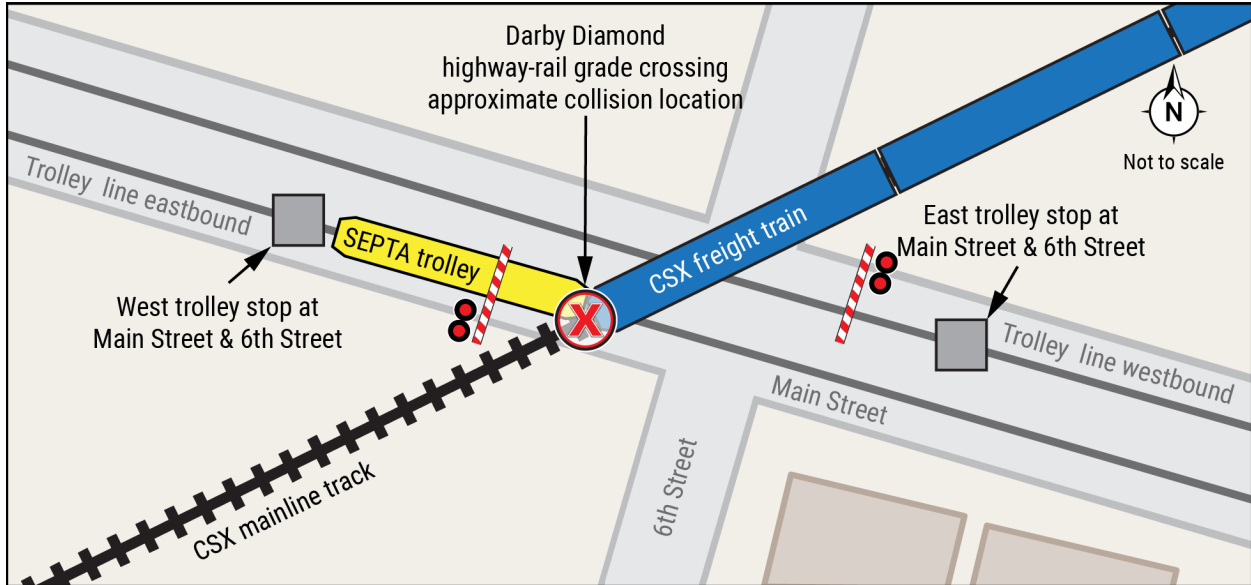
**Figure 1.** Illustration of the accident location.

After making a scheduled stop at the west trolley stop at Main Street and 6th Street, the trolley operator began to move the trolley forward and east into the Darby Diamond highway-railroad grade crossing. At 8:25:02 a.m., the automatic grade crossing protection red warning lights, maintained by CSX, began to flash, and the gate arms began to lower. National Transportation Safety Board (NTSB) investigators reviewed data from the trolley's outward-facing image recorder and observed that the trolley operator quickly glanced out the left window at 8:25:03 a.m., while the trolley continued to move forward toward the crossing. The automatic warning devices were active during this part of the movement. The trolley operator then looked forward again, put both hands on the console grab bar, and initiated braking with the foot brake, pushing the pedal past the detent.<sup>3</sup> This action activated the trolley air brake system's emergency brake function. The emergency brake brought the trolley to a stop at 8:25:06 a.m. with the front end of the trolley fouling the CSX track within the highway-railroad grade crossing. The south gate arm then closed on the roof of the trolley. The trolley could not be moved, and the air brakes would not release until reset.<sup>4</sup> In interviews with NTSB investigators, the trolley operator reported attempting to reset the trolley's air brake system unsuccessfully and then evacuated the trolley. The CSX freight train

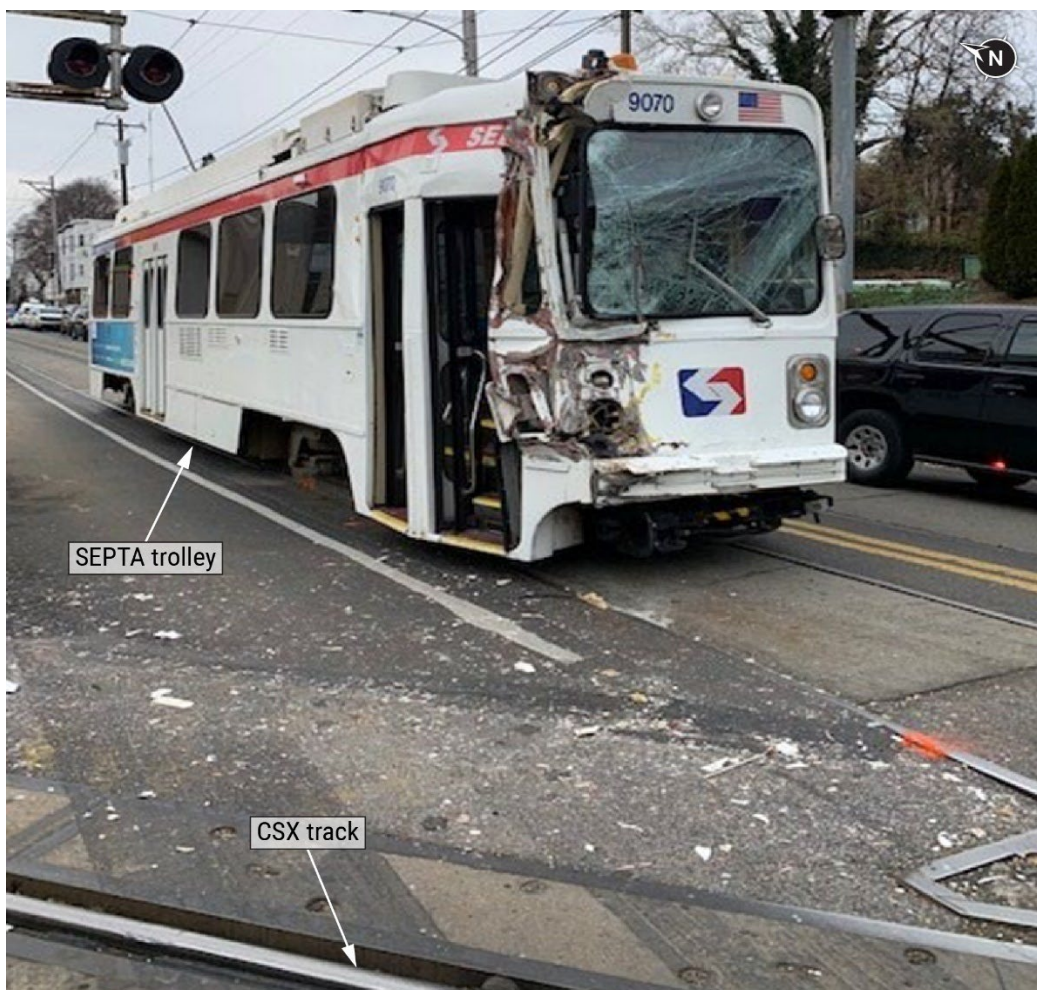
collided with the trolley at 8:25:38 a.m. at a speed of 22 mph. The train struck the right front and side of the trolley, pushing it backwards (west) but not derailing it.<sup>5</sup> (See figure 2.)

**Figure 2.** Damaged trolley and CSX track.
