Railroad Investigation Report: RIR-23-11

Collision between Amtrak Passenger Train and Union Pacific Railroad Roadway Maintenance Machine

Oakland, California
July 15, 2022

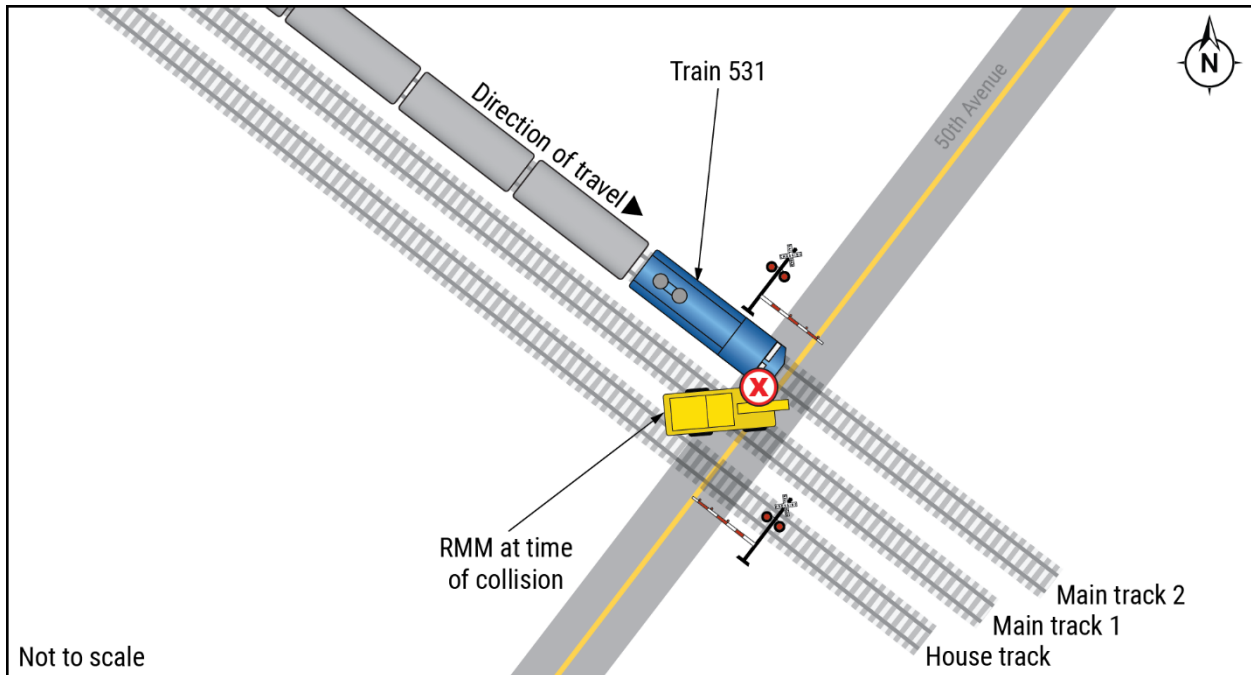
Figure 1. The collision site.

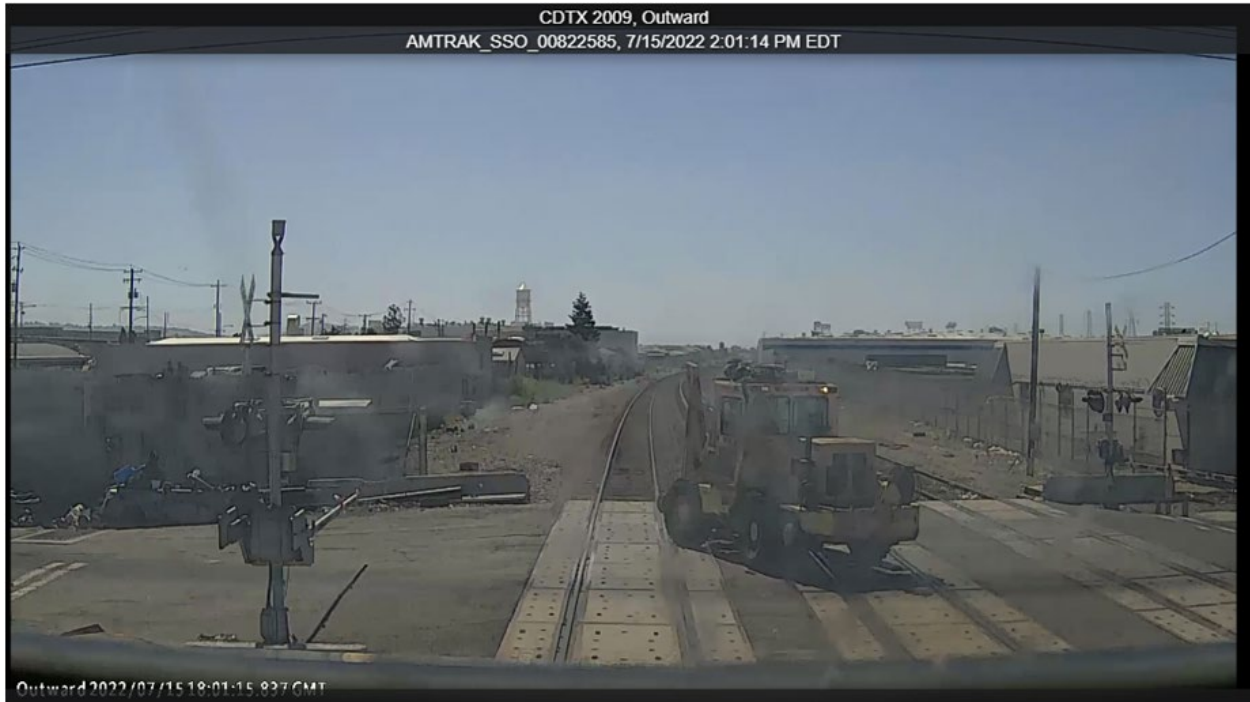
the NTSB's review of the crossing's electronic records, the crossing's gates were down and its lamps were flashing, indicating an approaching train. (See figure 2.)

Figure 2. Locomotive image recorder frame showing the RMM shortly before the collision.

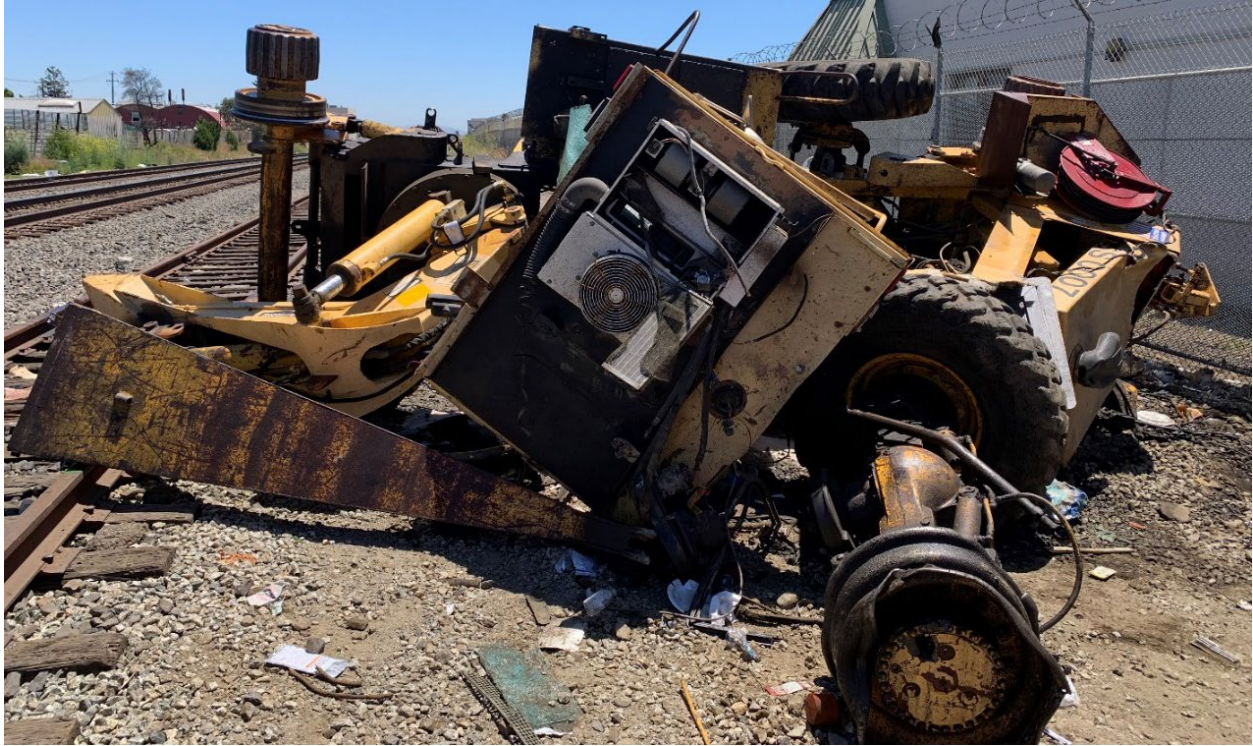
The RMM was destroyed by the collision. (See figure 3.) The RMM operator was severely injured, and emergency responders transported him to a local hospital for treatment. The locomotive of train 531 was heavily damaged; the front-right bulkhead was deformed and the engine was rendered inoperable. (See figure 4.) Two Amtrak

Figure 3. The RMM after the collision.

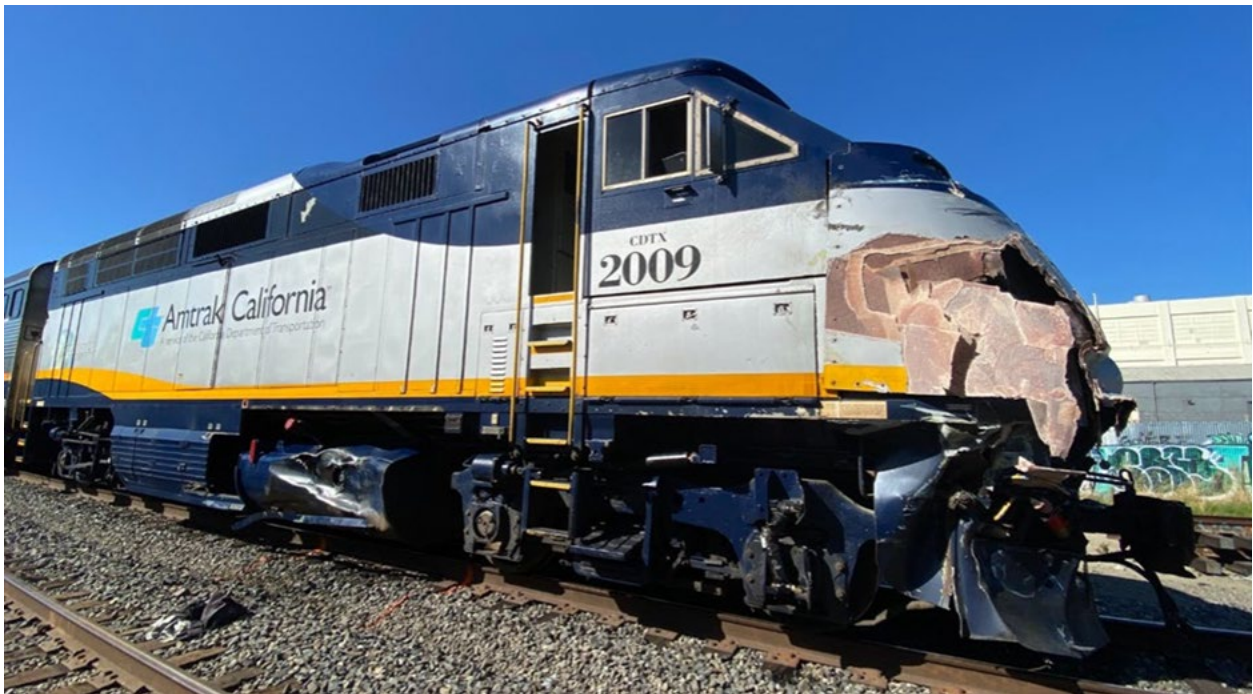
Figure 4. The locomotive after the collision.
