Railroad Investigation Report RIR-23-13

# Watco Dock and Rail, L.L.C.

## Employee Fatality

Houston, Texas  
October 29, 2021

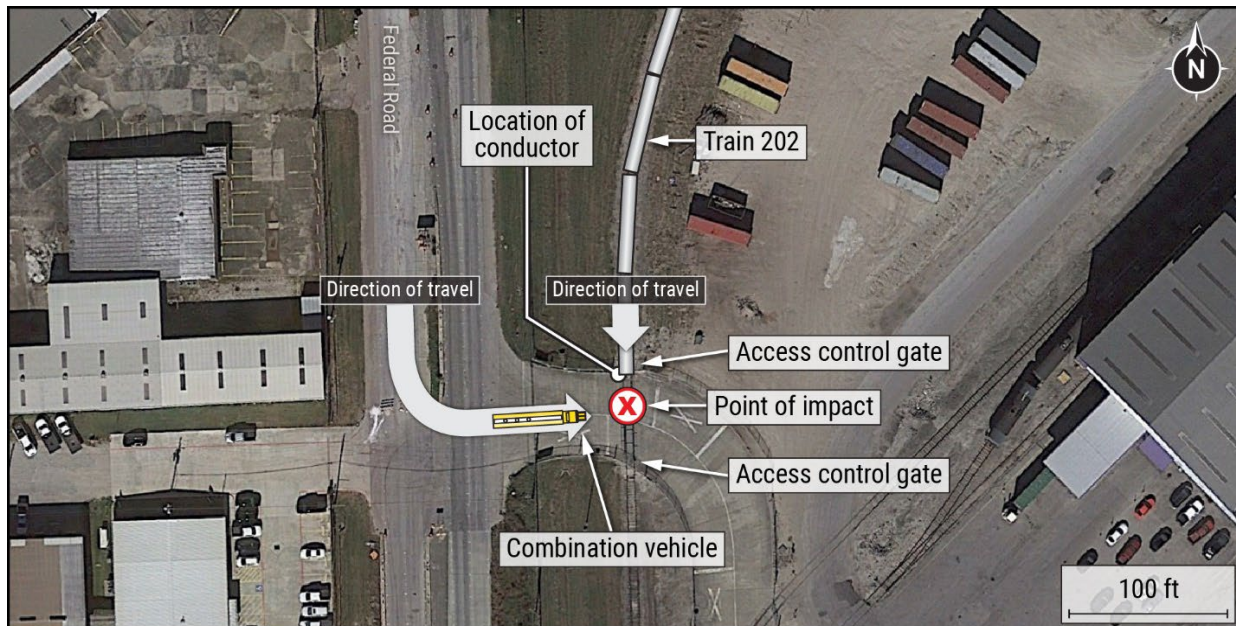
**Figure 1.** Overhead photograph of accident location. (Source: Google Earth.)

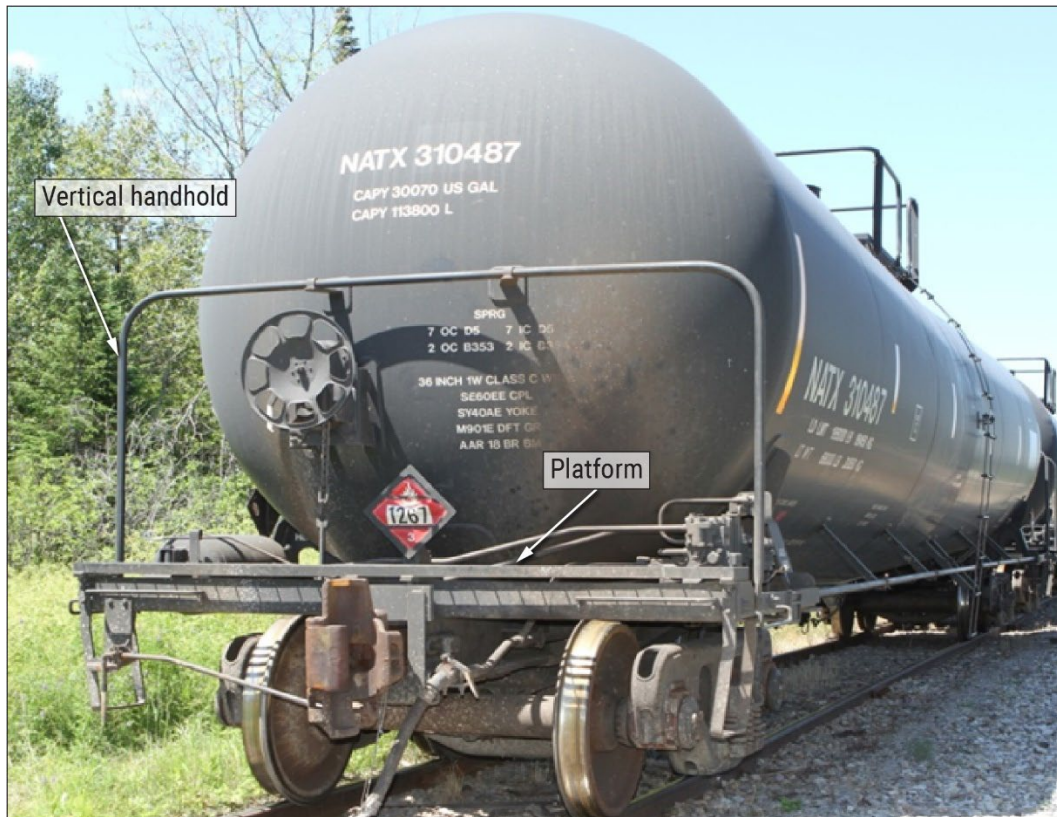
the tank car as required by WDRL's Transportation Safety Rule T-17, Riding In or On Moving Equipment, with three points of contact (two feet on the platform and one hand on a vertical handhold). (See figure 2.) The accident conductor held onto the vertical handhold with his left hand, so that his body was partially turned away from the side of the highway-railroad grade crossing from which Federal Road traffic approaches. He was holding his lantern in the crook of his right elbow with his right hand on the radio microphone button to communicate with the locomotive engineer.

**Figure 2.** Exemplar tank car depicting the vertical handhold and platform. (Source: Transportation Safety Board of Canada.)

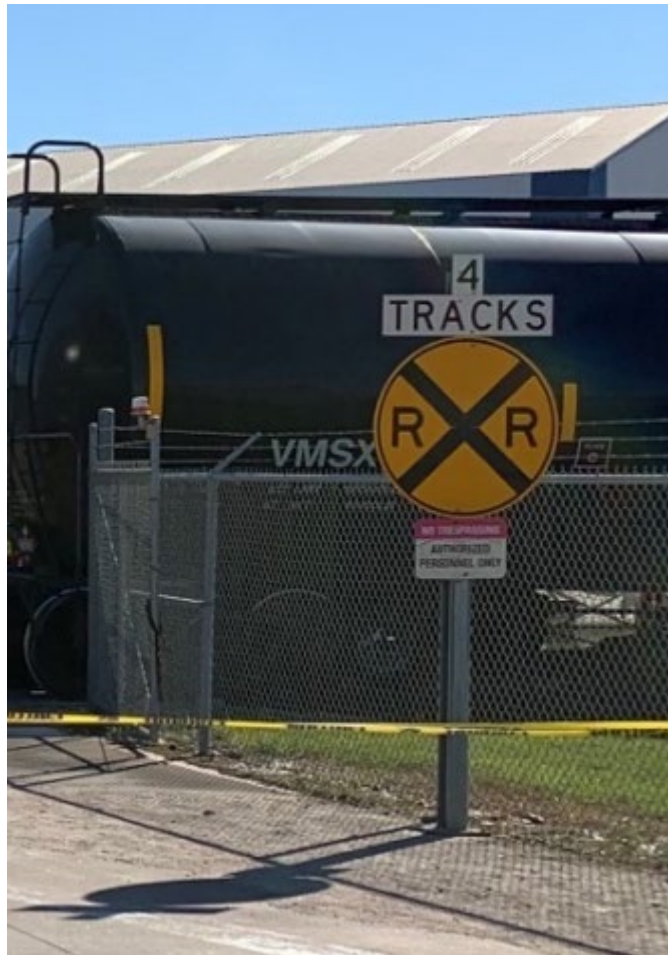
The grade crossing was equipped with passive warning devices including pavement markings and an advance warning sign facing Federal Road. (See figure 3.) The grade crossing was not equipped with active warning devices (such as lights that flash only when a train is approaching or occupying a crossing) or crossing gates, nor was an employee stationed at the crossing to protect it.

**Figure 3.** Highway-railroad grade crossing at Greens Port Industrial Park (Source: Federal Railroad Administration.)

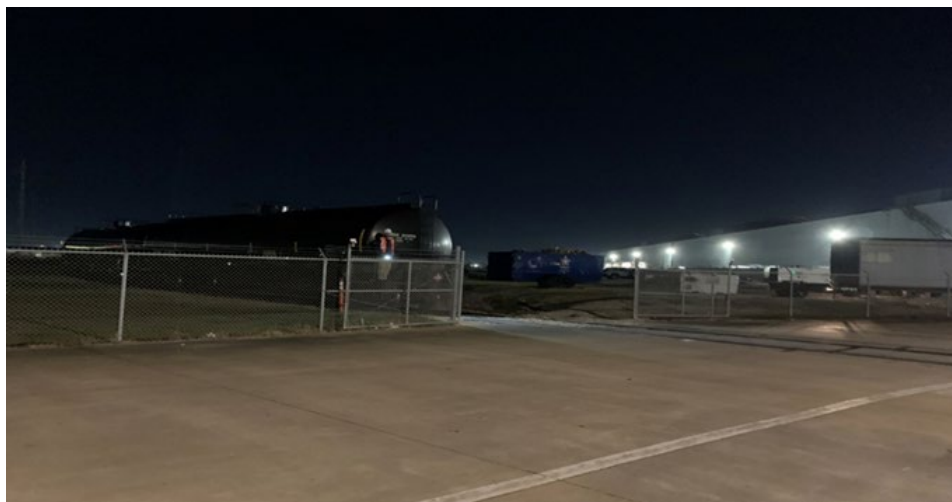
The NTSB conducted a partial re-enactment of the accident at the highway-railroad grade crossing near Greens Port Industrial Park about 4:00 a.m. on October 31, 2021. Multiple Gemini combination vehicles entered and exited the facility during the re-enactment. The NTSB observed that the south side of the driveway crossing the railroad tracks was well-illuminated by a private flood light located south of the highway-railroad grade crossing. (See figure 4.) The north side of the driveway did not have a flood light, and it was dark. Despite the darkness, NTSB personnel could see a person standing on a tank car moving toward the crossing.

**Figure 4.** Flood lights at the industrial park entrance.

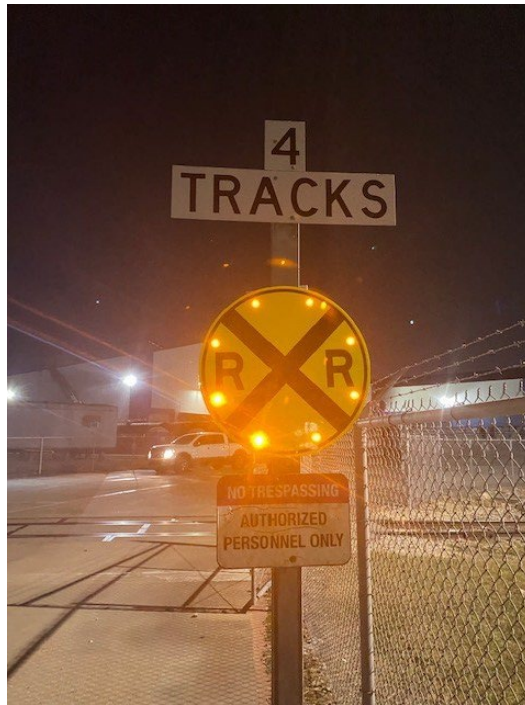
**Figure 5.** Highway-railroad grade crossing signage with LED lights.

WDRL also equipped the private highway-railroad grade crossing's advance warning signage with LED (light-emitting diode) lights. (See figure 5.) The intent was to make the signage more visible to truck drivers who enter the driveway that intersects with the private highway-railroad grade crossing. Further, WDRL conducted assessments to identify other crossings within the Greens Port Industrial Park that could benefit from this added protection.
