Railroad Investigation Report RIR-23-16

PSC Group Conductor Fatality

Beaumont, Texas

October 28, 2022

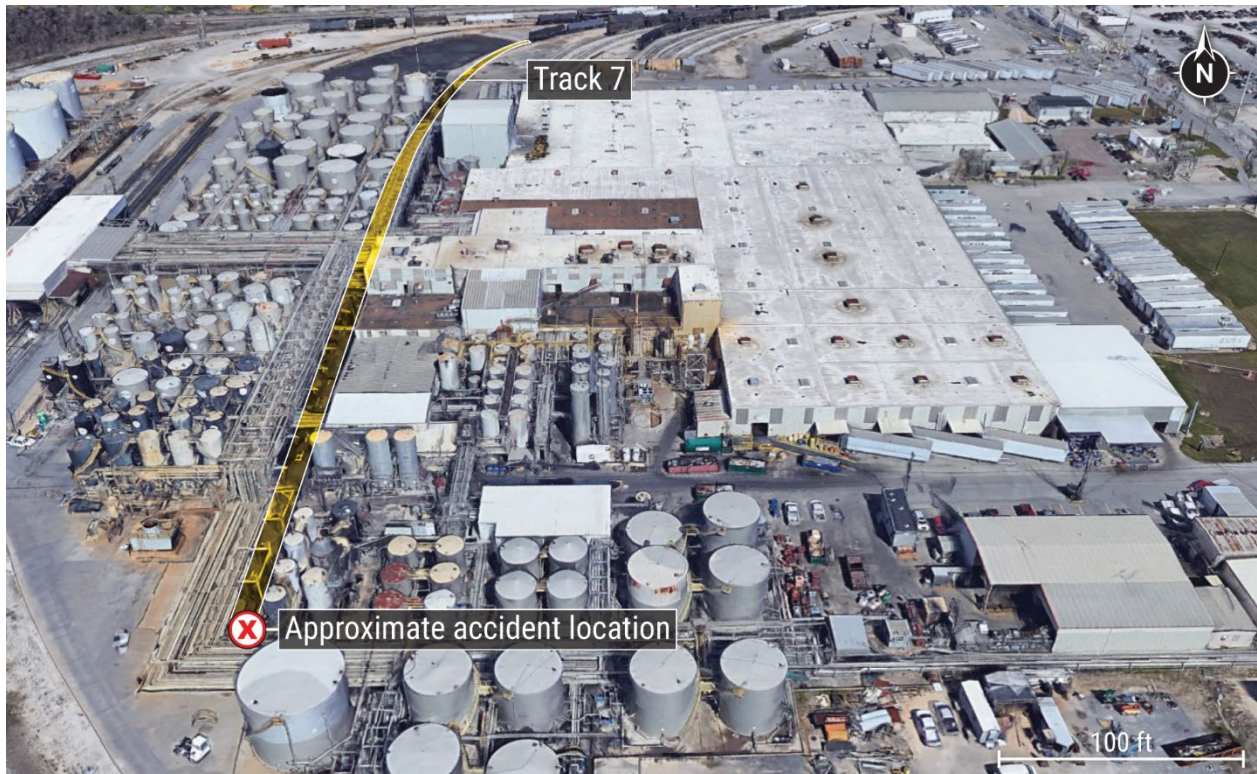
Figure 1. Overhead view of accident area.

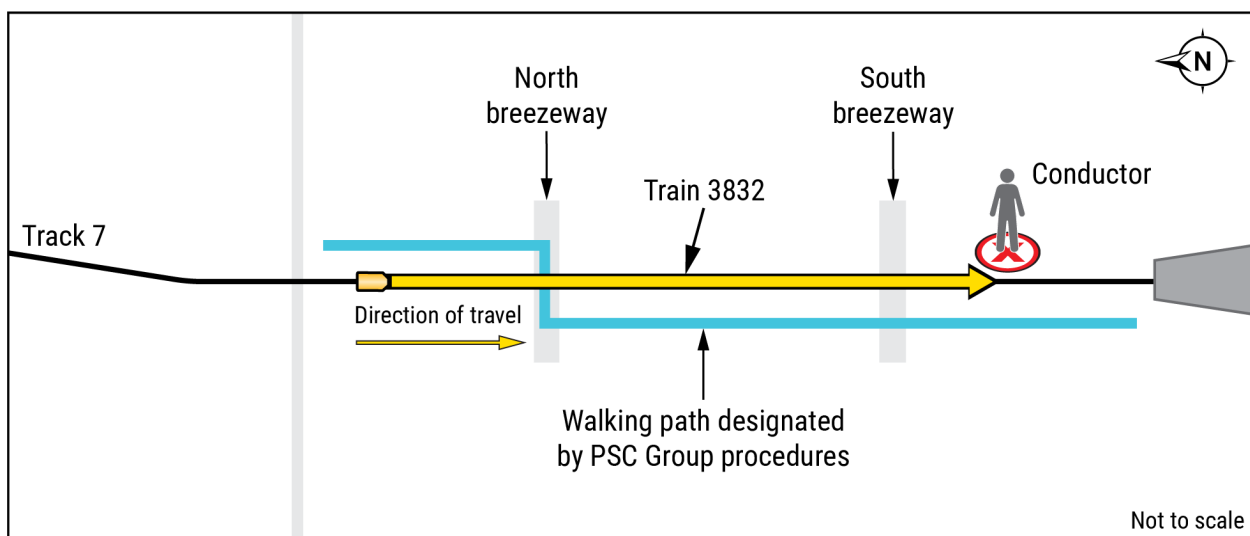
According to a postaccident interview with the NTSB, an ExxonMobil employee arrived at the accident location to assume product loading duties and found the deceased conductor beneath the last railcar in the consist, on the east side of track 7. This area was on the opposite side of the walking path designated by PSC Group procedures. (See figure 2.) Section 1.5 describes PSC Group's procedures.

Figure 2. Diagram of accident.

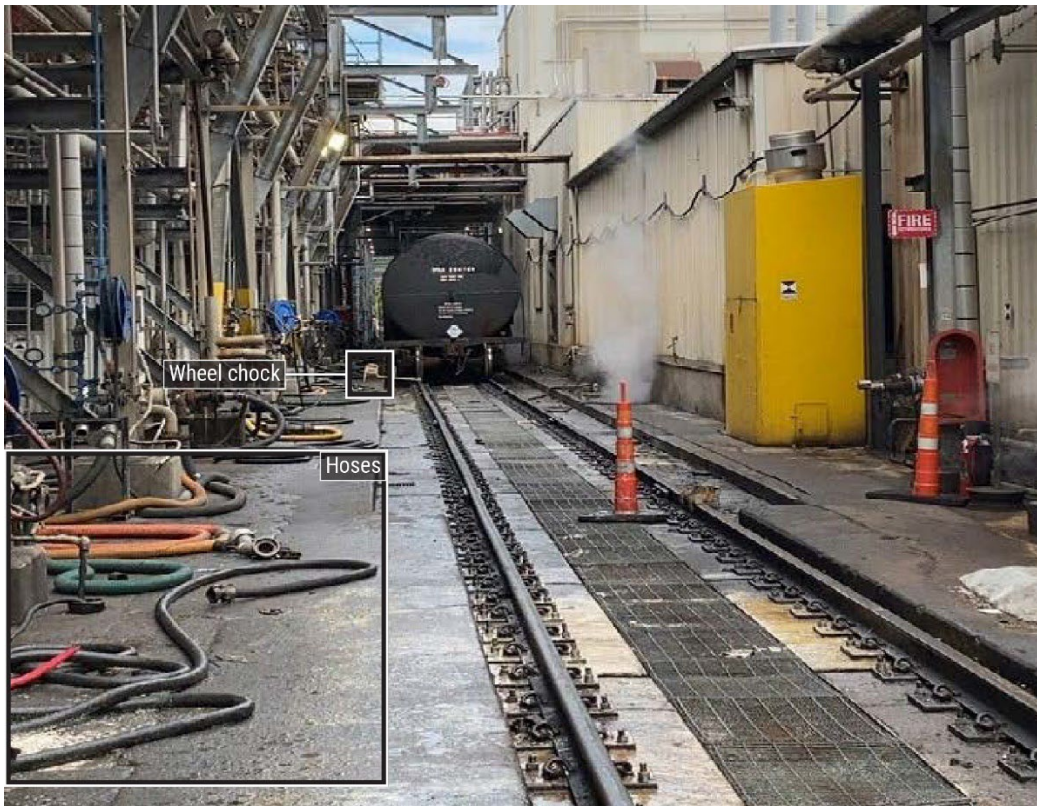
During postaccident site examinations on October 29, 2022, the NTSB observed hoses, wheel chocks, and other items left in the walking area at the end of track 7.⁷ (See figure 3.)

Figure 3. Walking conditions at the accident location.

After the accident, ExxonMobil cleaned up identified walking areas at the site by installing brackets for storing wheel chocks, adding storage for product loading hoses, pressure-washing the walking area, and removing unused scaffolding. ExxonMobil also added rail crossing signs at breezeways and more facility lighting.

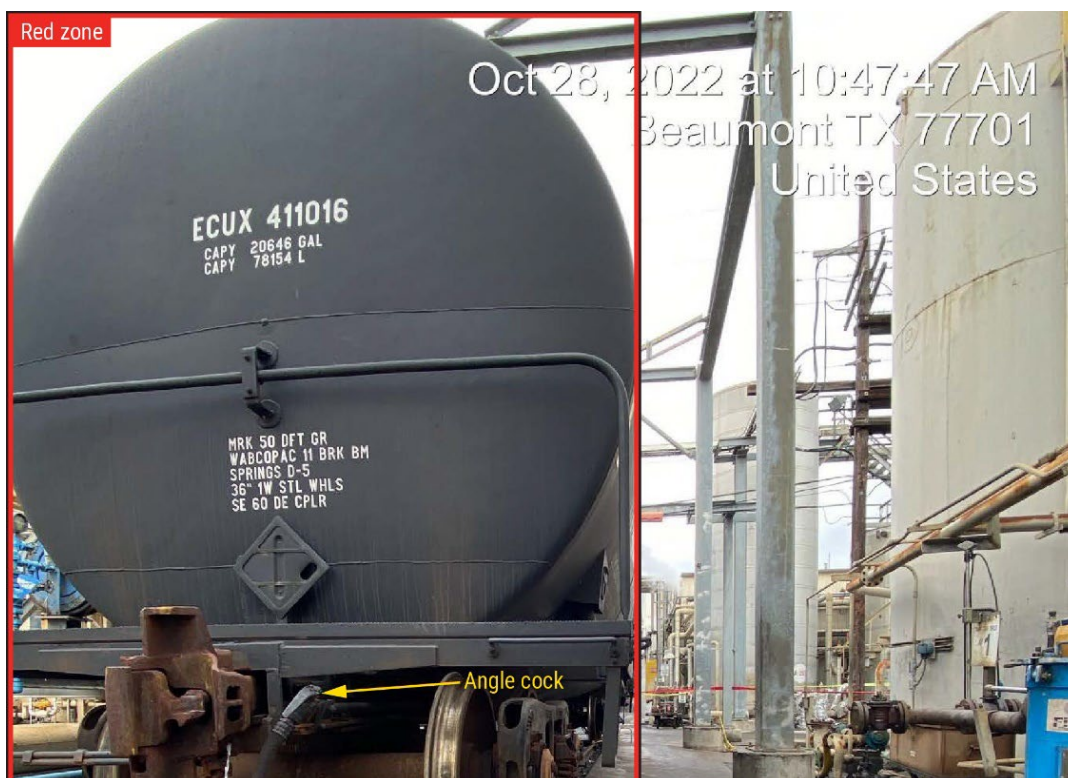
The NTSB observed that the angle cock on the rearmost railcar in the consist of train 3832 was in the open position.⁸ The angle cock was located in what is often called the “red zone,” or an area where a person working on or near the track could be struck by moving equipment.⁹ (See figure 4.)

Figure 4. Open angle cock and red zone on the rearmost railcar in train 3832.

The postaccident position of the conductor beneath the final railcar in the consist, the railcar's open angle cock, and a loss of brake pipe pressure before the engineer placed the train into emergency indicate that, for unknown reasons, the conductor had opened the angle cock immediately before the accident occurred. To open the angle cock from alongside the track while the train is in motion, a person must reach into the red zone, where the likelihood of being struck by equipment is higher. PSC Group's rack operations procedures in place at the time of the accident stated that 100% train protection was required from the ground. In practice, this meant that personnel walked alongside the train during the movement. After the accident, PSC Group revised their rack operations procedures, no longer allowing employees to walk alongside train movements.
