Railroad Investigation Report: RIR-24-01

# Caltrain Passenger Train Collision with Hi-rail Construction Vehicles

San Bruno, California  
March 10, 2022

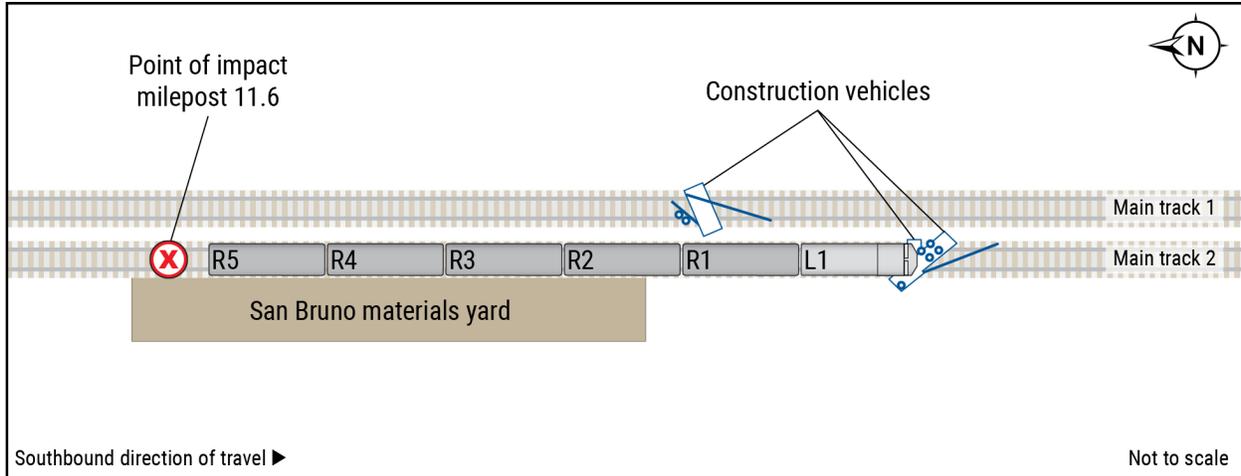
**Figure 1.** Illustration of the collision.

Train 506 was traveling from San Francisco, California, to San Jose Diridon Station and consisted of one locomotive and five passenger railcars. Event recorder data from the locomotive showed the speed of the train was 64 mph about 1/4 mile from the collision. The construction equipment was positioned on Main Track 2 at MP 11.6 with the pilot vehicle facing north, the crane was in the center position and also facing north, and the boom truck was behind the crane facing south.<sup>2</sup> As the train exited a left-hand curve, the engineer told the National Transportation Safety Board (NTSB) that he could identify construction equipment on a track, but he could not immediately identify which track the equipment was on. Event recorder data show the engineer applied the emergency train brake 13 seconds before colliding with the construction equipment. After applying the emergency brake, he sounded the train's horn to alert the construction work group of the impending danger and braced himself for impact. The train slowed to about 43 mph before it struck the first construction vehicle. The train then continued to strike the other two construction vehicles before stopping.
