Norfolk Southern Railway Collision and Employee Fatality

Location	Decatur, Alabama
Date	January 31, 2024
Accident type	Raking collision
Train 1	Yard job A08AA31; 18 railcars; 2 locomotives; conductor, engineer brakeman
Train 2	Yard job A80AA31; 35 railcars; 1 locomotive; conductor, engineer, conductor trainee
Track	Yard tracks
Hazardous materials	None
Fatalities	1
Injuries	0
Damages	\$61,500

Summary

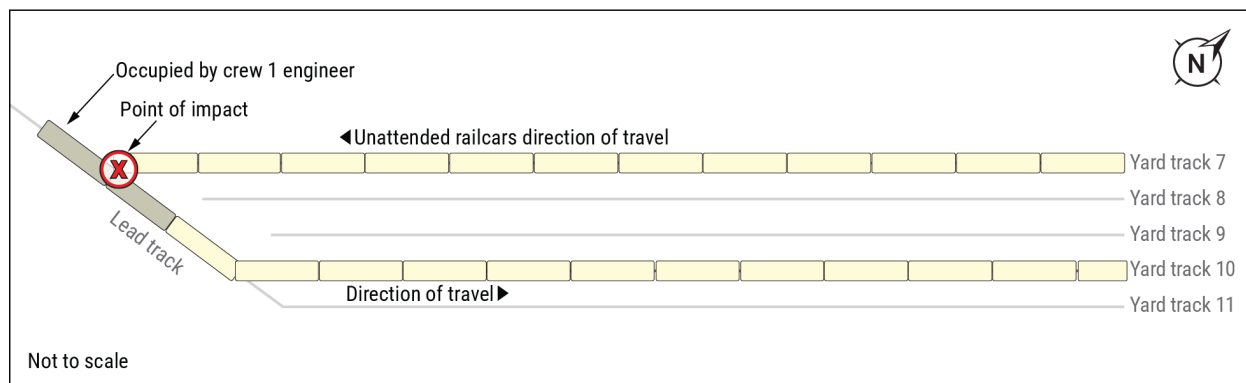
On January 31, 2024, about 4:15 p.m., the engineer of Norfolk Southern Railway (NS) yard job A08AA31 (crew 1) was fatally injured while performing switching operations when the locomotive he was operating was struck by a rolling block of railcars from yard job A80AA31 (crew 2) in Decatur Yard in Decatur, Alabama.¹ The locomotive was occupying the lead track at the west end of the yard and shoving railcars onto track 10 when 35 railcars rolled west on track 7 from the east end of the yard where crew 2 was working.² (See figure.) The 35 railcars fouled the lead track and impacted the rear of crew 1’s locomotive, raking along the side of the locomotive, and ultimately

striking the operating cab where the engineer was located.³ The engineer was transported to a hospital, where he was pronounced deceased.

Figure. Accident diagram of the west end of the yard showing unattended railcars impacting the locomotive operated by the crew 1 engineer.

Crew 2 was performing switching operations at the east end of the yard. Shortly before the accident, the crew positioned 35 railcars on yard track 7 and uncoupled them from the rest of the railcars with which they were working. When interviewed by the National Transportation Safety Board (NTSB), the crew 2 conductor said that he saw three railcars on the east end that had hand brakes applied.

Crew 2 had kicked 2 railcars to track 9 and were returning west on track 7 when the conductor noticed the 35 railcars previously left on track 7 were rolling west toward the lead track. The NTSB reviewed the radio recording and confirmed that the conductor had alerted the engineer of crew 2. About the same time, the crew 1 brakeman also noticed the railcars moving and alerted the engineer of crew 1, warning him to clear track 7 as quickly as possible. The engineer of crew 1 responded that he was trying to clear the track, seconds before the collision.

rolled, uncontrolled, to the west end of the yard and impacted the locomotive. Therefore, the NTSB concludes that the three hand brakes were not applied before the accident.

The National Transportation Safety Board determines that the probable cause of the Norfolk Southern Railway employee fatality was the conductor's failure to properly verify the handbrakes were applied on the block of railcars, as required, which allowed them to roll free and strike a locomotive.

On February 14, 2024, the Federal Railroad Administration issued "Safety Bulletin 2024-01 (Revised): Employee Fatality—Securement of Rolling Equipment," in reference to this accident. In this bulletin, the Federal Railroad Administration "remind railroads and railroad employees of the importance of ensuring rolling equipment is properly secured at all times."

On February 2, 2024, Norfolk Southern issued a Serious Incident Notice informing employees about the incident, rules to discuss regarding switching operations, and included a rules clarification packet on securement of equipment. NS cited this event in recurrent rules training and during safety interactions with employees to ensure employees are following established securement rules.
