Railroad Investigation Report: RIR-25-08

Union Pacific Railroad Train Collision and Conductor Fatality

Location	Melrose Park, Illinois
Date	July 6, 2024
Accident type	Raking collision
Striking train	Union Pacific freight train MCBCH-05 2 crewmembers 1 locomotive, 45 railcars
Departing train	Union Pacific freight train MPRNL-06 2 crewmembers 2 locomotives, 91 railcars
Track	Yard, other than main track
Hazardous materials	None
Fatalities	1
Injuries	0
Damages	\$89,000

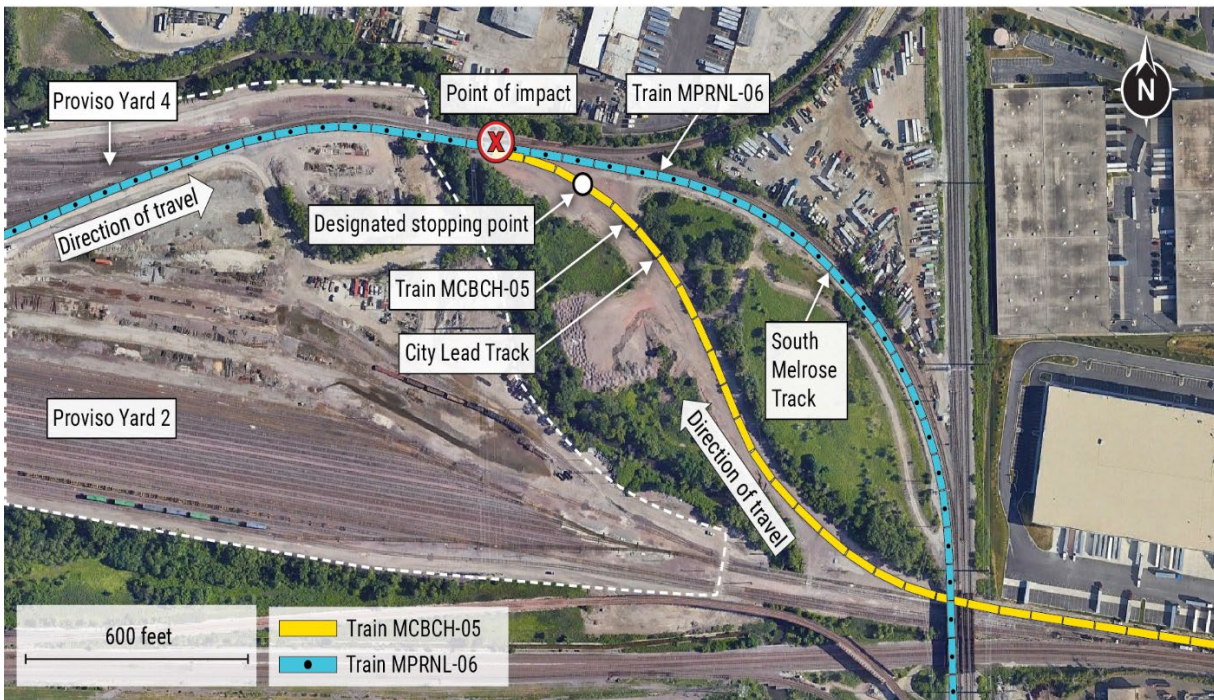
On July 6, 2024, about 1:36 a.m. local time, a Union Pacific Railroad (UP) conductor was killed in a raking collision while protecting a shoving movement at UP's Proviso Yard in Melrose Park, Illinois.¹ At the time of the accident, eastbound train MPRNL-06 was traveling along the South Melrose Track out of Proviso Yard 4. At the same time, train MCBCH-05 was shoving west on the City Lead Track, which merges with South Melrose Track. The conductor of train MCBCH-05 was positioned on the leading end of a tank car when it struck the right side of train MPRNL-06.²

Figure 1. An aerial view of the accident site.

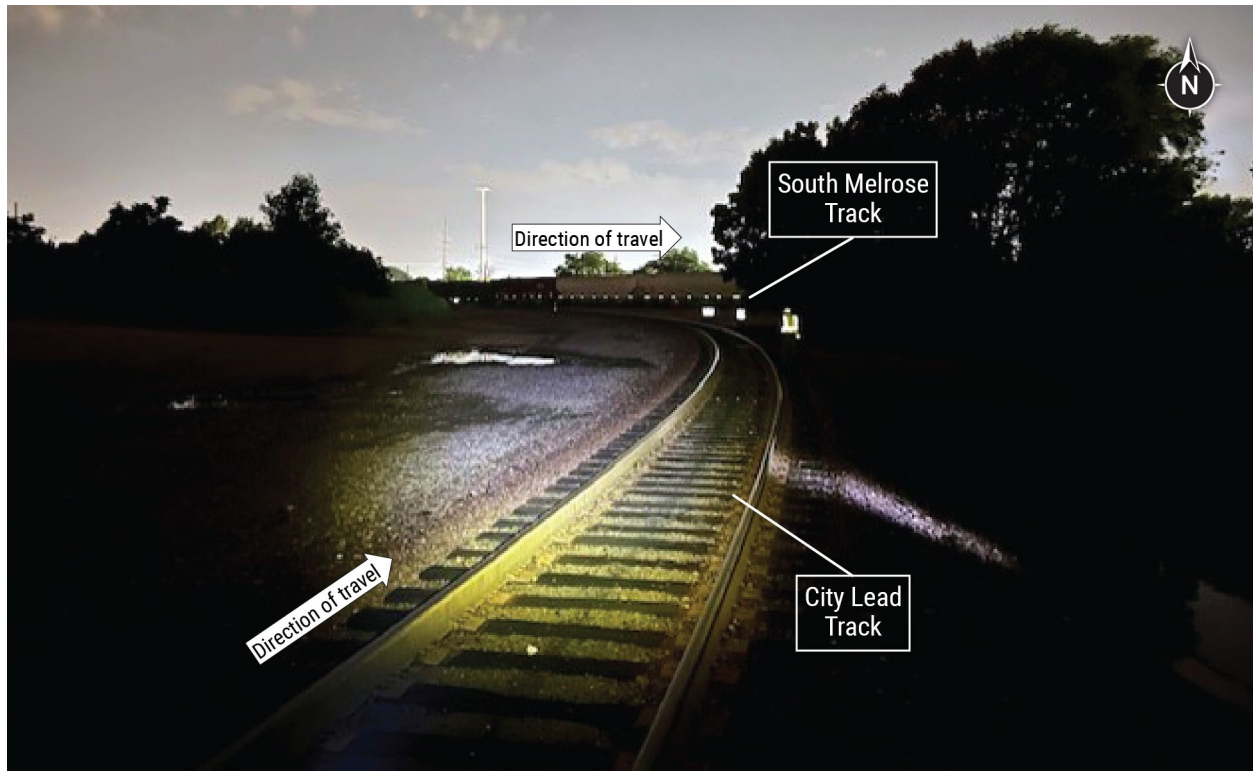
Postaccident sight distance observations demonstrated that a train pulling east on the South Melrose Track at the time of the accident would have been visible to a train making a shoving movement at 3.7 miles per hour up City Lead Track prior to traversing the designated stopping point. (See figure 2.)

Figure 2. A postaccident sight distance observation image of the City Lead Track demonstrating visual range as it would have been during the accident.
