Railroad Investigation Report: RIR-25-13

Norfolk Southern Railway Conductor Injury

Location	Norfolk, Virginia
Date	July 19, 2024
Accident type	Switching injury with equipment strike
Track	Yard/restricted limits
Hazardous materials	None
Fatalities	0
Injuries	1

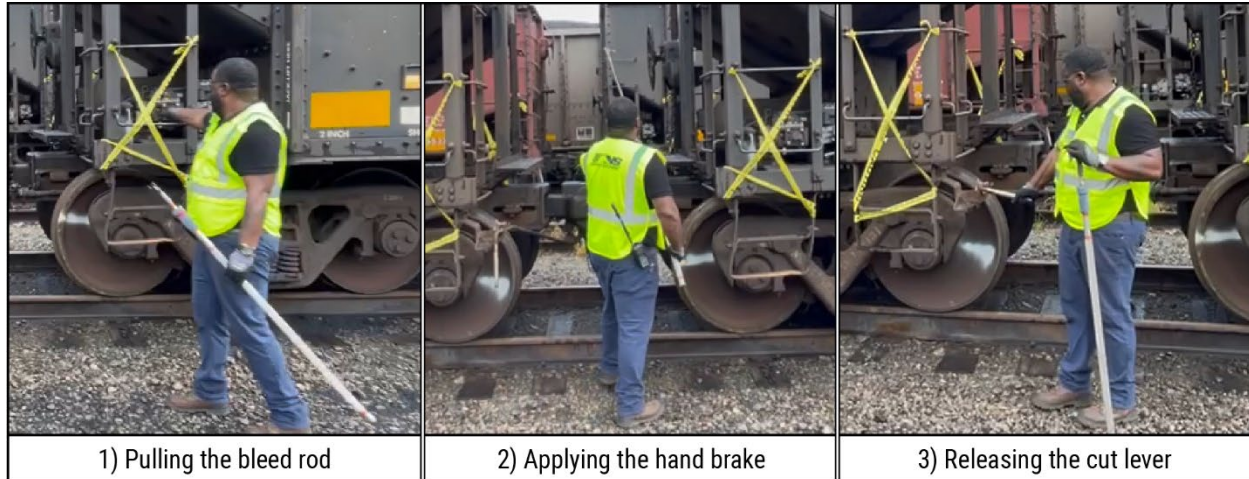
During interviews with the National Transportation Safety Board (NTSB), crew members described the steps required to uncouple coal cars and release them one at a time off the end of the westward-descending grade without letting other railcars roll freely. (See table.) Figure 2 depicts the process for relieving tension between couplers.

Figure 2. NS employee demonstrating the removal of tension between couplers. (Note: caution tape was installed postaccident to identify the accident cars and prevent usage.)
