Railroad Investigation Report: RIR-25-14

Massachusetts Bay Transportation Authority Train Derailment

Location	Somerville, Massachusetts
Date	October 1, 2024
Accident type	Derailment
Train	Green Line train 3874-3718 2 crew members (1 operator in each railcar) About 50 passengers
Track	Signalized
Hazardous materials	None
Fatalities	None
Injuries	7
Property Damage	\$1,500,000

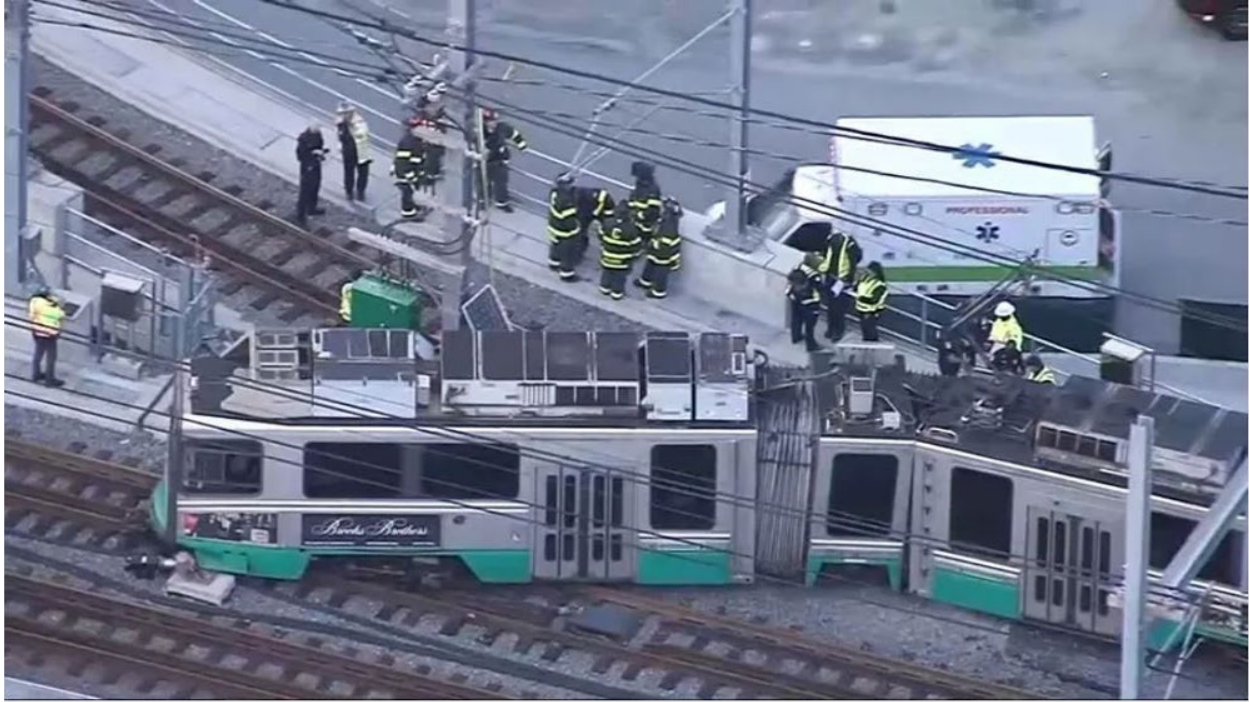
trucks took the diverging track and then derailed.² The second operator initiated an emergency braking application, and the train came to a stop.³ (See figure 1.) Seven passengers were transported to a local hospital with minor injuries. Visibility conditions at the time of the accident were clear. The weather was about 62°F with no precipitation.

Figure 1. Derailed lead railcar of train 3874-3718.

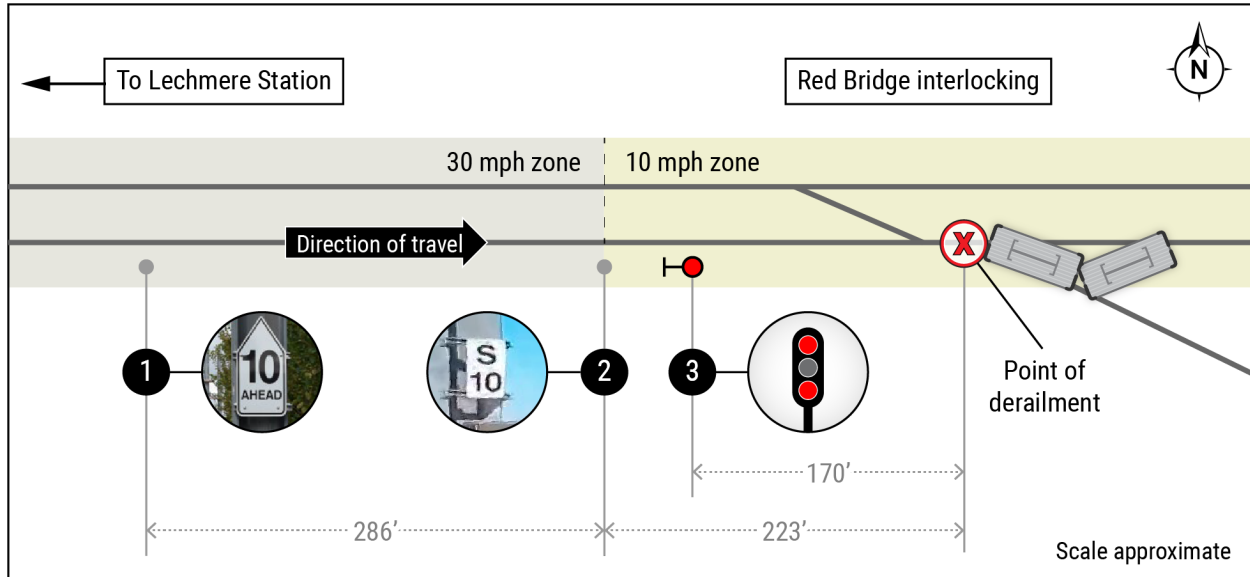
the start of the reduced speed area (signs 1 and 2 in figure 2).⁵ The speed limit sign was 223 feet west of the point of derailment. During on-scene observations, National Transportation Safety Board (NTSB) investigators did not identify obstructions or other visibility issues that could have affected the operator's ability to view these signs.

Figure 2. Track, signs, and signals near derailment.

The signal at the Red Bridge interlocking displayed aspects (the visual cues for operators that govern train movements) on a two-light aspect about 170 feet west of the point of derailment (sign 3 in figure 2). The signal logs for the day of the accident showed that the signal was displaying the correct indication (a stop signal) and that the switch was being lined for the correct route when the derailment occurred. The NTSB's examination of the signal found both lights functioning as designed, and there was no evidence of limits on sight distance or visibility.

MBTA changed the speed limits on the eastbound approach to the Red Bridge interlocking, reducing the maximum speed in the area from 30 mph to 25 mph. This is intended to decrease how much an operator accelerates and decelerates between Lechmere Station and Red Bridge and to provide more time to see and react to a signal requiring a stop.
