Railroad Investigation Report: RIR-25-15

Union Pacific Railroad Conductor Struck and Killed by METRA Train

Location	Kenosha, Wisconsin
Date	September 4, 2024
Accident type	Employee fatality
Southbound Striking Train	METRA Passenger Train M338 3 crewmembers, unknown number of passengers 1 locomotive, 6 passenger railcars
Northbound Stopped Train	Union Pacific Freight Train MCHAL-04 3 crewmembers 3 locomotives, 110 mixed manifest railcars
Track	Double-main track with positive train control
Hazardous materials	Ferric chloride, sulfuric acid, elevated temperature liquid, N.O.S. (asphalt), molten sulfur, ethanol, basic corrosive liquid, inorganic N.O.S., molten phenol
Fatalities	1
Injuries	0
Property Damage	No monetary damage

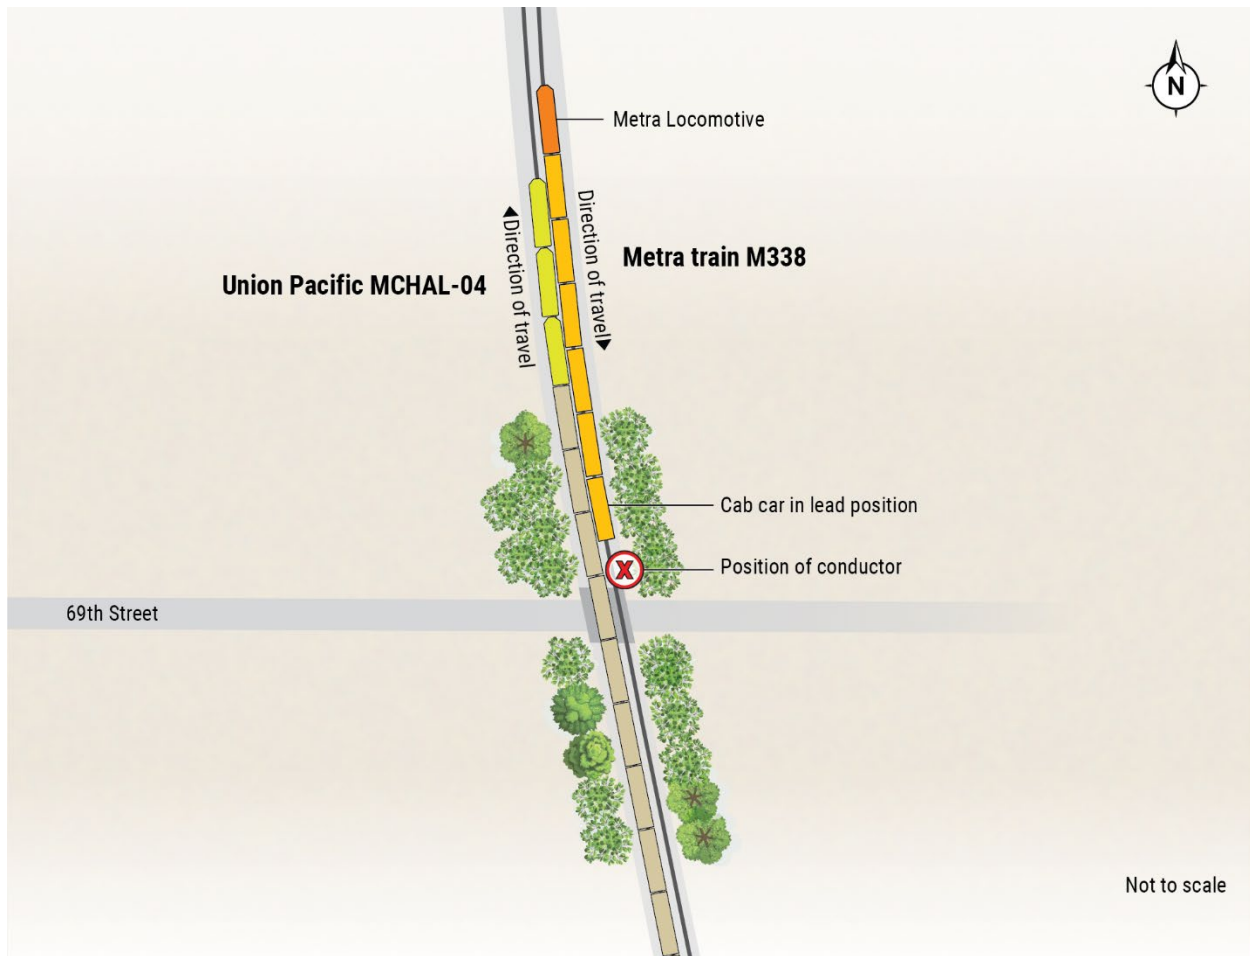
On September 4, 2024, about 12:11 p.m. local time, the conductor of northbound Union Pacific Railroad (UP) train MCHAL-04 was struck and killed by southbound METRA commuter train M338 at milepost (MP) 50.57 of the UP Kenosha Subdivision near Kenosha, Wisconsin.¹ (See figure 1.) There were no other fatalities or injuries. At the time of the accident, the temperature was 79°F with no precipitation. Skies were clear with midday light.

Figure 1. Accident scene.

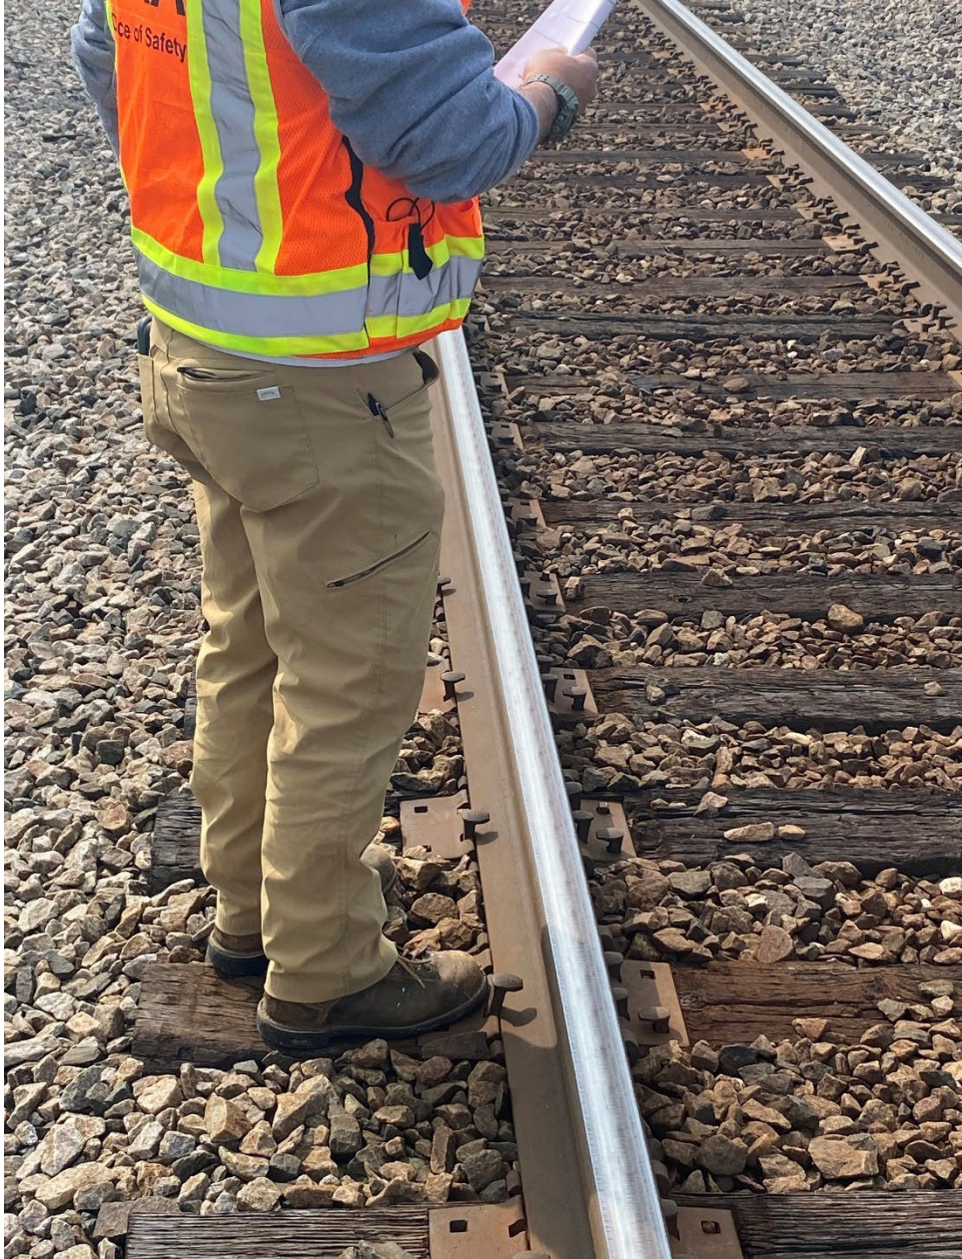
In an interview with NTSB investigators, the student engineer said that the crew held a job briefing to discuss where to stop the train to examine the wheel identified as being hot, wanting to make sure that the train was not blocking any train platforms or highway-railroad grade crossings. The student engineer said that the plan was for him to stop the train for the conductor to exit. He would then slowly move the train forward on Main Track 1 until the 51st railcar was in front of the conductor for the wheel examination. As planned, the conductor exited the locomotive at 12:05 p.m. However, he dismounted the train toward the adjacent Main Track 2, in opposition to UP operating rules. He then walked across the adjacent Main Track 2 and took up a position standing on the end of the crossties outside of the rails on the east side of the Main Track 2 as the student engineer moved the train forward.⁴ (See figure 2.) There was no barrier or impediment on the clear side of the track.

Figure 2. Exemplar photograph of the conductor's position at the time of the accident.

The conductor of UP train MCHAL-04 was struck by METRA train M338, operating as he stood on the ends of the rail ties of Main Track 2 waiting on the railcar with the identified hot wheel to be pulled to his location for further examination.⁵ The conductor dismounted the locomotive toward the adjacent Main Track 2 rather than away from it. This was a violation of UP operating rule 81.4.1 which states that employees should get on or off equipment on the side away from active tracks.

At the time of this accident, UP did not require track breach protection on the Kenosha Subdivision. Following the accident, on September 12, 2024, UP updated its system special instructions for track breach protection, which restricts trains from moving within the area, to be in effect where railroad employees are working on the ground, enabling them to safely occupy the area between the tracks on the Kenosha Subdivision.
