Railroad Investigation Report: RIR-25-17

New York City Transit Train Collision

Location	Manhattan, New York
Date	January 4, 2024
Accident type	Collision and derailment
Striking train	Train 1345-1-SFT-242 4 crewmembers 10 railcars
Struck train	Train 1427-1-SFT-242 2 crewmembers 10 railcars
Track	Main track, signalized
Hazardous materials	None
Fatalities	0
Injuries	24
Damages	\$13 million

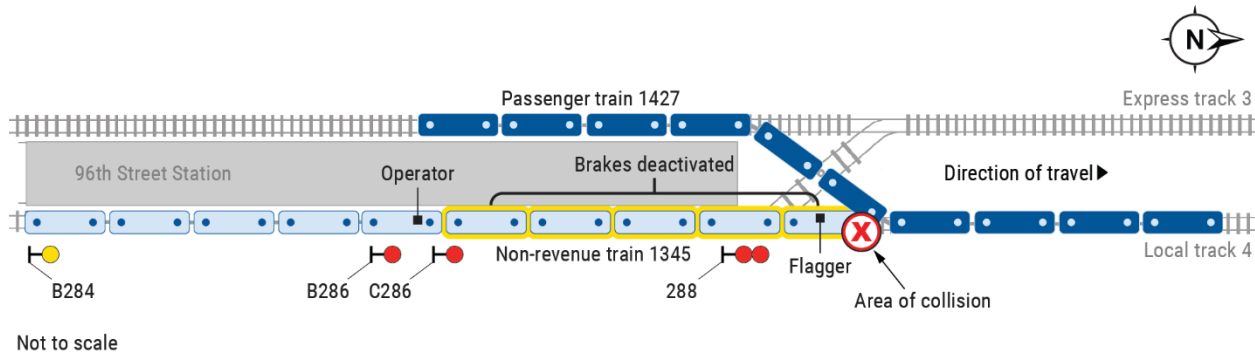
Figure 1. Illustration of the collision location showing the operator who was moving the train positioned in the sixth railcar.

To maneuver the train to the maintenance facility, the TSS assumed the role of train operator in a position in the sixth railcar, while the original operator assumed the role as the flagger and relocated to the first or lead railcar to provide movement protection by issuing radio commands.⁵

At 2:59:01 p.m., the struck train on Track 3 operated on a clear signal for his train to proceed and cross over from Track 3 to Track 4 in front of the striking train. At 2:59:19 p.m., the lead section of the striking train on Track 4 passed a signal displaying a red stop indication (signal 288) at the end of 96th Street Station platform. On the NYCT subway system, when a red stop signal is given, an automatic train-trip stop arm on the track bed raises. However, because the striking train's brakes were deactivated (cut out) on the lead section of the train, the train's brakes were not activated when it encountered the automatic train-trip stop.⁹ Consequently, the train continued past the red stop signal (signal 288) and collided with the struck train.

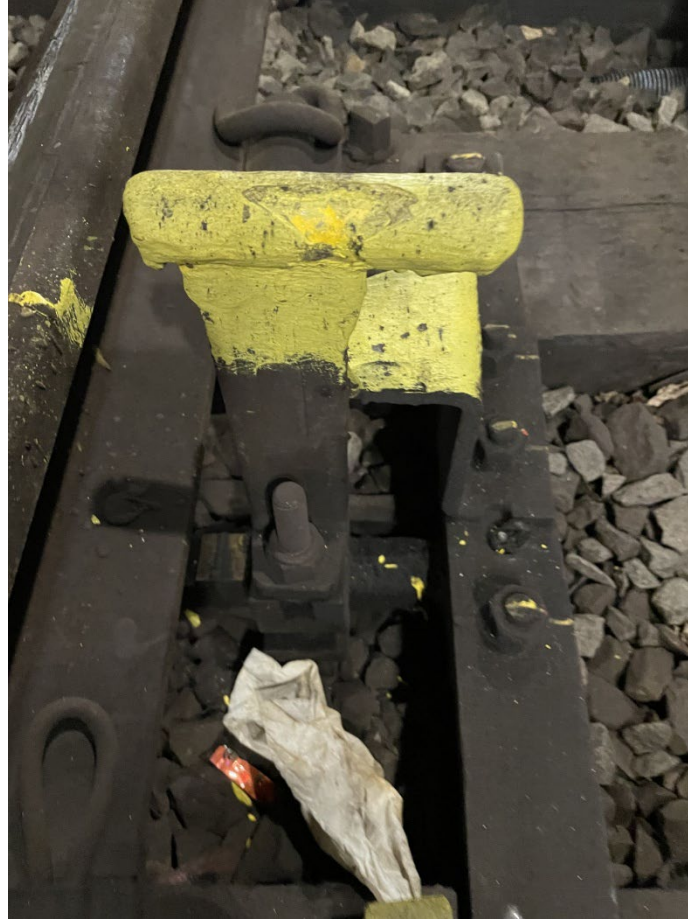
⁹ *Automatic train trip stops* devices are designed to enforce compliance with a "stop" signal. When a signal is clear, the stop arm on the device is positioned below the ball of the running rail. When a signal is at "stop," the stop arm is raised above the ball of the rail in the tripping position. When the stop arm is up when a train encounters it, the train's emergency brakes will be applied.

The track in the area was equipped with automatic train-trip stops, mechanical devices located on the wayside that work in conjunction with the wayside signal system that support the prevention of trains running a stop signal. Examinations and tests of the automatic train-trip stops did not identify any defects or problems that would have prevented them from functioning. The automatic train-trip stops were operating properly and functioning as designed.

Figure 2. Stop arm in the raised position.
