Railroad Investigation Report: RIR-25-19

# New Jersey Transit Light Rail Vehicle Collision

<b>Location</b>	Florence, New Jersey
<b>Date</b>	October 14, 2024
<b>Accident type</b>	Employee fatality
<b>Train</b>	Train 207 2 articulated railcars 1 operator 41 passengers
<b>Track</b>	Federal Railroad Administration regulated track; Class 4 main, signalized
<b>Hazardous materials</b>	N/A
<b>Fatalities</b>	1
<b>Injuries</b>	23 minor injuries
<b>Property Damage</b>	\$194,000

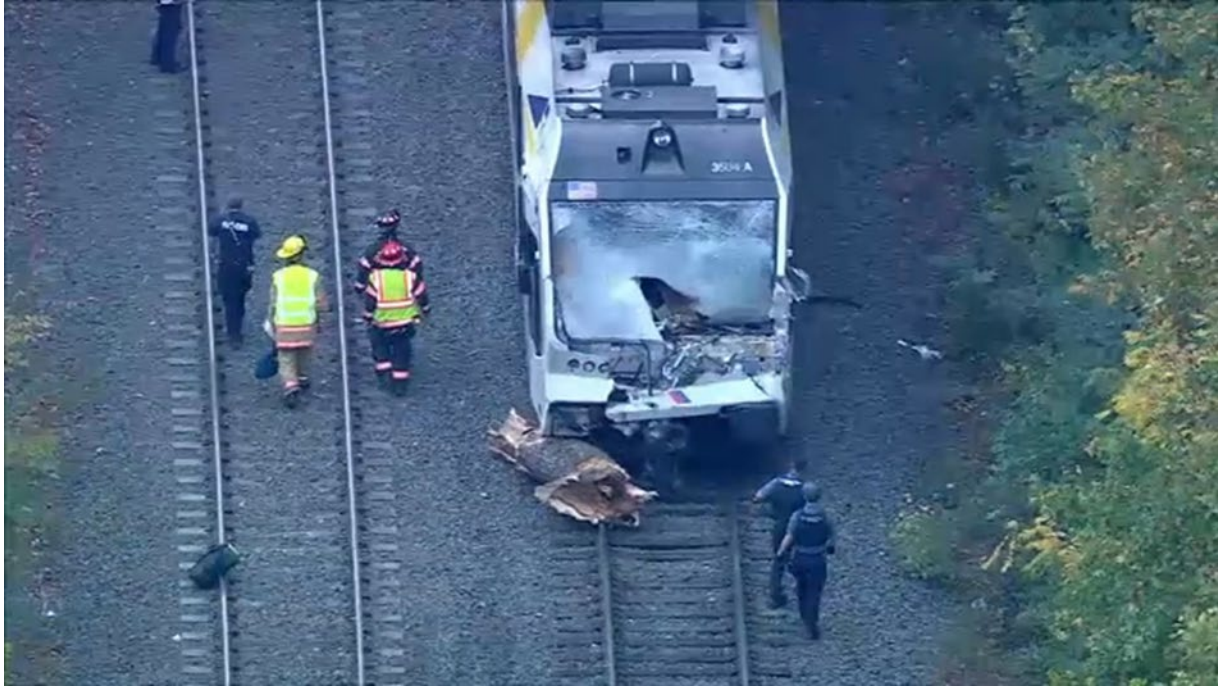
On October 14, 2024, about 5:58 a.m., an Alstom employee operating southbound New Jersey Transit (NJ Transit) train 207 was fatally injured when the train struck a tree that had fallen across the tracks of the River Line at milepost (MP) 24.53 near Florence, New Jersey.<sup>1</sup> (See figure 1.) Train 207 was a light rail vehicle consisting of two railcars with 41 passengers on board.<sup>2</sup> During the collision, a tree branch penetrated the lead railcar's forward windshield and struck the operator. Twenty-three passengers were

**Figure 1.** Aerial view of damaged train and portion of struck tree in their final positions. (Source: 6abc Action News.)

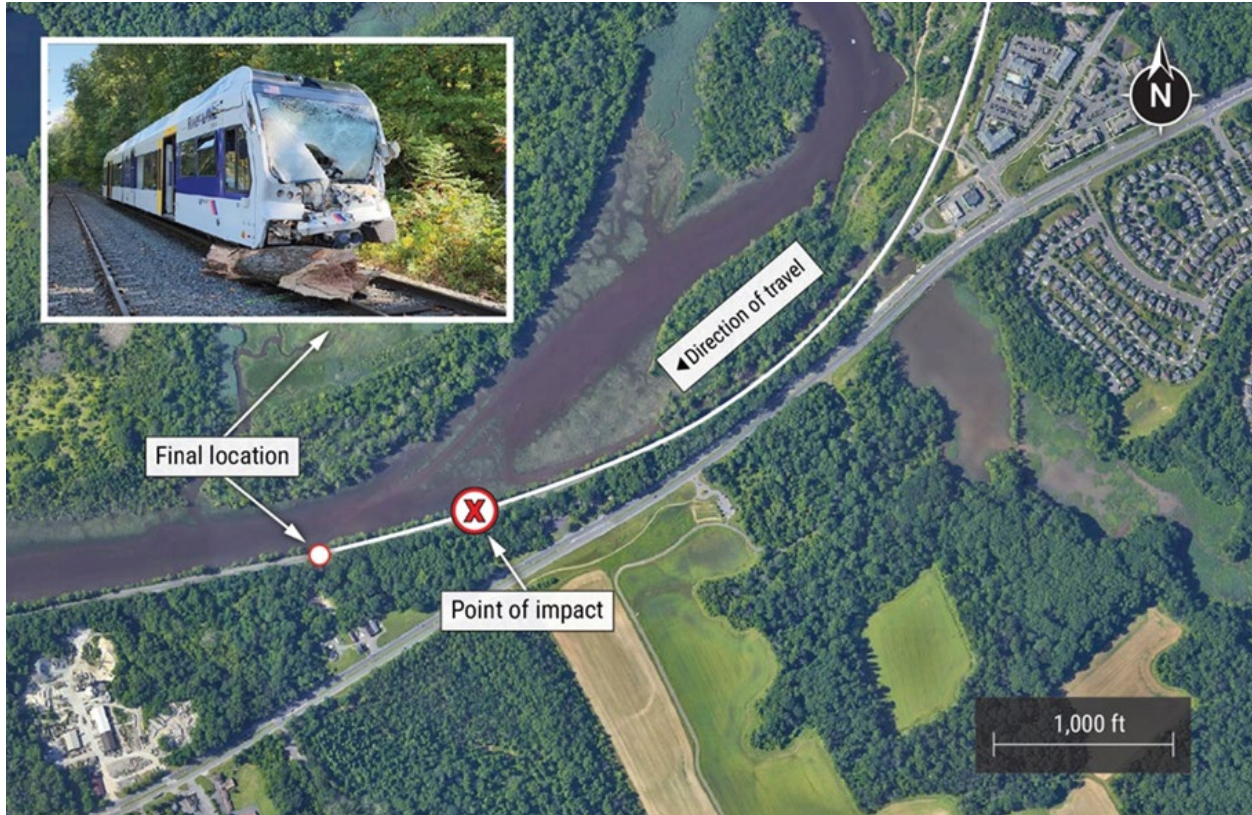
On the day of the accident, the operator reported for duty at 4:48 a.m. at an NJ Transit maintenance facility in Trenton, New Jersey. She started her scheduled trip from Hamilton Avenue Station at 5:47 a.m., operating train 207. This was the first train to operate on the River Line that day. About 5:55 a.m., the train departed Bordertown Station, the last station north of the accident area. According to event recorder data, the operator initiated an emergency braking application at 5:58:56 a.m. while rounding a right-hand curve north of the point of impact. The train was traveling 65 mph when the braking application began, and the train decelerated for several seconds before striking the tree.<sup>3</sup> The train came to a stop about 880 feet past the estimated point of impact. (See figure 2.)

**Figure 2.** Satellite image of accident location. (Source: Google Earth.)

While on-scene, the National Transportation Safety Board (NTSB) identified abrasive transfer marks on the rails consistent with emergency braking starting near MP 24.61, or about 430 feet north of the point of impact. Because the head end of the train was about 90 feet from its rearmost axle, this corresponds to an emergency braking application beginning when the head end of the train was near MP 24.59, or about 340 feet from the point of impact. The marks ended at the point of impact.
