Railroad Investigation Report: RIR-26-01

BNSF Railway Maintenance-of-Way Employee Fatality

Location	New Rockford, North Dakota
Date	November 4, 2024
Accident type	Maintenance-of-way employee fatality
Train	BNSF Railway freight train X-PTNNGT2-31A
Vehicle	BNSF Railway welding truck
Track	Single main track intersecting with farm road at highway-railroad grade crossing
Hazardous materials	None
Fatalities	1
Injuries	1
Damage	\$250,000

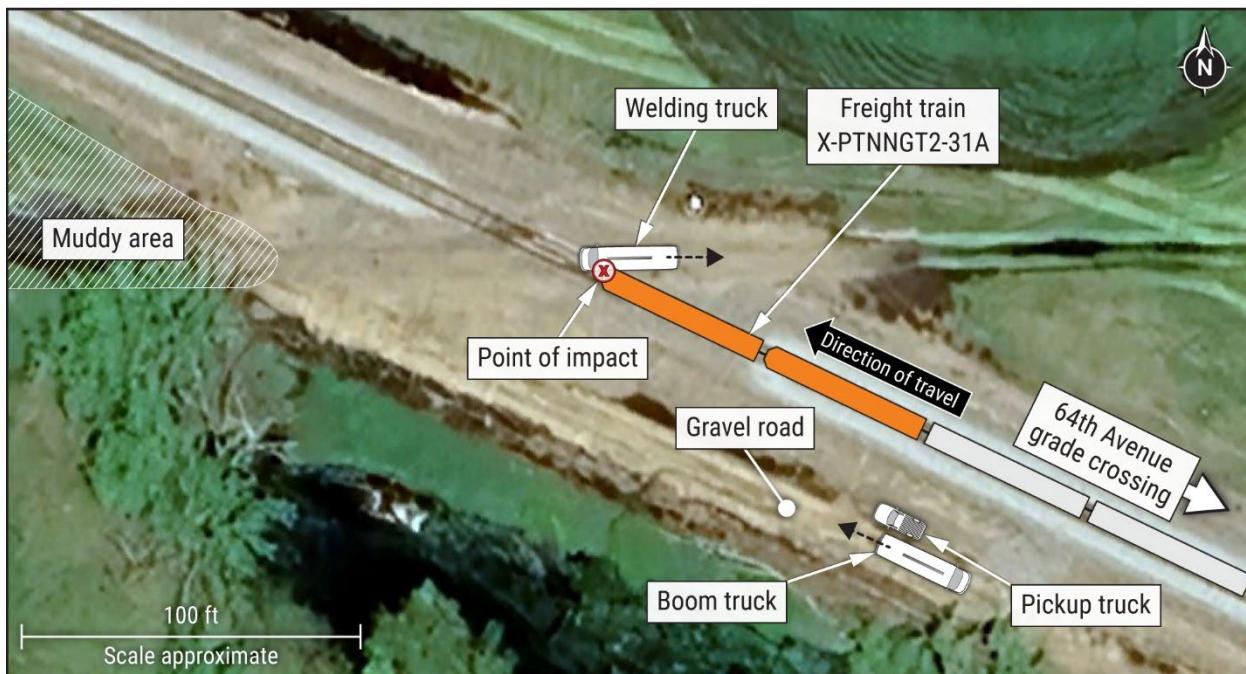
Figure 1. Aerial view of the accident site. (Source: BNSF Railway.)

At milepost 128.1, an unpaved farm road which ran east and west intersected the track at a skew angle of about 30°, making the grade crossing (accident grade crossing) a skewed intersection.⁶ The accident grade crossing was paved to facilitate the movement of vehicles and was at a higher elevation than the unpaved farm road. The accident grade crossing was passive but equipped with stop signs on either side of the track for eastbound and westbound vehicles traveling on the farm road.⁷ A gravel road on the south side of the track ran parallel to the track. This road was used by MOW employees to access the track for repair work.

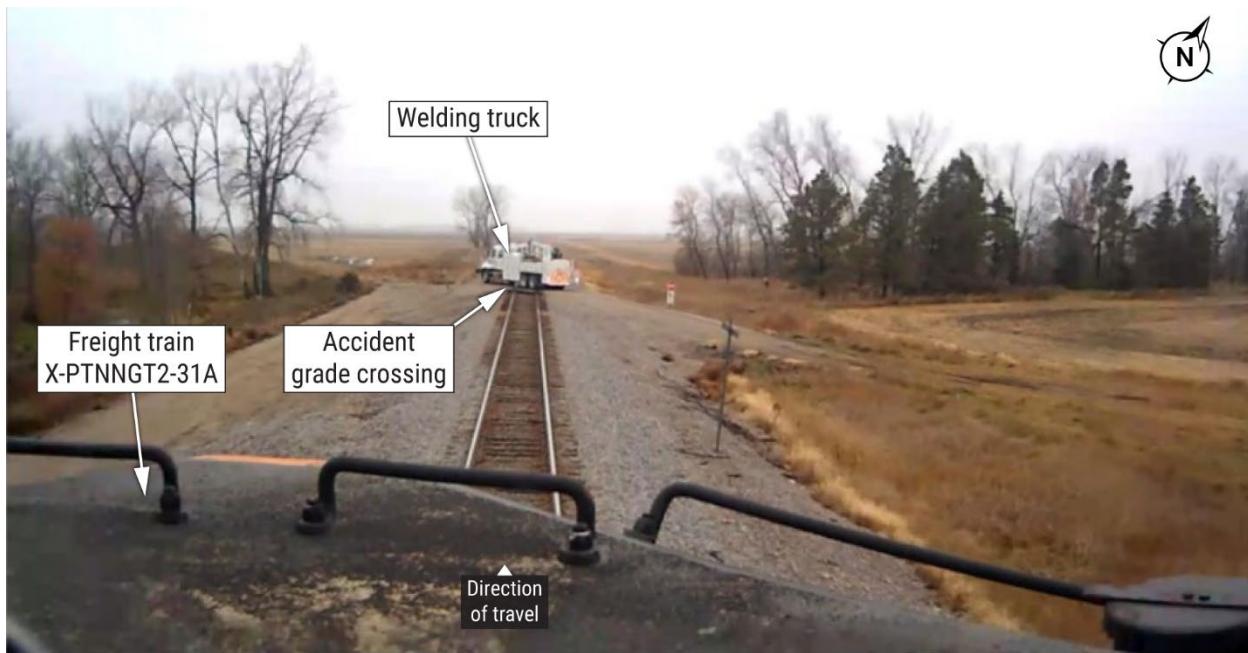
Table 1 is a timeline of the accident and Figure 2 is an image from the forward-facing camera of the train's lead locomotive as it approached the accident grade crossing.

Figure 2. Image from the forward-facing camera on the train as it approached the accident grade crossing.
