Railroad Investigation Report: RIR-26-02

# Metropolitan Atlanta Rapid Transit Authority Employee Injury

Atlanta, Georgia

October 19, 2024

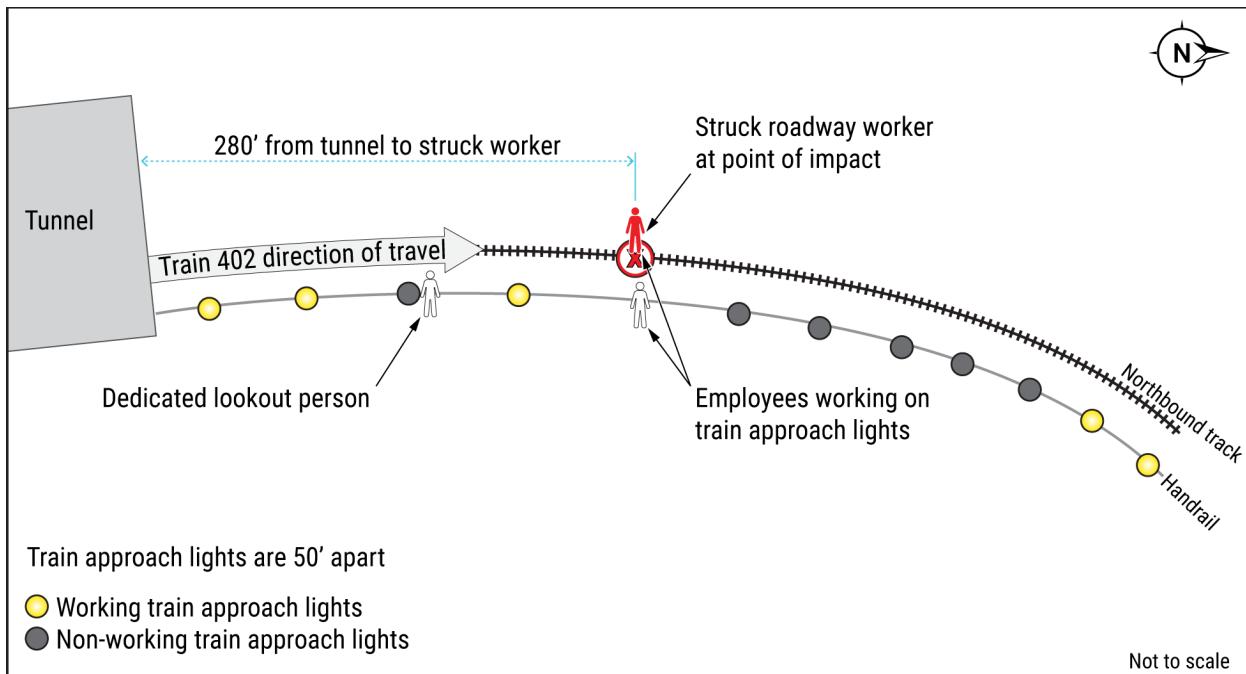
Technician 1 was part of a team of four automatic train control (ATC) technicians who were tasked with repairing wayside train approach lights on the AB bridge at chain marker 191+00 of the east track.<sup>2</sup> (See [figure 1](#).) MARTA has train approach lights installed on its right-of-way in any area where employees who would be working on their tracks do not have a direct line of sight to detect oncoming trains, such as at curves and tunnels. The lights provide an early-warning system for employees working along the right-of-way to alert them to approaching trains. The train approach lights are activated when an approaching train occupies a designated track circuit and they stay on until the train exits that track circuit.<sup>3</sup> However, on the day of the accident, the crew of technicians were to override this early-warning system and purposely cause the lights to flash to determine which bulbs needed to be replaced.

**Figure 1.** Diagram depicting the accident scene.

The accident occurred within a right-hand curve 280 feet north of a tunnel. The NTSB determined it would take about 3.8 seconds for a train to travel from the tunnel exit to where the technician was struck. Neither Federal Transit Administration regulations nor MARTA procedures required a minimum sight distance to use a dedicated lookout person as the primary method of protecting workers from being struck by passing trains and equipment. Rather, MARTA relied on the judgement of the dedicated lookout person to determine if there was enough time to alert the work group of an approaching train. The 3.8 seconds of travel time of the train from the tunnel exit to the point where the technician was struck were not enough time for the dedicated lookout person to recognize the danger, initiate a response, and have the technicians clear the track.

sight distance was 280 feet, well below 1,100 feet, and was insufficient to allow a dedicated lookout person to alert a work group in time. Therefore, the wayside inspection clearance method of on-track protection was inadequate for the location. Since this accident, MARTA has revised its procedures and now requires that technicians be able to clear to a designated place of safety 20 seconds before a train's arrival if a designated lookout person is used.

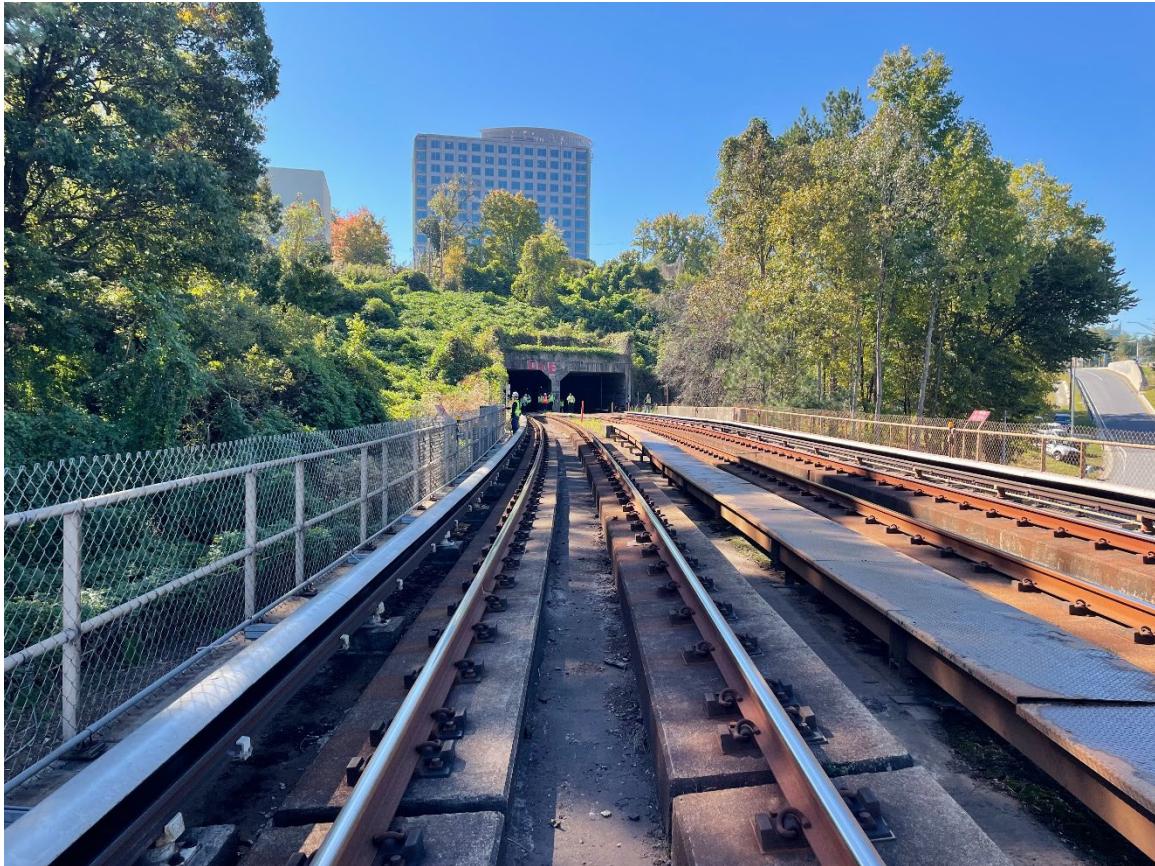
About the same time of the third radio check, the approach lights flashed outside the tunnel. In an interview with NTSB investigators, technician 2 said that he saw the approach lights begin to flash and since he had heard a radio transmission from technician 3, he assumed technician 3 had de-energized the relay at the TCR to cause the lights to flash. Technician 2 (dedicated lookout person), who was the technician closest to the tunnel, began unscrewing the third train approach light bulb about 150 feet from the tunnel, which was not part of his assigned tasks as the dedicated lookout. At the same time, technicians 1 and 4 were preparing to repair nonfunctional lights 100 feet farther north from the tunnel.<sup>6</sup> Technician 2 saw the train exiting the tunnel. He called out “train, train” and moved against a nearby fence to avoid getting struck. Later, in an interview with NTSB investigators, technician 4 said that he did not hear the train, nor did he hear technician 2’s verbal warning; however, he did spot the train and also moved to a nearby fence in time to avoid the passing train. At 11:14 a.m., on the day of the accident, MARTA train 402, traveling northbound, struck technician 1, who was in the track envelope about 280 feet past the tunnel exit, about 3.8 seconds after leaving the tunnel.<sup>7</sup> The NTSB was unable to determine if technician 1 was standing still within the track envelope or if he was moving through from one location to another. [Figure 3](#) shows the tunnel from the location where technician 1 was struck.

**Figure 3.** View of the tunnel from the location of the accident.

At the time of the accident, the dedicated lookout person, whose primary role was to protect the on-site technicians, was working to unscrew an approach light and failed to devote his full attention to the detection of trains approaching the work area. Furthermore, he did not stand at the most advantageous location to watch for approaching trains and alert the technicians. His position limited his line of sight of trains exiting the tunnel and his ability to see other train approach lights.
