Railroad Investigation Report: RIR-26-03

Hulcher Services Inc. Employee Injury

Location	Stockton, California
Date	March 11, 2025
Accident type	Railroad contractor injury
Track	Port of Stockton, Track 840
Hazardous materials	None
Fatalities	0
Injuries	1

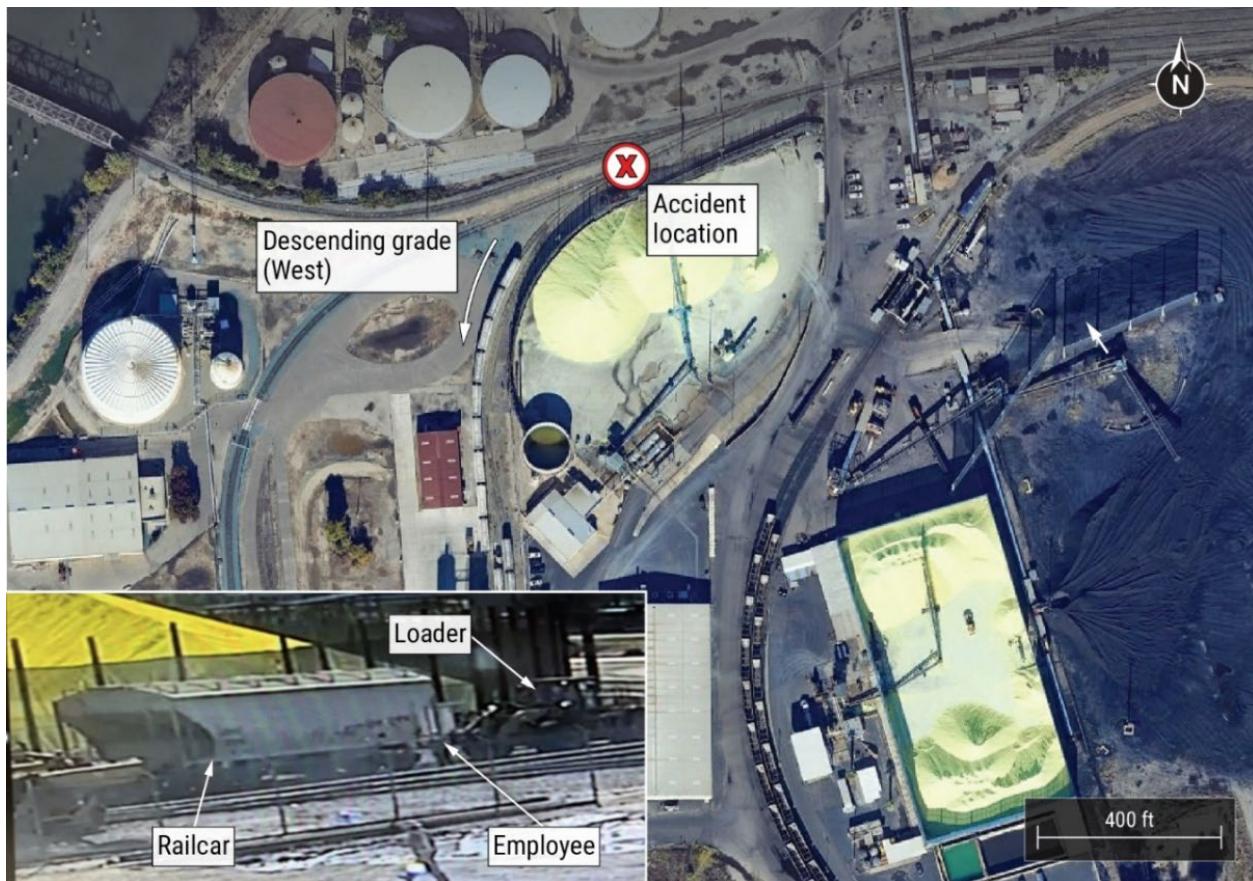
On March 11, 2025, about 3:00 p.m., a Hulcher Services Inc. (HSI) assistant division manager trainee (ADMT) sustained serious injuries during a rerailing operation at the Port of Stockton in Stockton, California.¹ (See figure 1.) The injured ADMT was part of an eight-person HSI crew contracted by the Central California Traction Company (CCT Railroad) to rerail four railcars that had derailed the day before at a switch on Track 840.² During the rerailing task, the ADMT stepped between a rubber tire loader and a railcar to release a hand brake, causing the railcar to roll toward the loader. As the equipment collided, the ADMT was pinned between the end of the car and the loader. At the time of the accident, visibility conditions were clear, unobstructed, and sunny; the weather was 69°F with no precipitation.

Figure 1. Overhead view of the Port of Stockton and (inset) a still frame showing the accident. (Source: Google Earth; inset source: Port of Stockton security camera footage.)

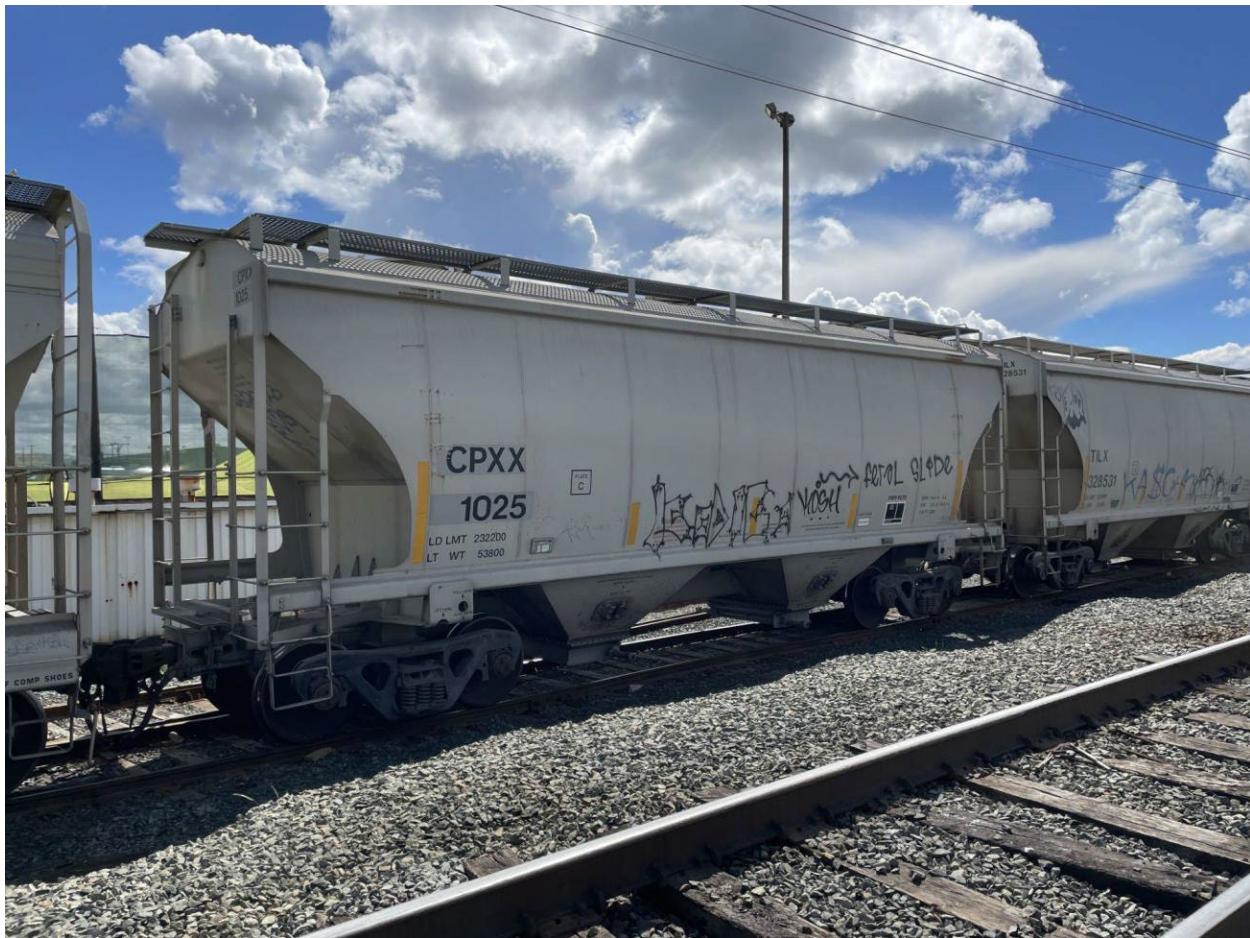
Figure 2. Accident car CPXX 1025.

According to interview testimony and surveillance video, the loader was positioned on the west end of car CPXX 1025 with the cab of the loader facing east, providing the loader operator with a clear view of the area in front of him. The ADMT then walked between railcar CPXX 1025 and the mast of the loader to chain the car and the loader together.⁶ Once the chain joining the railcar to the loader was secure, the ADMT stepped out from between the equipment and instructed the operator to take the slack out of the chain by reversing the loader slightly. The ADMT then positioned himself back between the equipment, pulled the rail car's quick release on the hand brake, and railcar CPXX 1025 began to roll westward toward the mast of the loader. The ADMT, still positioned between the railcar and the loader, while attempting to reapply the railcar's hand brake, was struck and crushed between the end of the railcar and the loader.

Hulcher Services Inc. lack of a standardized process for how and where to be safely positioned when operating a hand brake, which led the injured assistant division manager trainee to place himself in an unsafe position between a car and a piece of equipment while standing on the ground as he released the hand brake, resulting in crushing injuries.

After the accident, HSI added a new rule to the Safe Practices Handbook and incorporated it into their Standard Operating Procedure 33. This rule covers where an employee should position themselves to operate a hand brake safely. Specifically, the rule explains that the hand brake or quick release lever should always be operated from the brake platform when turning by hand. Further, the rule explains that under no circumstances should the hand brake or quick release lever be manipulated from the ground at the end of car, while positioned between cars or equipment, or from any position where movement of cars or equipment would put an employee in a pinch point. This change in the rules was incorporated into the daily safety briefing and training practices both in the field and at the HSI headquarters training facility.
