Railroad Investigation Report: RIR-26-04

R.J. Corman Railway Group Conductor Injury

Location	Guthrie, Kentucky
Date	June 26, 2025
Accident type	Conductor Injury
Accident train	Freight train MG 20 2 crewmembers 1 locomotive, 13 railcars
Track	Other than main track, non-signalized
Hazardous materials	None
Injuries	1

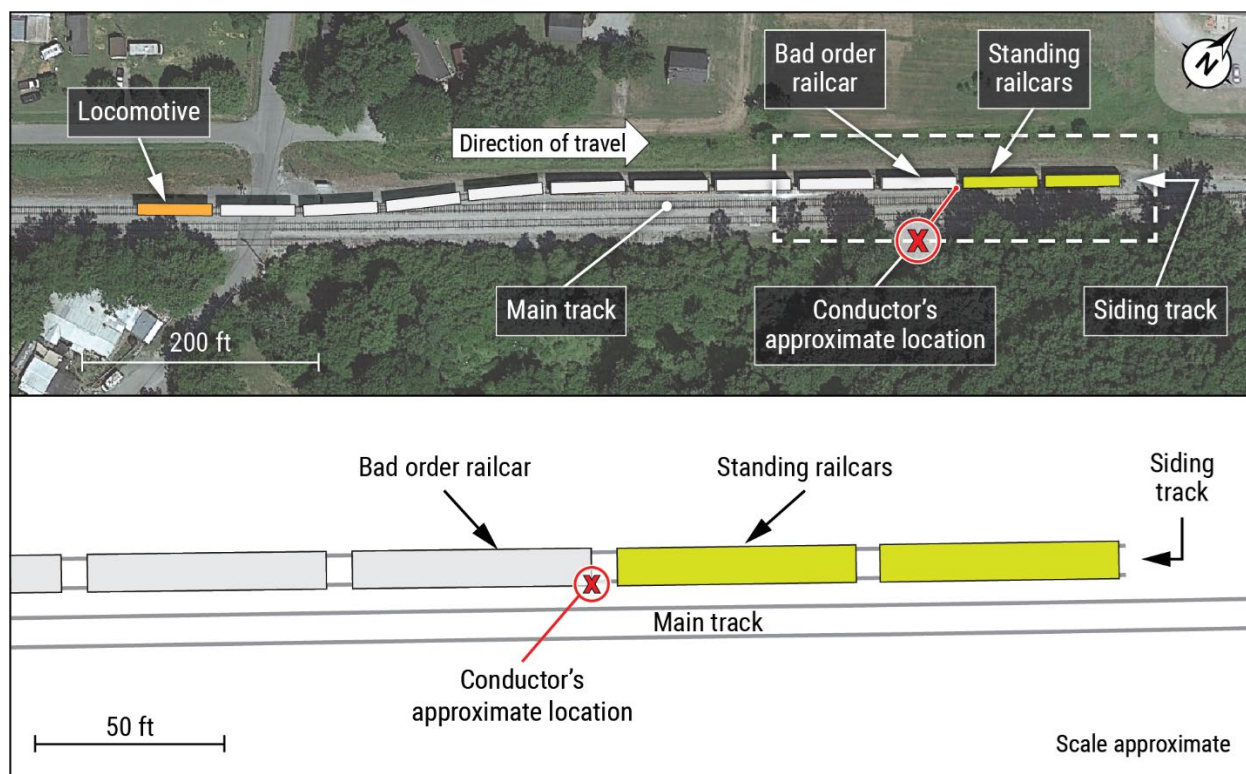
Figure 1. An aerial view of the accident site.
