Railroad Investigation Report: RIR-26-05

Southeastern Pennsylvania Transportation Authority End-of-Track Collision

Location	Norristown, Pennsylvania
Date	May 11, 2025
Accident type	End-of-track bumping post collision
Train	Single railcar light rail vehicle 153
Crew and passengers	1 operator 15 passengers
Track	Transit track, signalized
Fatalities	0
Injuries	10 minor, including the operator; 2 serious
Property damage	\$920,000

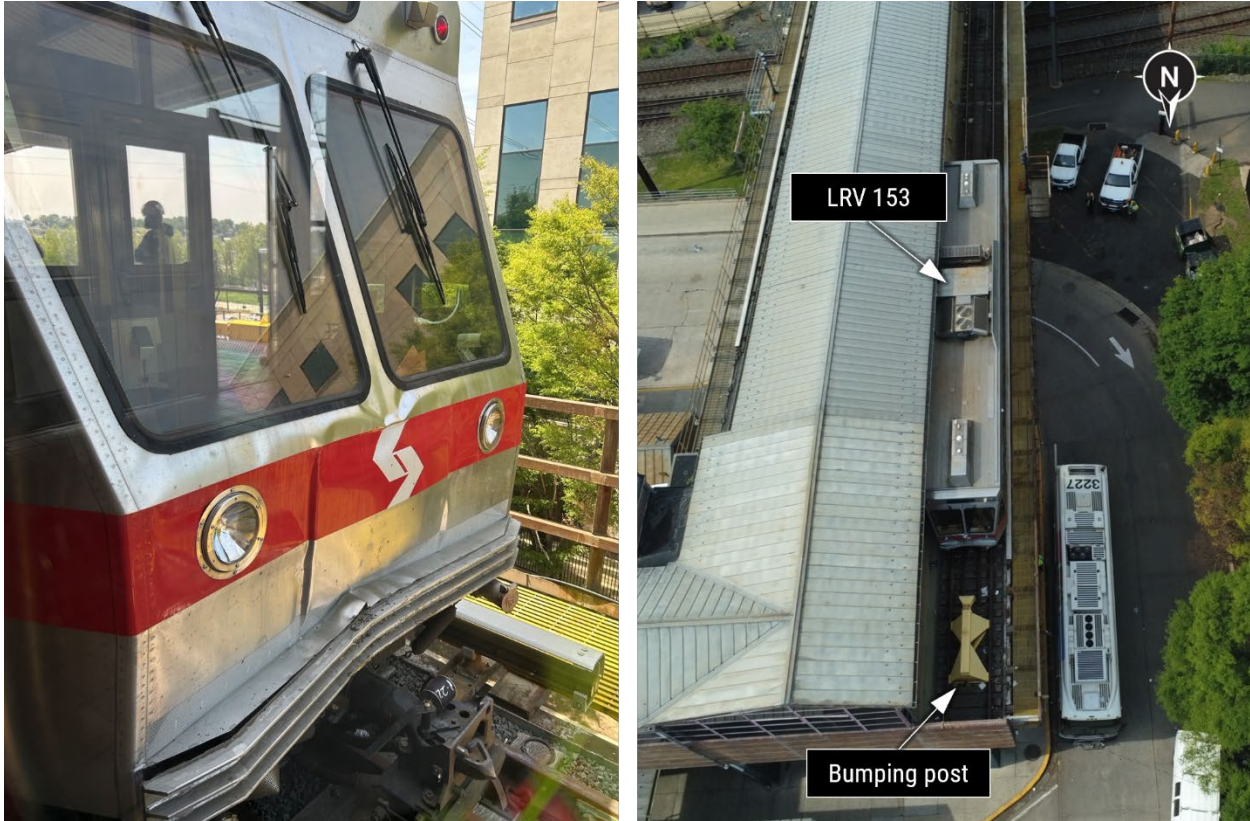
Figure 1. Damaged end of LRV 153 (left) and aerial view of accident scene (right).

Visual examination of LRV 153 found body deformation to the lead end of the LRV from the impact with the bumping post (see figure 1 above), but the vehicle was operable. On May 15, investigators performed a series of four stopping distance tests from 15 mph using LRV 153. No adjustments were made to the LRV's braking or propulsion systems before the tests. The brakes applied normally during each test.

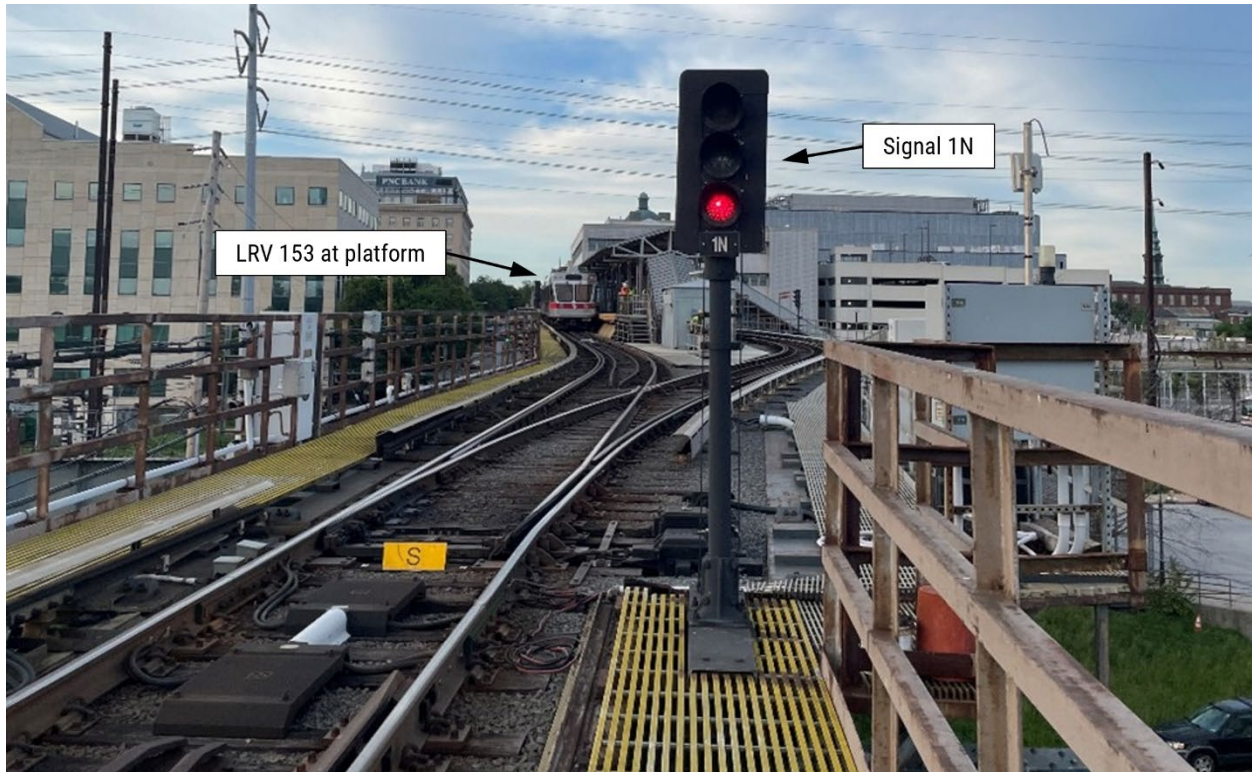
continue toward the turnout and signal 1N, the northmost signal on the M Line.³ This signal is about 380 feet from the end of track 1 as shown in figure 2.

Figure 2. Signal 1N and final approach to Norristown Station platform.

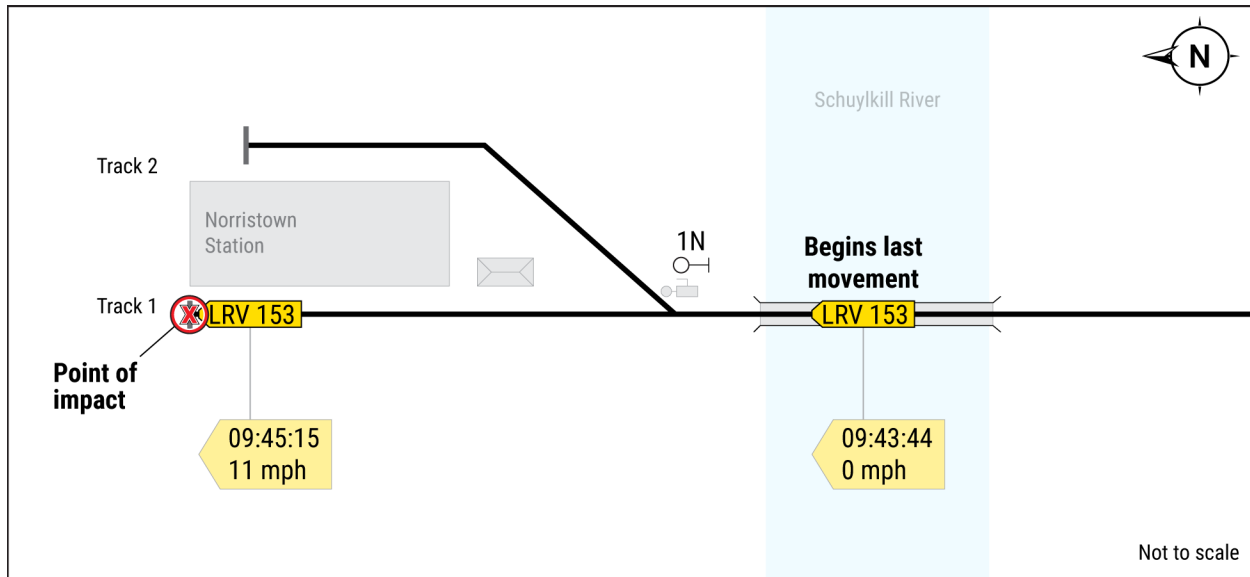
The event recorder did not record a brake application or other control manipulations before the collision with the bumping post at 9:45:15 a.m. The LRV's final movement is summarized in figure 3.

Figure 3. Diagram of LRV153's final movement.

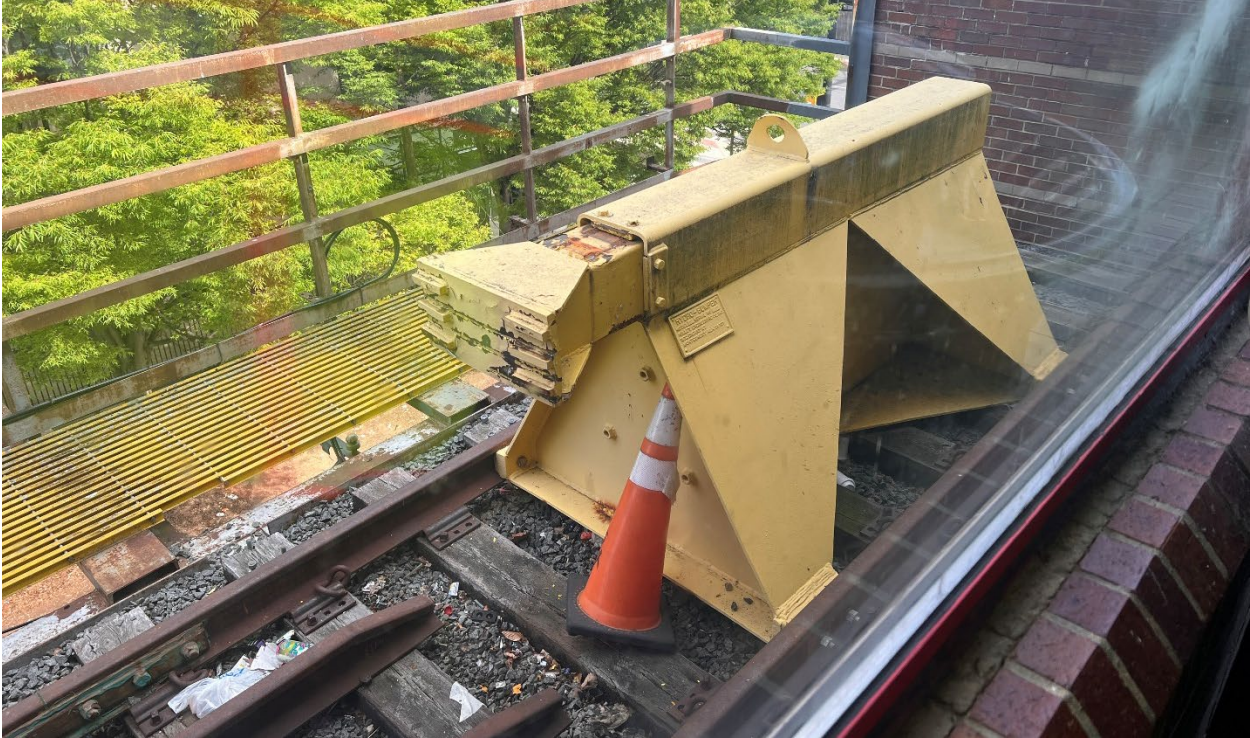
The ends of both tracks at Norristown Station, and their counterparts at 69th Street Station, are equipped with hydro-style bumping posts, which use hydraulic mechanisms to control the collapse of a piston and absorb energy during collisions. The bumping posts at Norristown Station normally extend 2 feet, 8.5 inches from their housings. Postaccident examination found that the bumping post involved in the collision had collapsed about 2 feet, as shown in figure 4.

Figure 4. Norristown Station bumping post after collision with the piston driven into the housing.

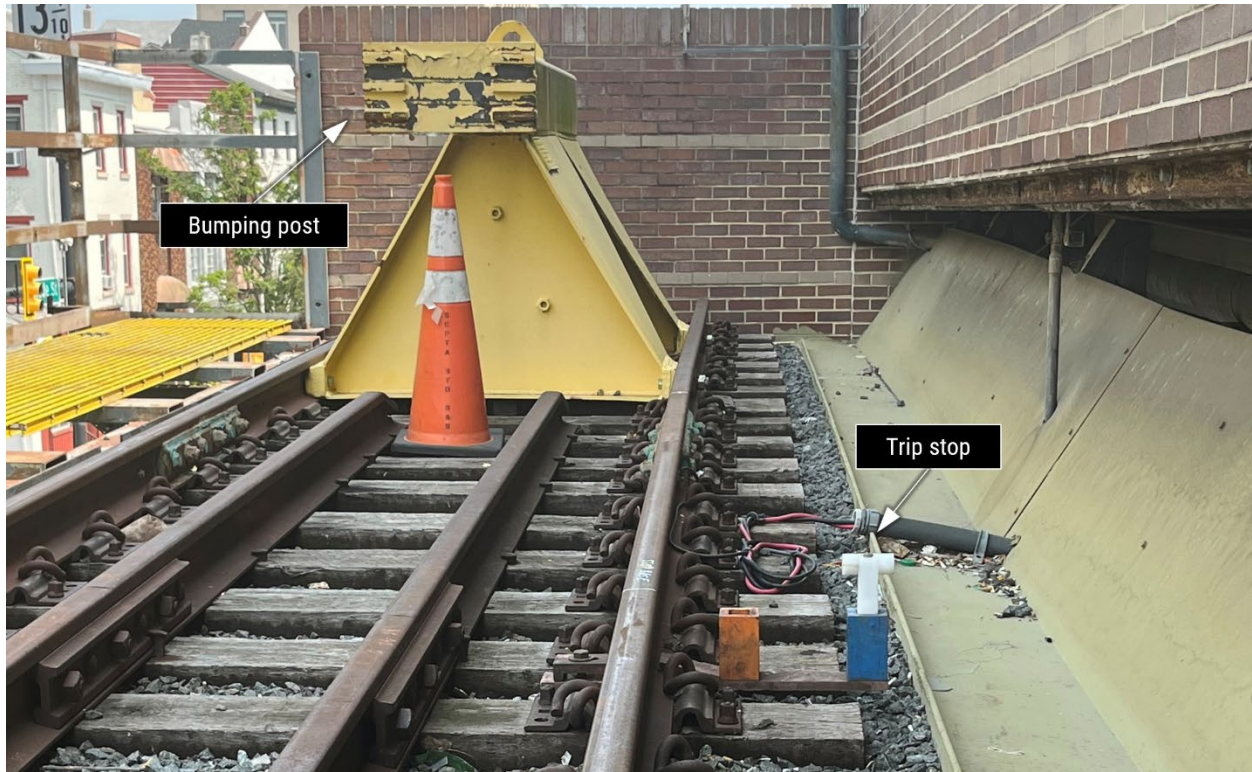
Figure 5. Trip stop on track 1.

SEPTA has installed trip stops at Norristown Station ahead of the bumping posts to automatically apply a train's air brakes before a collision. However, the available braking distance is limited by the trip stops' position: less than 6 feet for track 1 and less than 2 feet for track 2. Both intervals fall far short of an N-5 LRV's 23-foot minimum braking distance from 15 mph, as established by postaccident testing of LRV 153. The trip stops are therefore unlikely to mitigate bumping post collisions when a train is moving at or near the maximum ATC-enforced speed at Norristown Station. SEPTA did not install trip stops at 69th Street Station, an operating environment similar to Norristown Station. This postaccident action therefore does not address the lack of ATC protection against operator error.

On May 22, 2025, in response to the collision, SEPTA issued an operations bulletin imposing a speed restriction near Norristown Station, reducing the maximum authorized speed from 15 mph to 5 mph between the 1N signal and the end of the track. SEPTA did not reconfigure its ATC system to enforce this limit but installed trip stops near the end of the tracks at Norristown Station about 1 foot past the trains' normal berthing positions as shown in figure 5.⁹ On track 1, the trips stops are positioned to activate with 5.5 feet between an N-5 LRV coupler and the bumping post; on track 2, this distance is 1.75 feet. SEPTA did not install trip stops at 69th Street Station which is at the other end of the M Line, citing space and access limitations.
