Railroad Investigation Report: RIR-26-06

# Norfolk Southern Railway Conductor Injury

Location	Muscle Shoals, Alabama
Date	April 9, 2025
Accident type	Serious injury of conductor
Train	2 locomotives and 55 mixed freight railcars
Crew	Crew of yard job AH-01
Track	Yard track in Sheffield Yard
Hazardous materials	None
Fatalities	0
Injuries	1
Property Damage	None

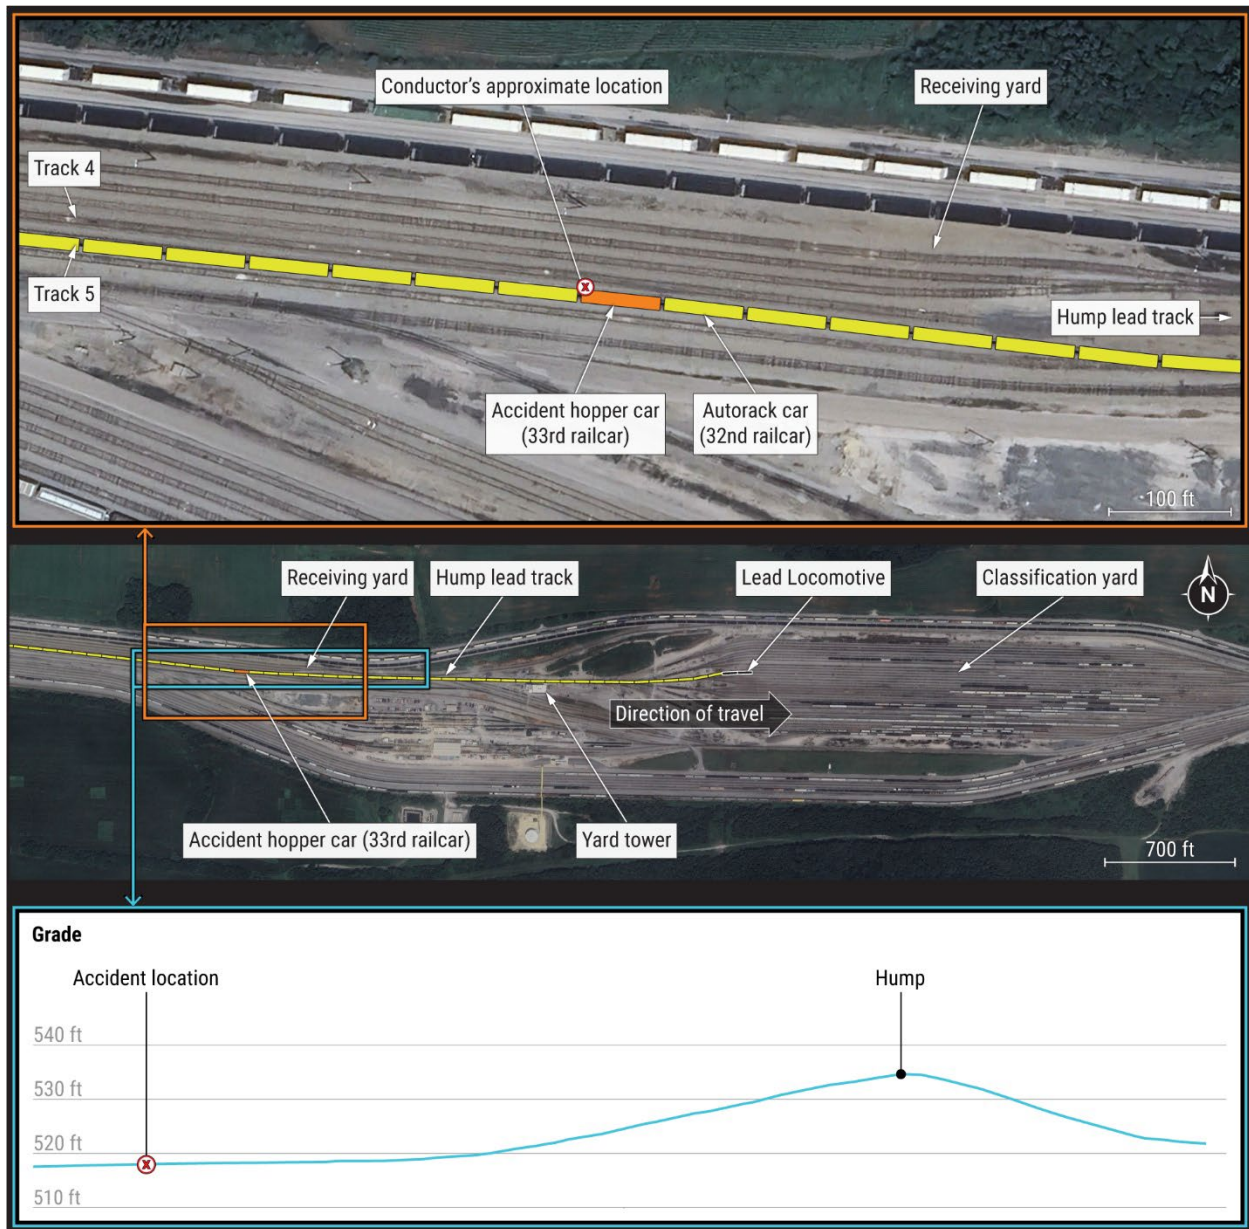
On April 9, 2025, about 1:15 p.m. local time, a Norfolk Southern Railway (NS) conductor on yard job AH-01 was seriously injured while performing switching operations at NS’s Sheffield Yard in Muscle Shoals, Alabama.<sup>1</sup> (See figure 1.) The conductor was found on the ground near the north rail of track 5 in the receiving yard with severe injuries to his lower legs and feet.<sup>2</sup> The Sheffield Yard supervisor called 911; emergency medical services arrived on the scene and airlifted the conductor to the University of Alabama at Birmingham Medical Center, where he was admitted for treatment of his injuries. Visibility conditions at the time of the accident were daylight and clear; the weather was 63°F with no precipitation.

**Figure 1.** Accident site in Sheffield Yard.

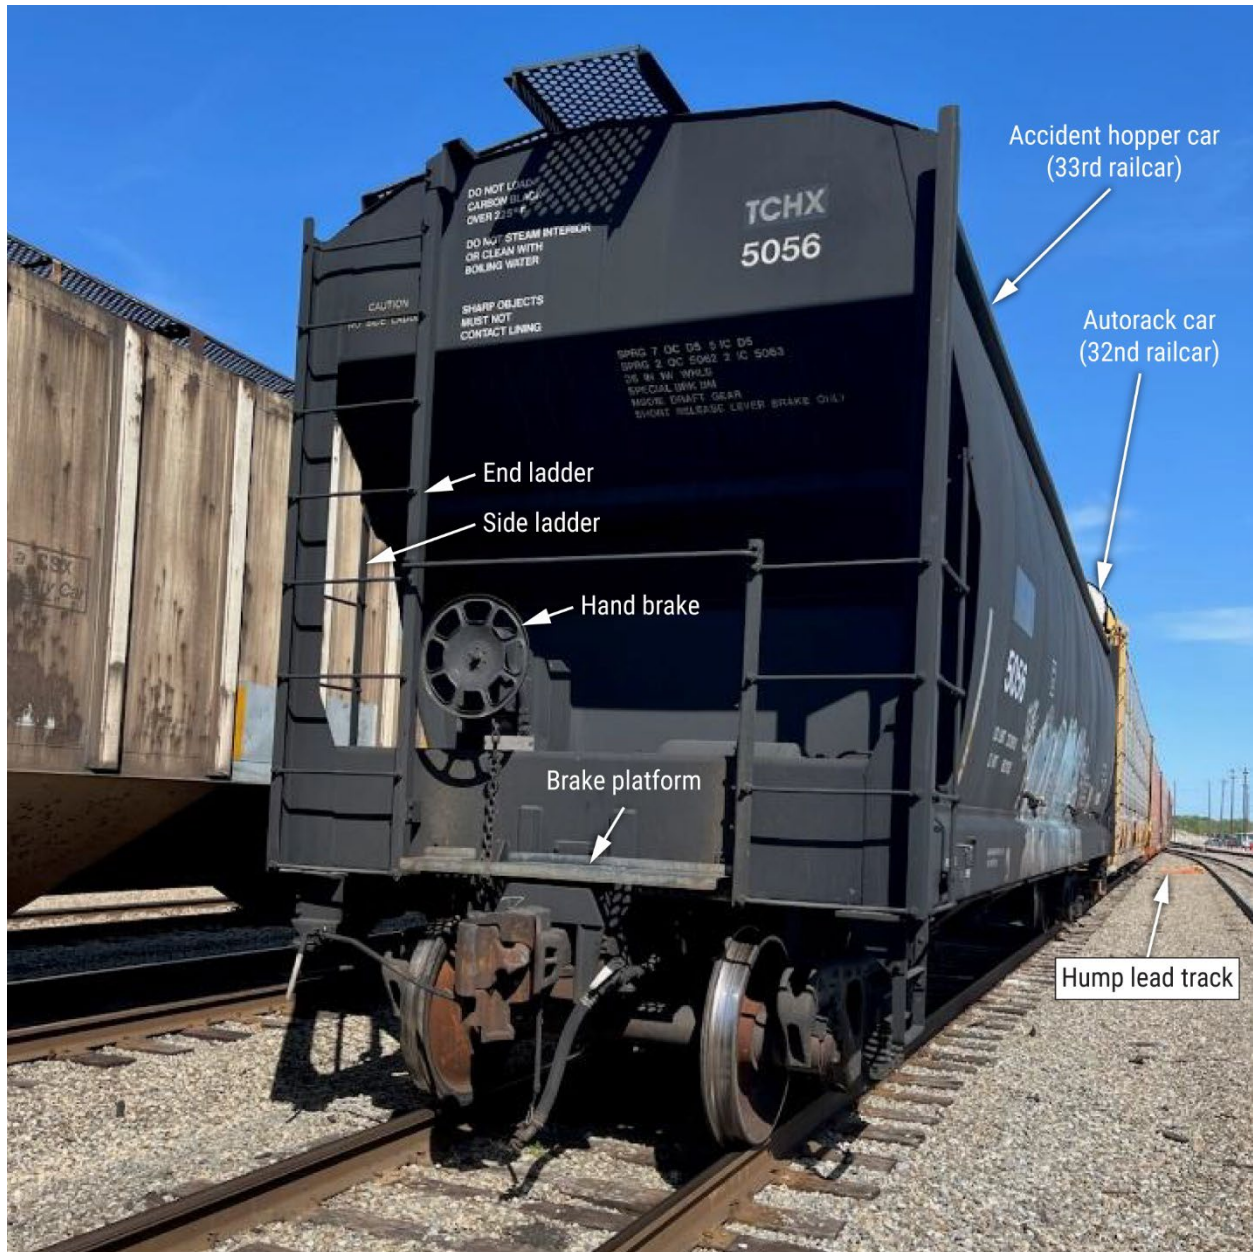
employees in the yard tower at Sheffield Yard heard the conductor's call for help and responded. Employees at Sheffield Yard found the conductor on the ground near the north rail of track 5 at the rear end (or B-end) of the hopper car, close to the hand brake. (See figure 2.)

**Figure 2.** The hand brake at the rear end of the hopper car.

While on scene, NTSB investigators examined the hopper car and did not find any defects that may have contributed to the accident. However, investigators found that the hopper car's hand brake was partially applied and that the hopper car had rolled about

NTSB's investigation concluded that the condition of the hopper car, including the hand brake, did not contribute to the accident.

The NTSB investigators found that the hand brake on the hopper car was partially applied, indicating that the conductor was likely in the process of applying the hand brake when he was struck. The hopper car was probably stationary when the conductor began to apply the hand brake (conductors usually apply the hand brake when railcars are stationary and the conductor had instructed the engineer to stop). The postaccident position of the hopper car relative to where the conductor was found indicates that the hopper car had struck the conductor and had continued to move about 16 feet on the descending grade from the hump. The NTSB's review of the event recorder showed that the engineer did not move the train for 27 seconds between bringing the locomotive to a stop and the conductor's call for help. Because the locomotive was stopped, the only other reason for the railcar's movement was slack adjustment. Consequently, this indicates that the hopper car moved because of slack adjustment while the conductor was attempting to apply the hand brake.
