American Auto Works Conductor Fatality

Location	Richmond, California
Date	April 4, 2025
Accident type	Conductor fatality
Accident train	3 crewmembers 2 locomotives, 5 railcars
Track	Other than main track, non-signalized
Hazardous materials	None
Fatalities	1
Injuries	0
Property Damage	\$0

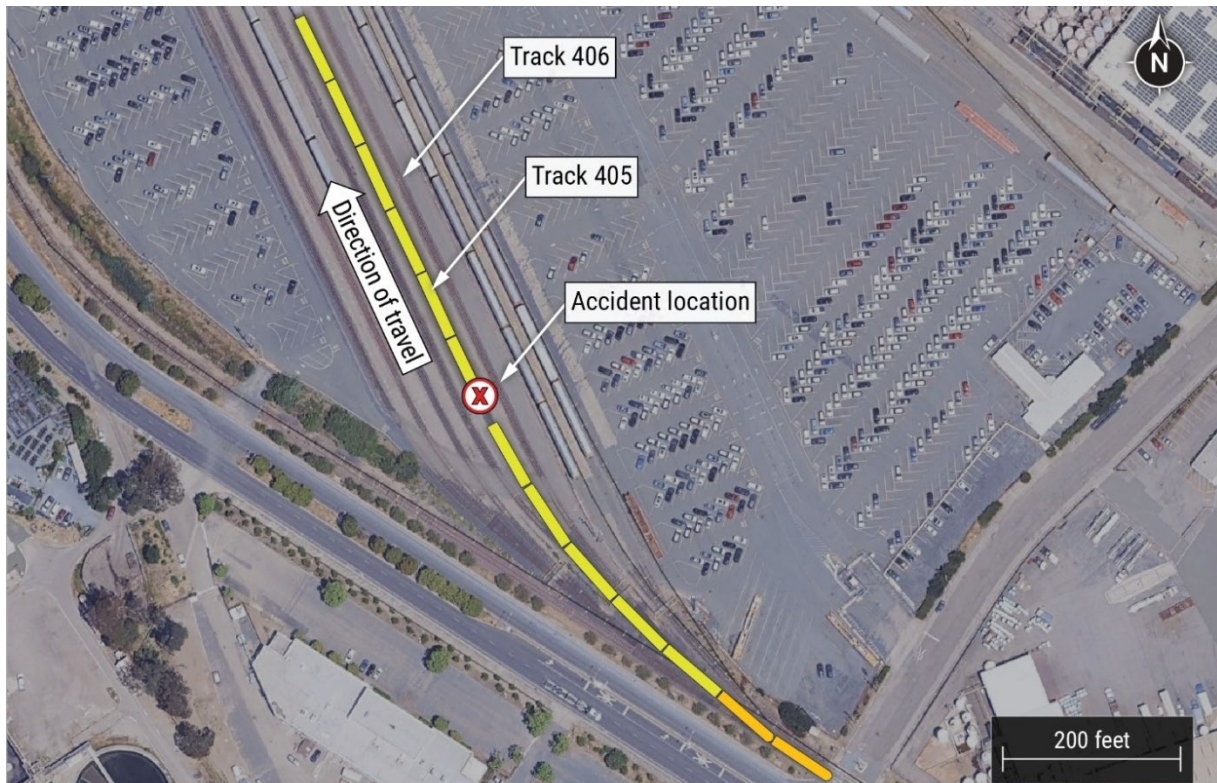
Figure. An overhead graphic depicting location of the employee and equipment.

Event recorder data show that immediately following the “pin it” transmission at 9:17:35 a.m., the engineer began shoving the train about 57 feet toward railcar TTGX 971194 (the railcar that the crew was attempting to couple to their train). After the movement stopped, the brakeman discovered the conductor crushed between the drawbars of railcars BNSF 301064 and TTGX 971194.
