Railroad Investigation Report: RIR-26-09

# Union Pacific Railroad Conductor Injury

| Location | Lexington, Nebraska |
| Date | June 25, 2025 |

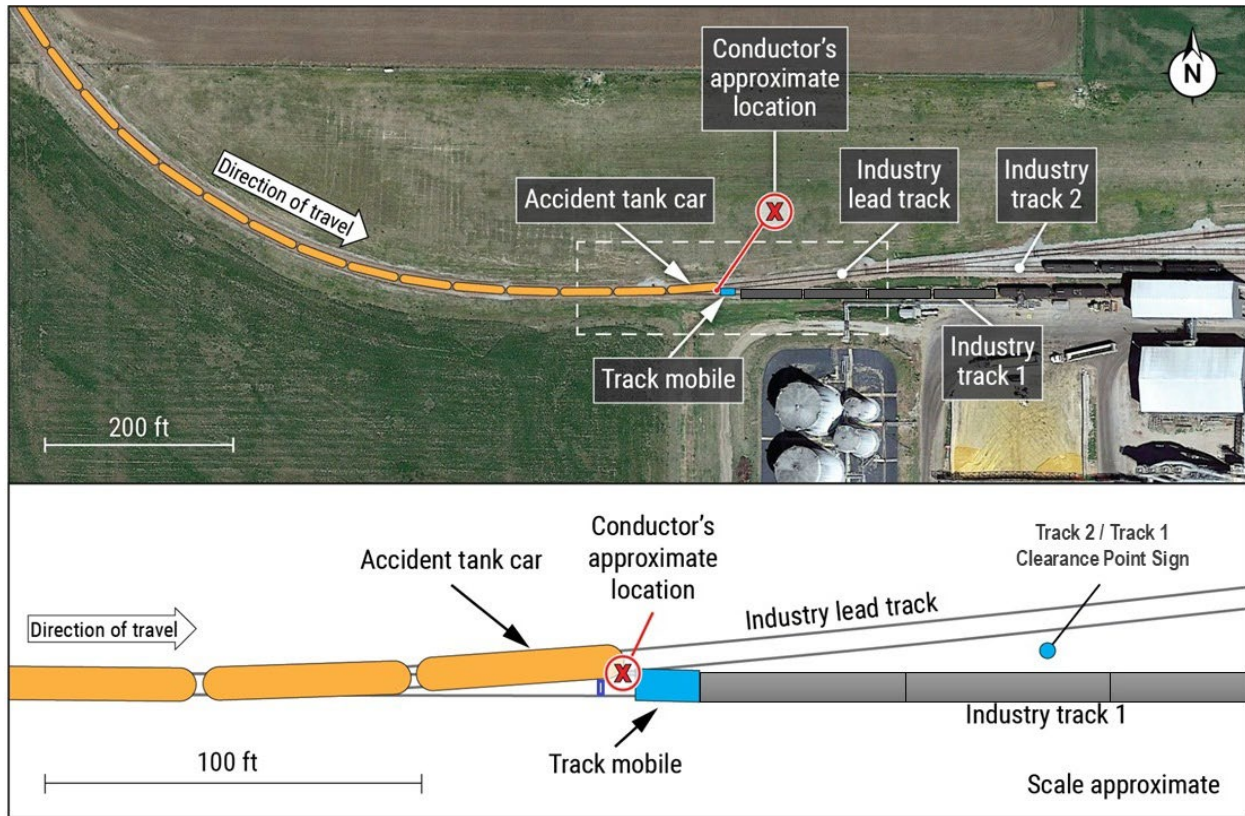
**Figure 1.** Overhead view of the accident site and diagram of the accident.

The investigation revealed that the trackmobile was fouling the lead track and positioned beyond the clearance sign (identifying the clearance point or location where equipment can safely be positioned) located between the two tracks. CEF operators were not trained in railroad operating procedures such as not leaving equipment in the foul of other tracks. CEF's new hire training consisted of informal on-the-job training that focused on the operation of the equipment. CEF is an industry not governed by FRA regulations. Thus, CEF operators are not required to comply with the GCOR rules specifying that conductors must determine that the portion of track to be used is clear of conflicting movements and equipment fouling the track. CEF stated that they installed clearance signs with the purpose of aiding their operators determine where equipment could be positioned safely. However, in this case, the operators were not trained to identify where it was safe to leave equipment on track 1 such that it would not interfere with equipment on adjacent tracks.

During the shoving movement, the UP conductor gave the engineer a 10-car count into track 2 which suggests that he believed the track was clear for approximately 700 feet. The conductor was approximately 233 feet from the trackmobile at the time of this communication. Radio communication records did not capture any additional communication between the conductor and engineer about stopping for the trackmobile until just before impact. The absence of such communication indicates that the conductor thought the trackmobile was clear (not fouling track 2) or that he overlooked the trackmobile and was focused on the route into track 2 to determine if the switches were lined for the route.

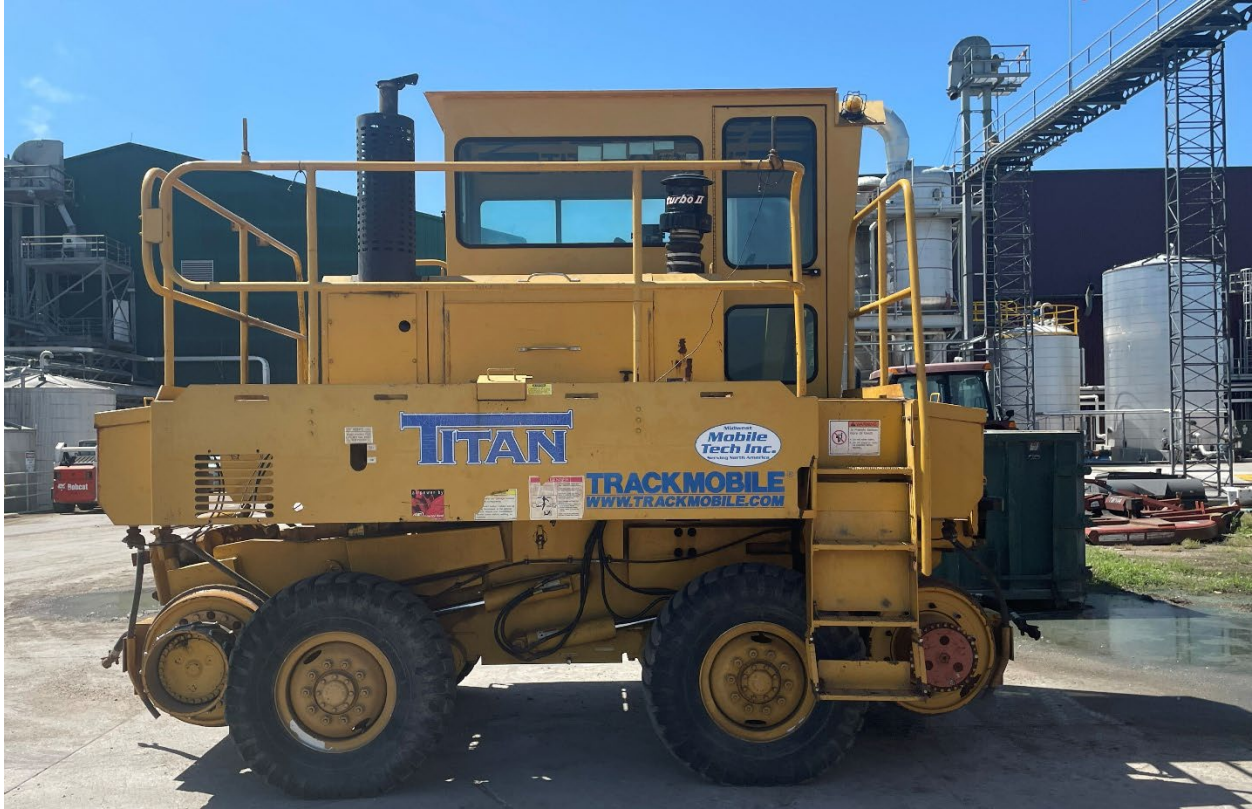
On the day of the accident, two CEF operators were switching tank cars on the industry tracks within the CEF facility using a trackmobile.<sup>3</sup> (See figure 2.) The tank cars were being switched to accommodate loading operations by facility personnel. One of the operators was lining switches while the other was controlling the trackmobile from the ground with a remote control.<sup>4</sup> The operator of the trackmobile had been hired by CEF about 3 weeks before the accident and the accident happened in the first week he was assigned to operate the trackmobile unsupervised. Before the accident, CEF's training for new operators consisted of up to 2 weeks of on-the-job training on the trackmobile or until determined proficient. This training does not include standard railroad operating rules and procedures.

**Figure 2.** Exemplar Trackmobile at the CEF facility.
