Railroad Investigation Report: RIR-26-10

# Port Authority Trans-Hudson Corporation Third Rail Feeder Cable Fire

| <b>Accident type</b> | Third rail fire |

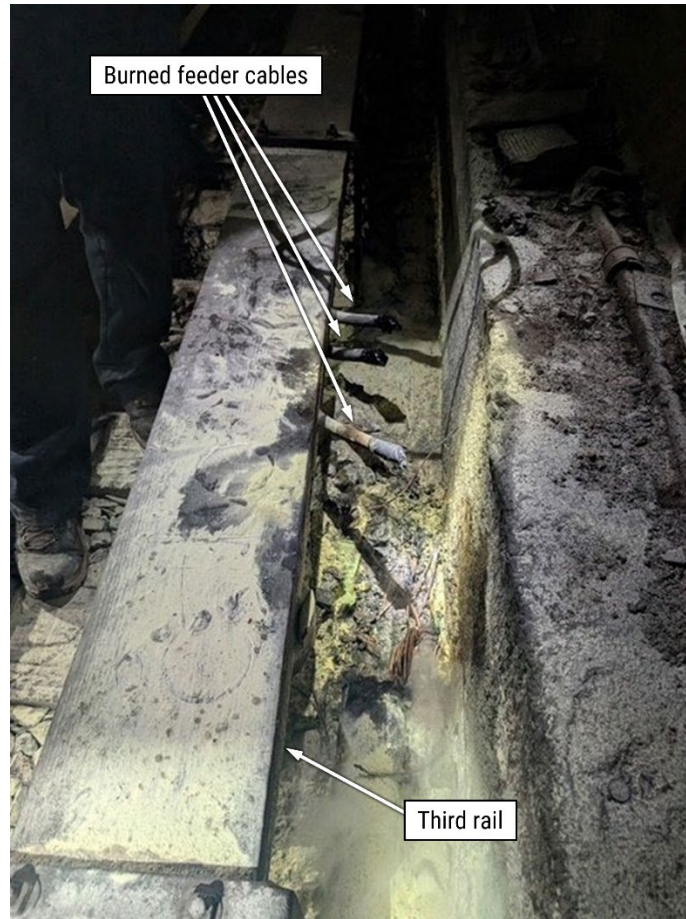
The OE determined that the fire involved the third rail feeder cable. The fire had further damaged other third rail cables so PATH suspended train service about 7:58 a.m.

rail at strategic locations throughout the transit network. The third rail feeder cables at the accident location included one of these jumper cable sections.<sup>12</sup> (See figure 2.)

**Figure 2.** Section of third rail and burned feeder cables after the accident.

<sup>5</sup> As a temporary measure, the power railman removed the damaged cable and rerouted power from another area to energize that section of rail. PATH completed additional repairs overnight.

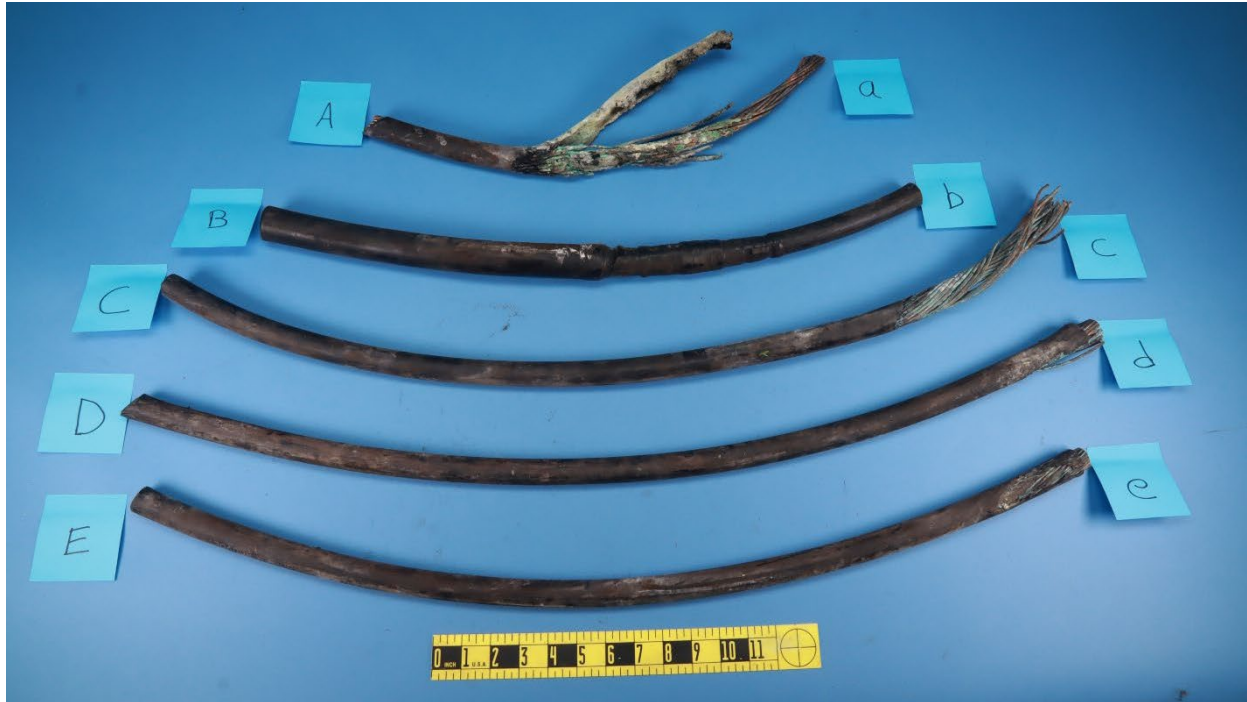
The National Transportation Safety Board (NTSB) recovered four sections of damaged feeder cables and sent them to the NTSB Materials Laboratory in Washington, DC, for examination.<sup>13</sup> Figure 3 shows the cable sections and their names.<sup>14</sup>

**Figure 3.** Cable segments and their labels.

According to PATH employees, the feeder cables at the accident location were more than 25 years old. PATH employees also identified cable section Aa as the source of the fire and smoke in the accident. The NTSB's Materials Laboratory examination of cable section Aa revealed extensive corrosion: most of the cable's 37 individual copper conductors were separated and exhibited material loss.<sup>15</sup> This corrosion was not uniformly distributed but was concentrated within a short length of cable section Aa. The conductor wires in the other cable sections (Cc, Dd, and Ee) exhibited some surface oxidation, and their insulation jackets exhibited thermal damage consistent with exposure to the fire itself.

<sup>15</sup> Corrosion reduces the cross-sectional area of conductor wires. When the conductor's ability to carry an electrical load (current) is diminished but the load remains constant, electrical resistance and localized heating increase, along with the risk of ignition.

The NTSB conducted a postaccident examination of the third rail feeder cable that had caught fire and observed corrosion and separations in the cable's wire conductors concentrated in the section of cable from which the fire originated. The focused area of severe corrosion seen in that section of cable suggests a stray (or leakage) current causing localized electrolytic corrosion.<sup>18</sup> It is likely that the cable's insulation jacket had become compromised at the accident location, allowing a leakage current to exit the cable. With the conductor wires corroded and separated, the electrical resistance of the cable increased until the cable overheated and ignited. Electrolytic corrosion is a time-based material transport process causing material loss, and it would have been slow to develop and consequently visible for an extended period. Undamaged polyethylene thermal insulation would have made corrosion of the conductor wires far less likely. Given the level of corrosion at the time of the accident, visual inspections just before the accident could have identified the degraded insulation and poor cable condition, but PATH's most recent inspection before the accident on February 10 showed no defects, indicating the inspection was not satisfactory.

In October 2025, PATH developed and implemented formal electrical operating instructions to their track division, which standardized third rail inspections, maintenance, and operating requirements. PATH increased its third rail tunnel inspection frequency from quarterly to monthly and introduced an electronic inspection and recordkeeping system that included a process for recording and tracking the observation and repair of third rail system defects. PATH also introduced the use of thermal imaging technology in handheld devices and in artificial intelligence-assisted thermal imaging systems

After the accident, PATH developed new procedures for third rail inspections and maintenance and implemented new training and qualification processes for employees engaged in this work. PATH also implemented a new thermal imaging inspection process that, before the publication of this report, identified multiple areas of compromised third rail and power cable, allowing these areas to be remediated before a critical failure.
