Railroad Investigation Report: RIR-26-11

# BNSF Railway Raking Collision with Subsequent Derailment and Conductor Injury

| Location | Denver, Colorado |
| Date | August 5, 2025 |

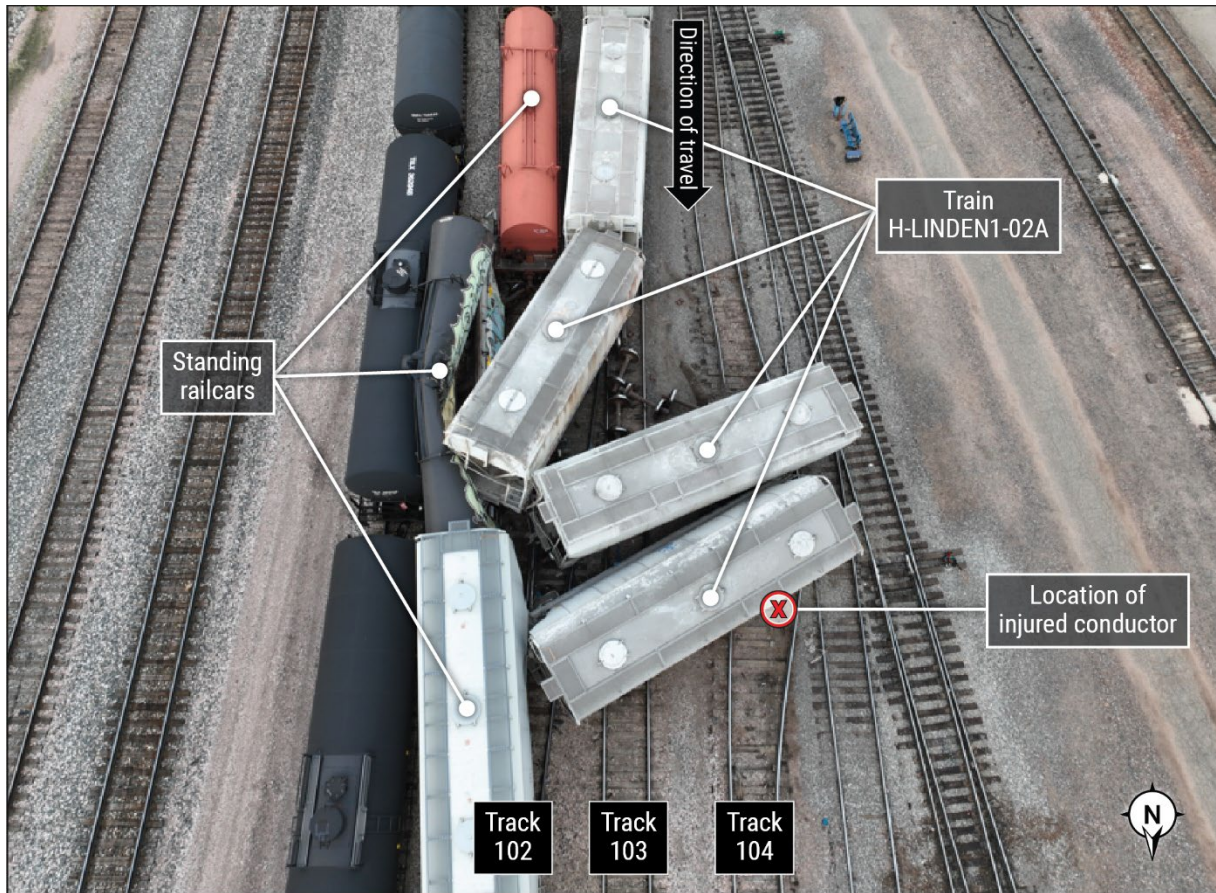
**Figure 1.** Aerial of accident scene.

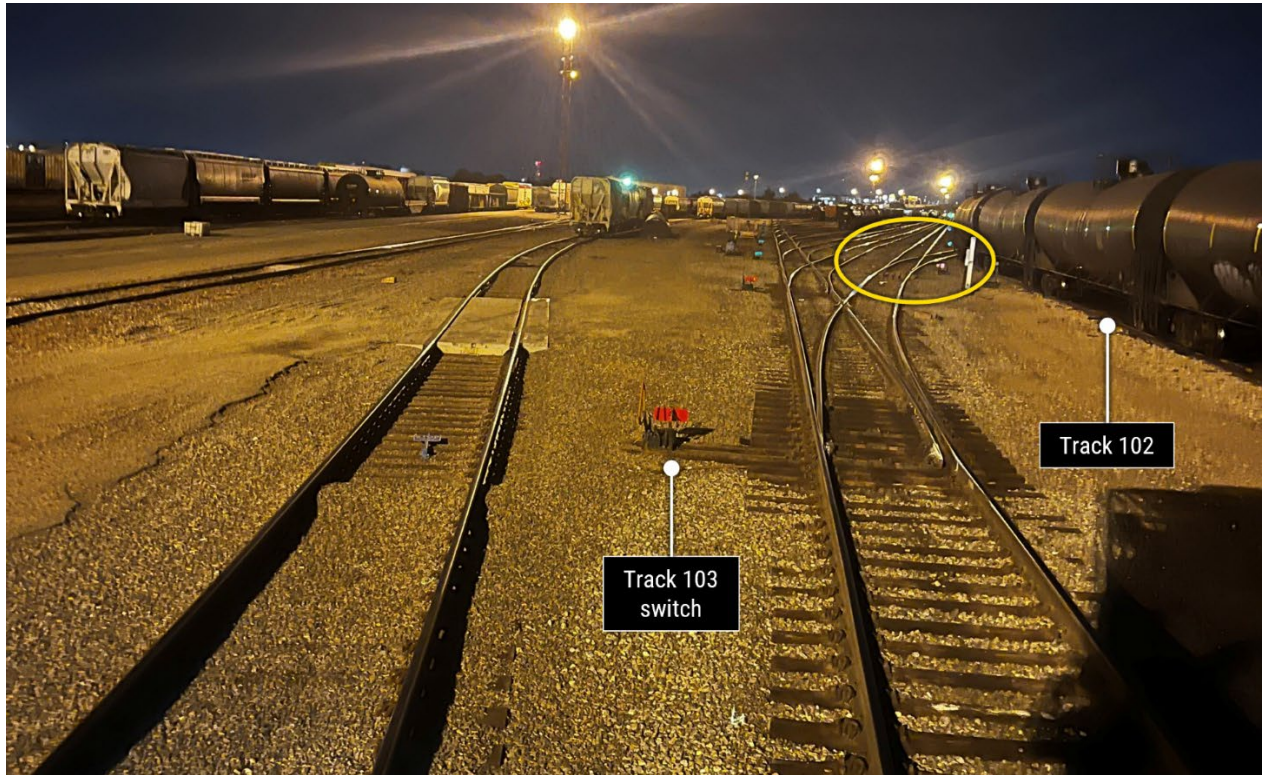
**Figure 2.** A nighttime reenactment from a mounted position on an exemplar railcar, looking north in the direction of the intended route, showed the south switch of the 103-102 crossover (circled) visibly lined for crossover movement into a standing cut of railcars in Track 102.

Based on review of yard camera footage and information obtained in interviews, the NTSB determined that prior to the accident, the south switch of the 103-102 crossover had been left out of correspondence and lined for crossover movement by a BNSF car inspector to provide protection.<sup>5</sup> Protection is provided by denying access to tracks being worked on or next to by lining and locking switches in a way that prevents rail equipment from accessing the tracks being protected. Lining a crossover switch out of correspondence is an approved method used by mechanical employees, including car inspectors, to provide this protection. However, when the protection was no longer needed, the car inspector did not restore the crossover switch into correspondence as required by BNSF mechanical safety rule S-24.2.3.

Due to the risks associated with crossovers left out of correspondence following the accident, BNSF repaired the track and placed mechanical locks on both switches of the 103-102 crossover, which prevent them from being used by car inspectors to provide protection. BNSF stated that they plan to remove this crossover completely. Discontinuation of use, or even the planned removal of this crossover, will mitigate the possibility for this crossover to be left out of correspondence, but it will not eliminate the risks employees are exposed to when riding equipment while protecting shove movements.
