Railroad Investigation Report: RIR-26-12

# Canadian National Railway Derailment and Hazardous Materials Release

| Date | July 6, 2025 |

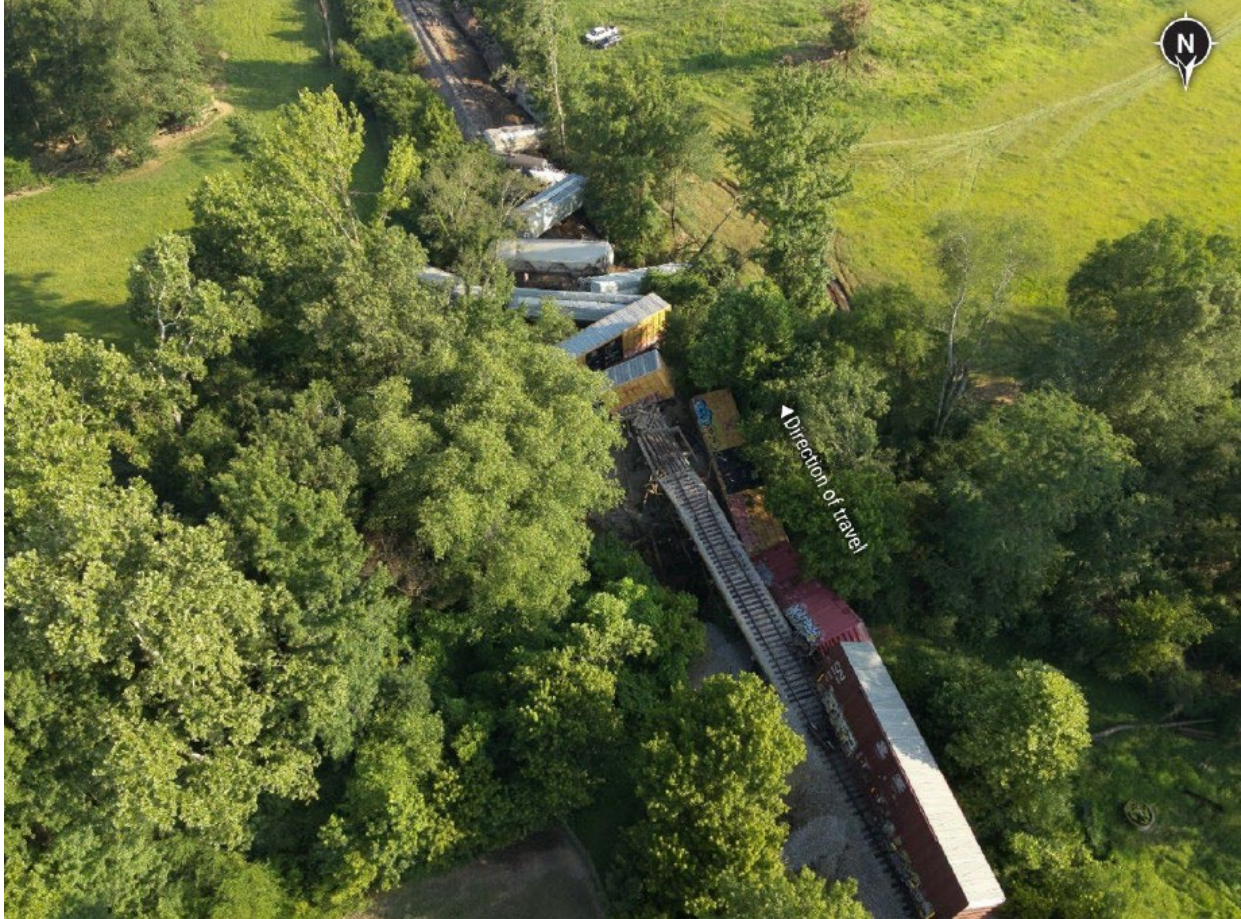
On July 6, 2025, about 3:19 p.m. local time, southbound Canadian National Railway (CN) train A48871-06 derailed 21 mixed-freight railcars on the Grenada Railroad (GRYR), a Pinsly Railroad Company subsidiary, near Sardis, Mississippi.<sup>1</sup> (See figure 1.) The derailed equipment included four tank cars carrying hazardous materials: two containing sulfuric acid and two containing sodium hydroxide. One of these tank cars (a DOT-111 tank car) breached, releasing about 10,500 gallons of sodium hydroxide.<sup>2</sup> CN and GRYR estimated damages to be about \$2 million. No injuries were reported. Visibility conditions at the time of the derailment were partly cloudy with no precipitation; the temperature was 93°F.

**Figure 1.** Aerial view of the derailment location. (Courtesy of Panola County Emergency Operations.)

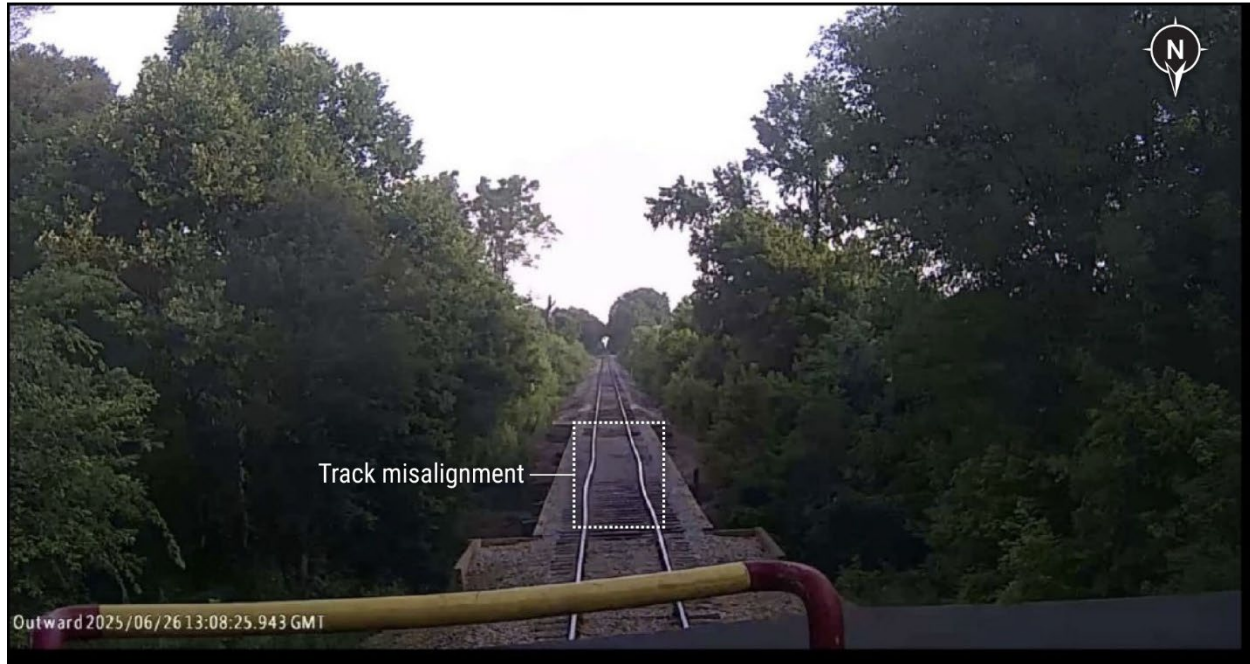
From May 1, 2025, through May 9, 2025, a GRYR contractor replaced the accident bridge deck.<sup>9</sup> About a month and a half later, on June 26, 2025, about 8:08 a.m., 10 days before the derailment, a GRYR train crew reported to a GRYR assistant roadmaster that there was “rough track” on the accident bridge. (“Rough track” is often associated with misaligned track.) On the same day, a GRYR employee and a GRYR contractor employee investigated the condition of the track on the bridge. These employees told the National Transportation Safety Board (NTSB) that they identified a “heat kink” on the bridge and reported it to the GRYR assistant roadmaster. A “heat kink”—which the industry also refers to as a “track buckle” or a “thermal misalignment”—is a type of track misalignment that occurs, typically during hot weather, when the track structure cannot restrain compressive-longitudinal forces and moves, or kinks, laterally into an “S” or “C” shape, which allows the rail to expand and relieves compressive forces. Track buckles indicate tight-rail conditions, such as lateral-rail movement, and extreme internal-compressive forces in the CWR. In response to the track misalignment, GRYR placed a 10-mph slow order on the track.<sup>10</sup> Figure 2 shows an image from a train's lead locomotive outward-facing camera as it approached the accident bridge on June 26, 2025, with the track misalignment visible. The video timestamp reads 13:08:25 Greenwich Mean Time, which

**Figure 2.** June 26, 2025, outward-facing camera view of derailment location. (Courtesy of GRYR.)

CN train A48871-06 derailed when it traversed a misaligned section of track (a track buckle).<sup>15</sup> Ten days before the derailment, on June 26, a train crew reported rough track at the derailment location; the two track workers (a GRYR employee and a GRYR contractor) who inspected the track identified a track buckle. Five days later, on July 1, GRYR attempted to repair the track buckle by straightening the track and tamping the ballast; GRYR did not destress the rail. The FRA recommends that railroads destress rail to repair track buckles. Had GRYR destressed the rail to repair the June 26 track buckle, the July 6 track-buckle induced derailment likely would not have occurred. After the derailment, GRYR updated its CWR plan to require (1) employees to destress tight-rail conditions, which include track buckles, within 24 hours of discovery and (2) a qualified employee to supervise train movements over locations with tight-rail conditions. GRYR retrained its employees on the updated CWR plan.

On July 1, 2025, between 9 a.m. and 11 a.m., 5 days before the derailment, a GRYR track foreman used a backhoe to straighten the track misalignment and tamp the ballast in the surrounding area.<sup>11</sup> After the track foreman completed this work, he removed the 10-mph slow order on the track. GRYR did not destress (cut and remove) a portion of the rail during its July 1 repair of the June 26 track buckle. The FRA recommends that railroads destress rail to repair track buckles.<sup>12</sup>

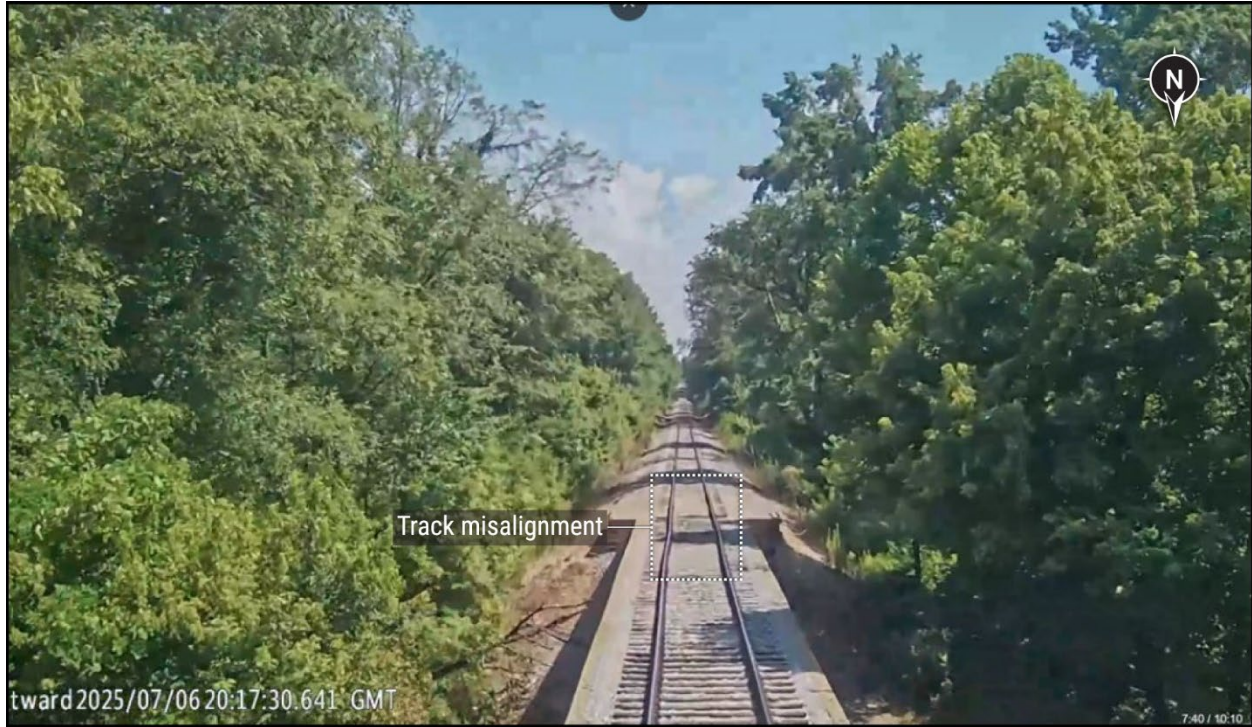
**Figure 3.** July 6, 2025, outward-facing camera view of derailment location. (Courtesy of CN.)

Moments before the derailment, the accident train's outward-facing locomotive camera captured an image of a slight track misalignment at the derailment location (see figure 3), the same location where GRYR had identified a track buckle on June 26 (10 days earlier). Track buckles typically occur under trains, with the load of the train being a factor. Thus, the image of the track misalignment captured moments before the derailment was likely a precursor to a more pronounced track buckle that would occur as the accident train, which was relatively long and carrying a heavy load, traversed over the misaligned tracks.<sup>17</sup>

The NTSB determines that the probable cause of the July 6, 2025, train derailment in Sardis, Mississippi, was Grenada Railroad's inadequate repair of a track buckle that occurred 10 days before the derailment at the same location, which resulted in the track buckling again under the accident train. Contributing to the severity of the derailment was a manufacturing defect in a coupler shank on the lead end of the 45th

The Sardis derailment demonstrates the importance of proper track-repair practices, particularly the need to promptly distress CWR in response to tight-rail conditions, including track buckles. By distressing rail that exhibits tight-rail conditions, railroads treat the underlying cause of track buckles rather than the symptoms. Railroads should remain vigilant to the dangers of track buckles even if CWR represents only a small percentage of their total-rail trackage.

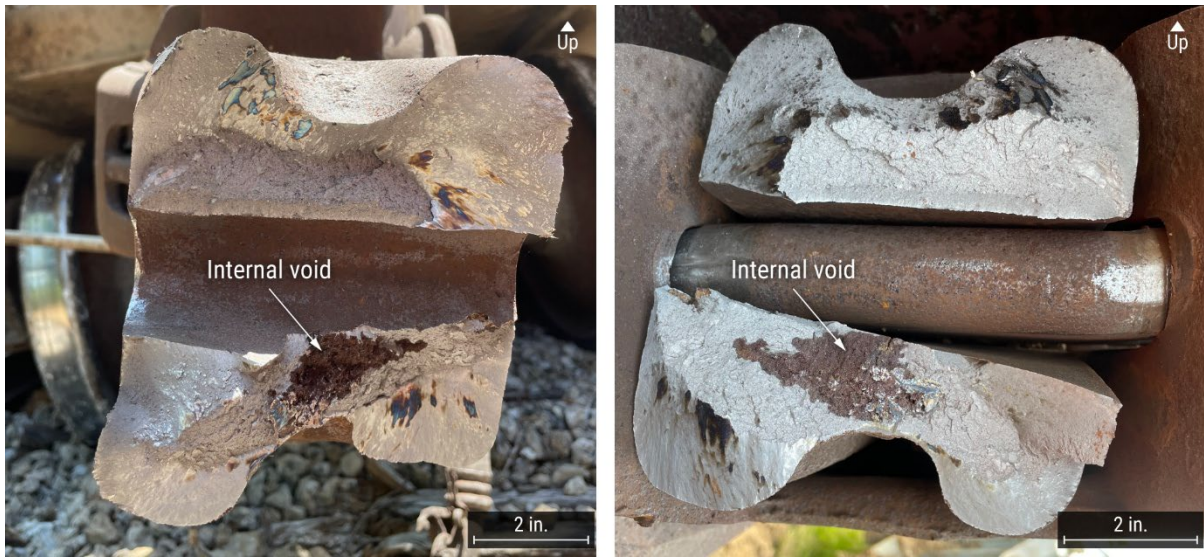
While on the scene, the NTSB identified a fractured-coupler shank on the lead end of the 45th railcar behind the locomotive and determined it was the point where railcars separated during the derailment.<sup>14</sup> After the derailment, the NTSB Materials Laboratory examination identified an internal shrinkage void (an internal cavity in the material formed during the manufacturing process) at the coupler shank fracture. Figure 4 shows on-scene photographs of the opposite ends of the coupler-shank fracture, highlighting the internal void.

**Figure 4.** Opposite ends of fractured coupler shank with internal void visible.

Postaccident, the NTSB Materials Laboratory identified an internal void in the coupler shank of the 45th railcar (see figure 4) consistent with a manufacturing defect. The void created an area of higher stress concentration, increasing the probability that the coupler shank would fracture during a high-load event, such as a derailment, as it did in this accident. Thus, the coupler shank fracture separated the train, which removed the mechanical support that maintained the alignment and stability of the trailing railcars.
