Railroad Investigation Report: RIR-26-13

# Southeastern Pennsylvania Transportation Authority Pantograph Separation From Trolley Car

| Date | September 25, 2025 |
| Accident type | Pantograph separation with injuries |

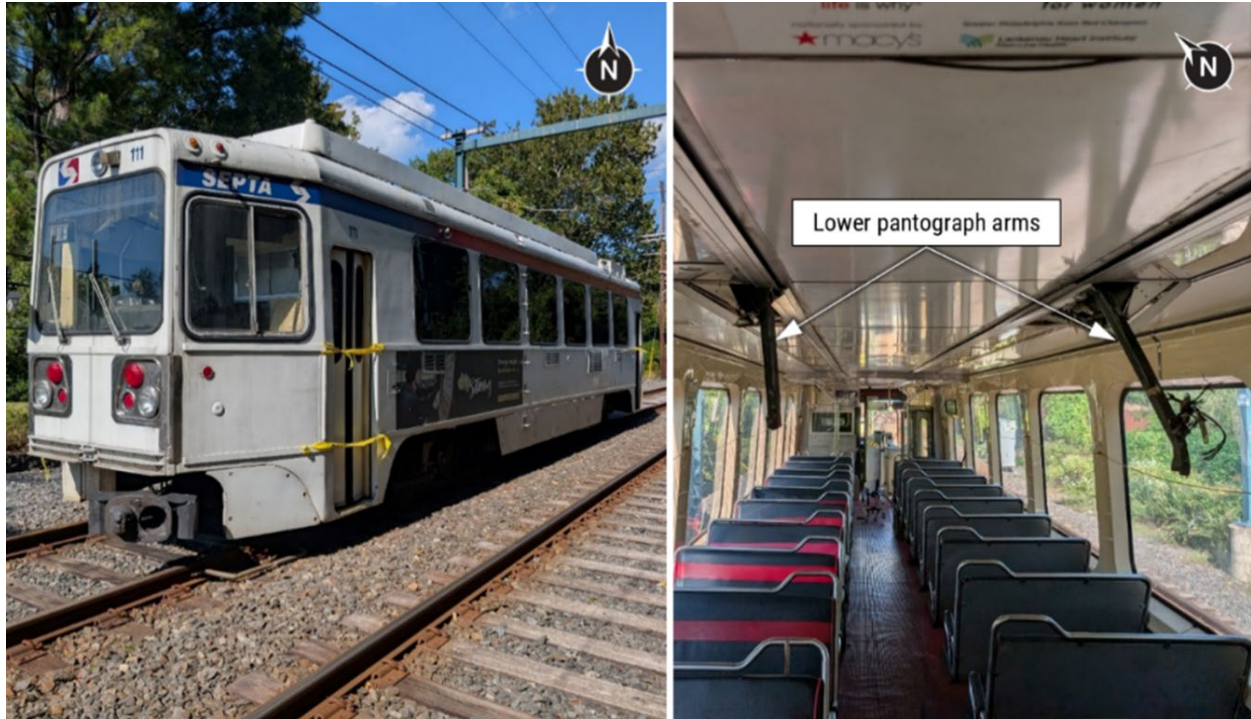
**Figure 1:** Trolley 111 postaccident (*left*) and passenger compartment of Trolley 111 (*right*).

entangled, parts of the pantograph assembly disconnected from the trolley and were subsequently found adjacent to the track. The entanglement also caused the two lower pantograph arms to penetrate the passenger compartment of the trolley.

The incident severed the contact wires and tore them from their supports; responding personnel later found the downed wires on the ground. The incident also tripped the circuit breakers at both traction power substations supplying power to the OCS at the location, interrupting power to the contact wire and de-energizing the OCS in the vicinity.

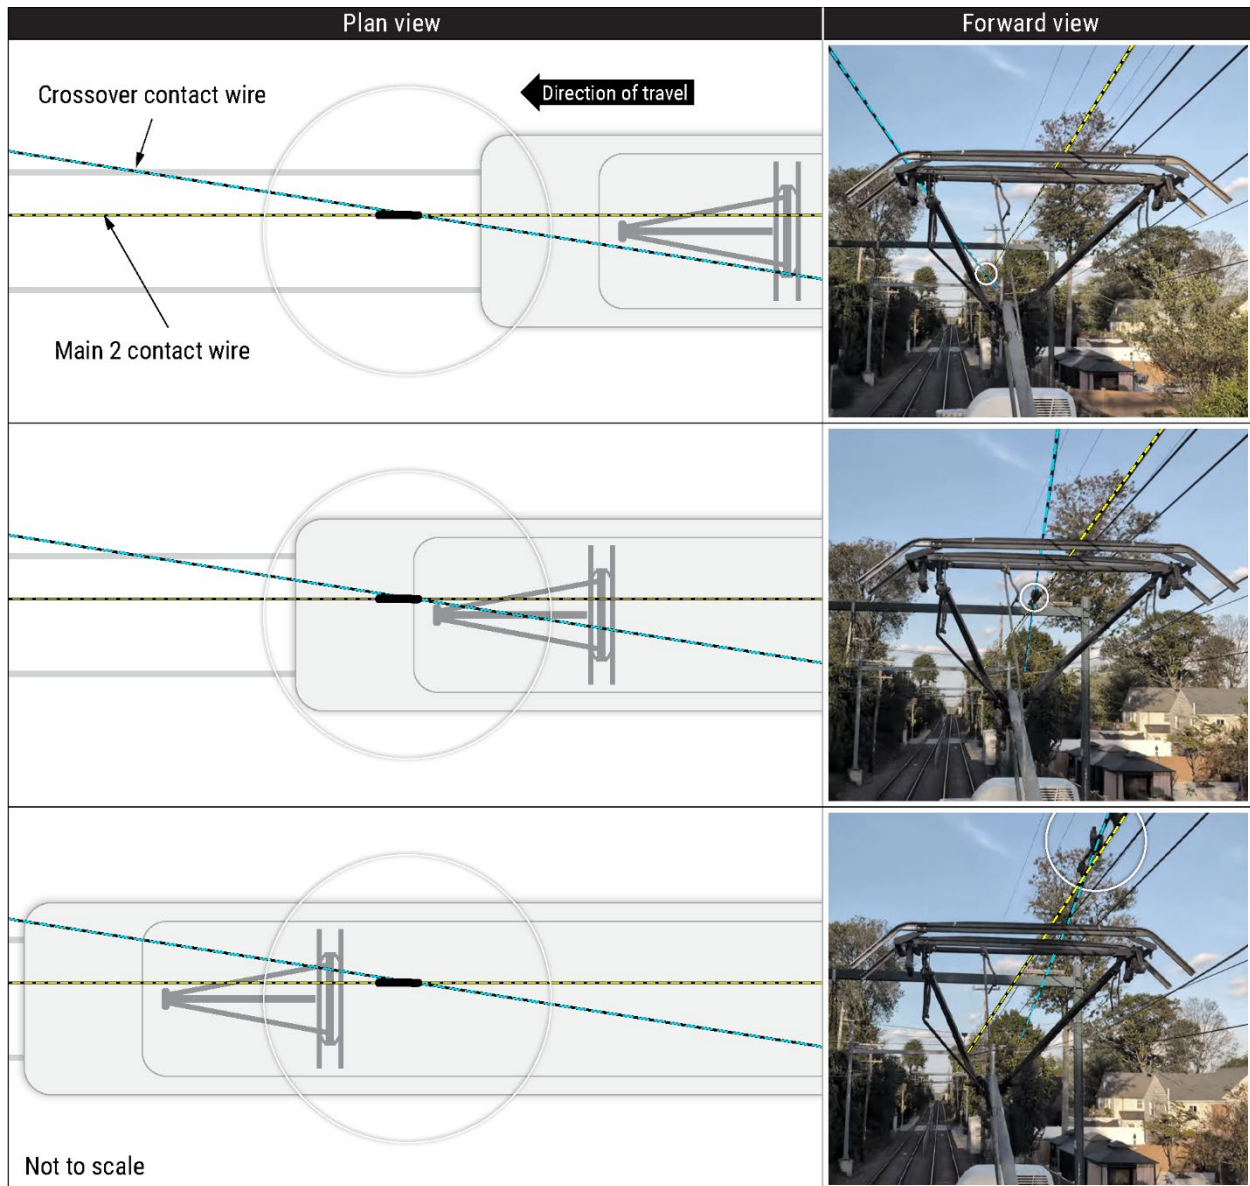
A trolley's pantograph usually touches a single contact wire of the OCS. When tracks come together at a crossover, there is a contact wire for the main track, and a contact wire for the crossover that passes above the main track contact wire. (See figure 2.) If contact wires are not properly tensioned, they will sag excessively. Sagging wires, or crossover wires that are too low, can cause the wires and the pantograph to bounce

vertically as a trolley passes. At a crossover, this bouncing action creates a dangerous condition as the pantograph navigates the multiple contact wires and could become entangled.

**Figure 2.** Diagrams and photos of an exemplar pantograph and catenary wire arrangement as a trolley passes through a crossover.

In this accident, the pantograph first became entangled with the OCS where the two contact wires—which were likely sagging from inadequate tension or improper configuration—crossed at the east crossover on main track 2 at the Scenic Road interlocking. SEPTA’s postaccident inspections identified 17 other locations where OCS wires were sagging or too low, six of which were at crossovers. However, because the D Line trolley fleet was not equipped with roof-mounted video cameras that record the
