Railroad Investigation Report: RIR-26-14

# BNSF Railway Conductor Fatality

| Location | Columbus, Montana |
| Date | October 19, 2025 |

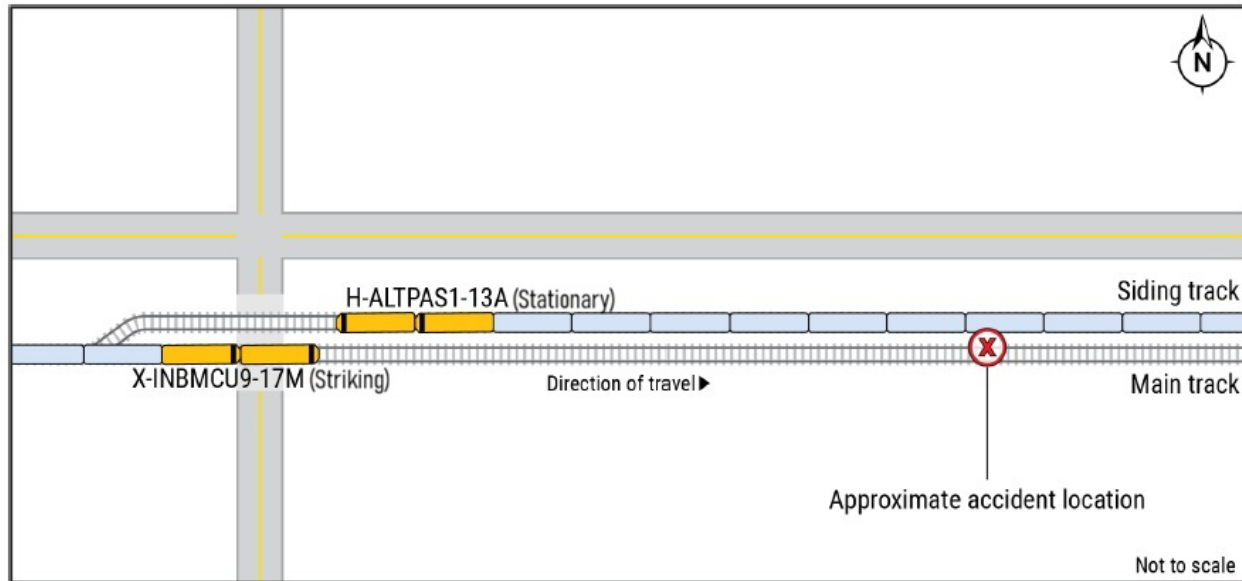
**Figure 1.** An overhead diagram of the accident scene.

The crew, which consisted of a locomotive engineer and a conductor, went on duty at 7:05 a.m. at Laurel Yard in Laurel, Montana. The crew was transported by van from Laurel to Columbus, Montana, to assume duties on the train for a trip to Helena, Montana. While performing pre-departure duties in the siding at Columbus, the conductor dismounted the locomotive and walked east between the siding and the main track to release hand brakes that had been applied on the first seven railcars of the train. The hand brakes were located on the south side of the stationary railcars, the side next to the main track. The hand brakes were not accessible from the opposite side.

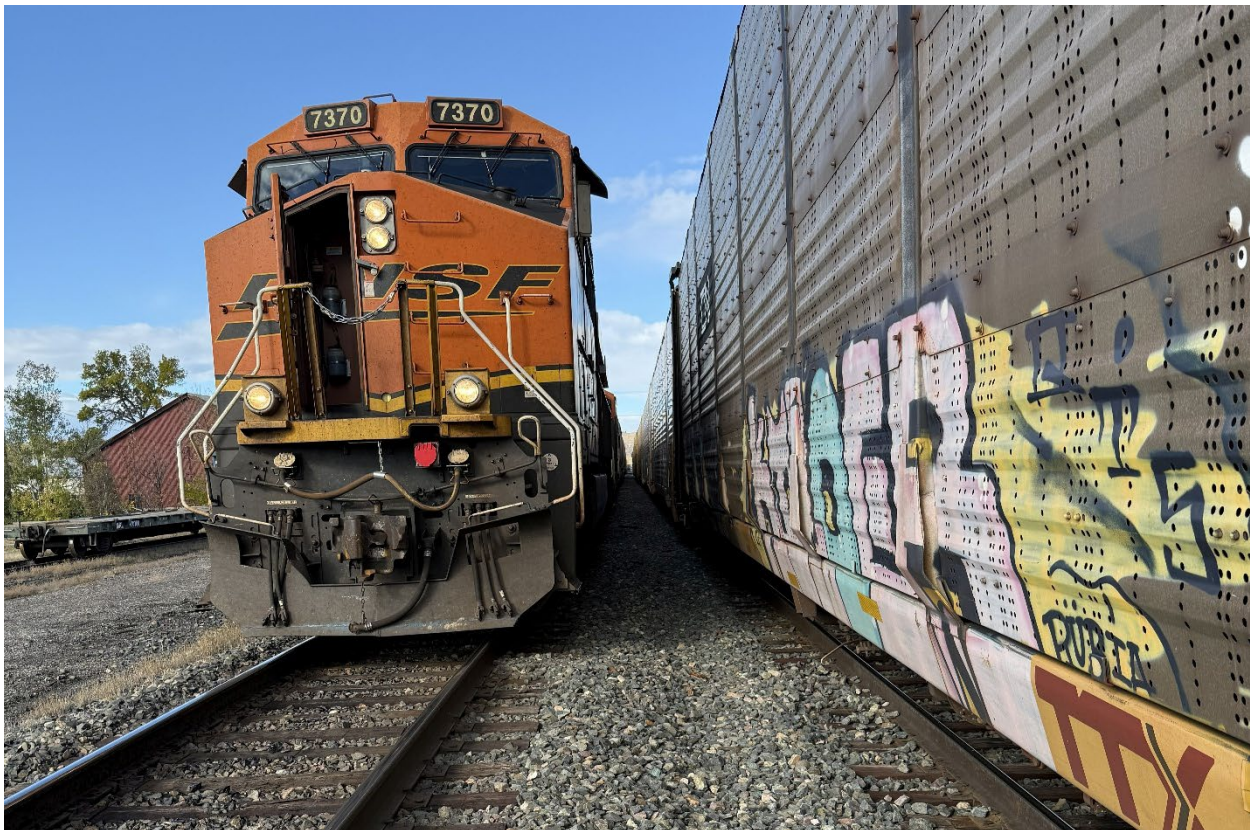
While the conductor was in the process of releasing hand brakes on the siding track, the striking train was operating eastbound on the adjacent main track. The distance between the siding track and the main track was 14 feet and 4 inches from the center of each track. (See figure 2.) The National Transportation Safety Board (NTSB) reviewed video from the forward-facing camera on the lead locomotive of the striking train which recorded the conductor in the foul of the main track shortly before the accident.<sup>2</sup> When the engineer of the striking train saw the conductor of train H-ALTPAS1-13A (the stationary train), he attempted to warn the conductor by sounding his locomotive's horn and contacting the conductor on his radio, all while initiating an emergency brake application on the train. After the engineer activated emergency

**Figure 2.** A photograph of the lead locomotive of the striking train staged at the accident location to show the clearance between the siding and the main track.

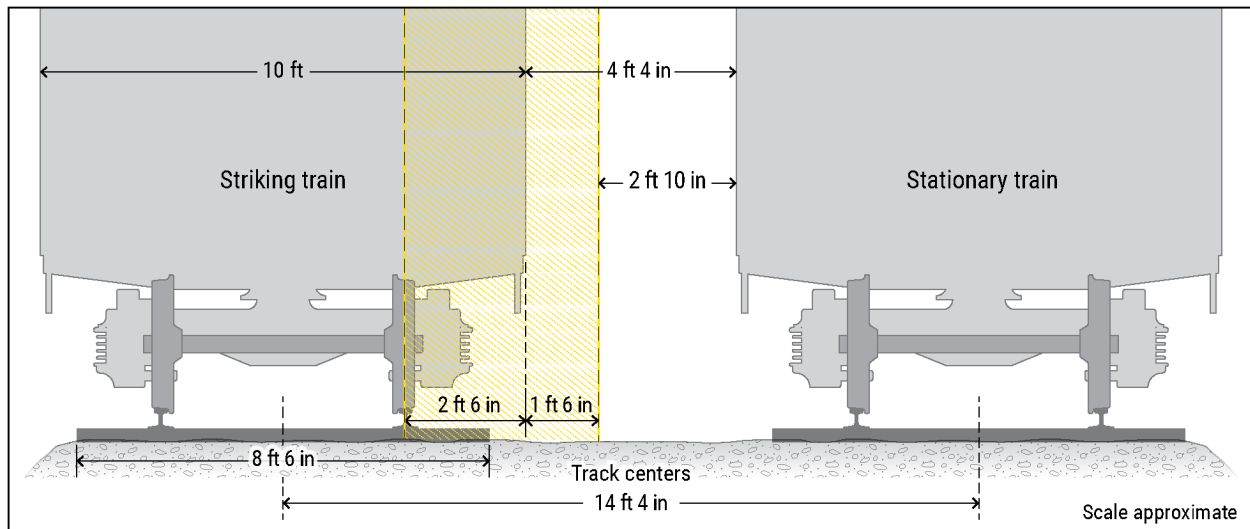
The conductor was fatally struck by a passing train while in the process of releasing hand brakes on his stationary train in the Columbus siding. The distance between the siding track and the main track (14 feet and 4 inches between track centers) created a close clearance situation where the conductor could unknowingly foul the live track. The Federal Railroad Administration's adjacent track rules for roadway workers apply whenever the tracks are spaced 19 feet apart or less.<sup>4</sup> The adjacent track rules do not apply to conductors or engineers working in the same conditions. The conductor had about 4 feet and 4 inches of space between tracks to remain clear of a passing train and only 2 feet and 10 inches to stay clear of fouling the main track. (See figure 3.) This can be dangerous even if the employee stays clear of the passing train. BNSF train, yard, and engine (TY&E) Safety Rule S-1.6.2, requires employees to be alert to train movement at any time on any track and in any direction; however, given the space between the tracks, it would be difficult to work without accidentally fouling the main track.

**Figure 3.** Diagram of the accident location showing the approximate distance between the tracks and the fouling zone.

On-track safety procedures on the adjacent main track were not required by FRA or BNSF rules. Had some form of on-track safety been established on the main track, the passing train would not have been permitted to operate through the area while the conductor was on the ground, or additional safeguards would have been in place such

as a speed restriction for passing trains and the train crew would have had more time to identify an approaching train. The absence of on-track safety protection left the conductor exposed to passing trains and directly resulted in the conductor being struck. In comparison, roadway workers are required to establish on-track safety when working on the ground with equipment when near an adjacent controlled track. Thus, in this location, a roadway worker would have been required to follow on-track safety procedures according to BNSF Maintenance of Way Operating Rule 12.2 and establish working limits on the adjacent track or use train approach warning.<sup>5</sup>
