PRELIMINARY REPORT

Amtrak Passenger Train 501 Derailment

DuPont, Washington

RRD18MR001

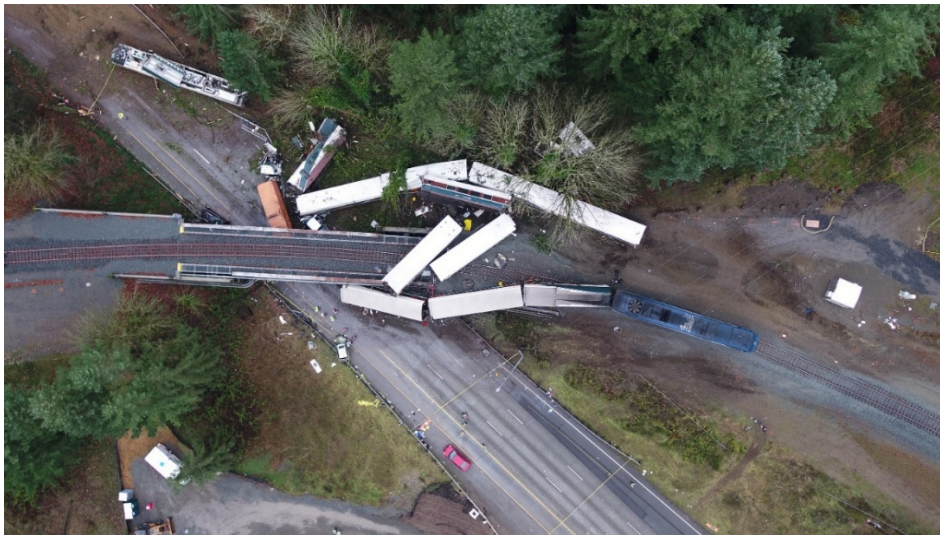
Figure 1. The accident site. (Provided by Washington State Patrol.)

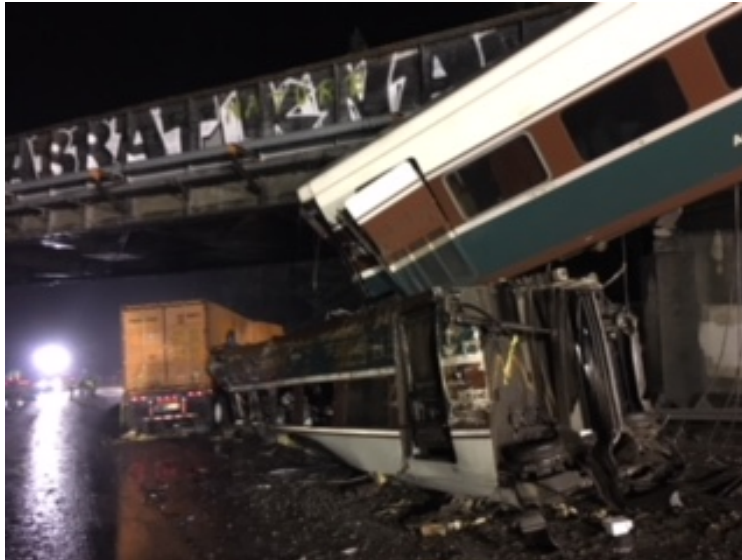
Figure 2. Derailed Passenger Railcars on Interstate 5.
