PRELIMINARY REPORT

Head-on Collision Between Amtrak Passenger Train and CSX Freight Train

Cayce, South Carolina

RRD18MR003

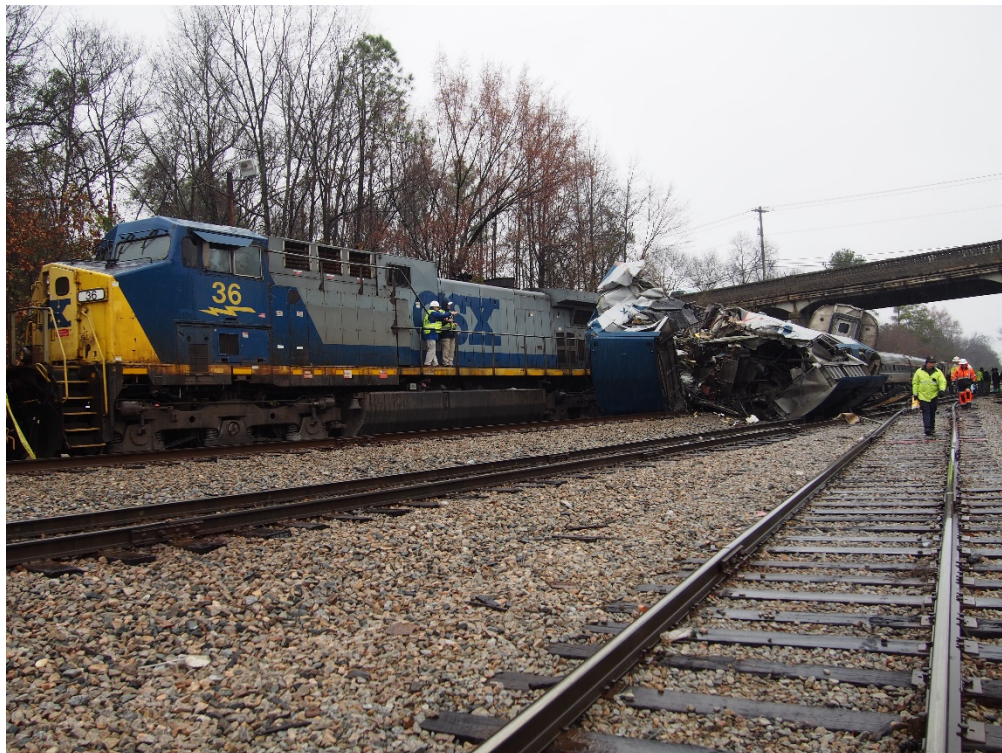
Figure. A view of the accident scene.
