# PRELIMINARY REPORT

### CSX Transportation Freight Train Derailment

**Alexandria, Virginia**  
**May 19, 2018**  
**RRD18MR007**

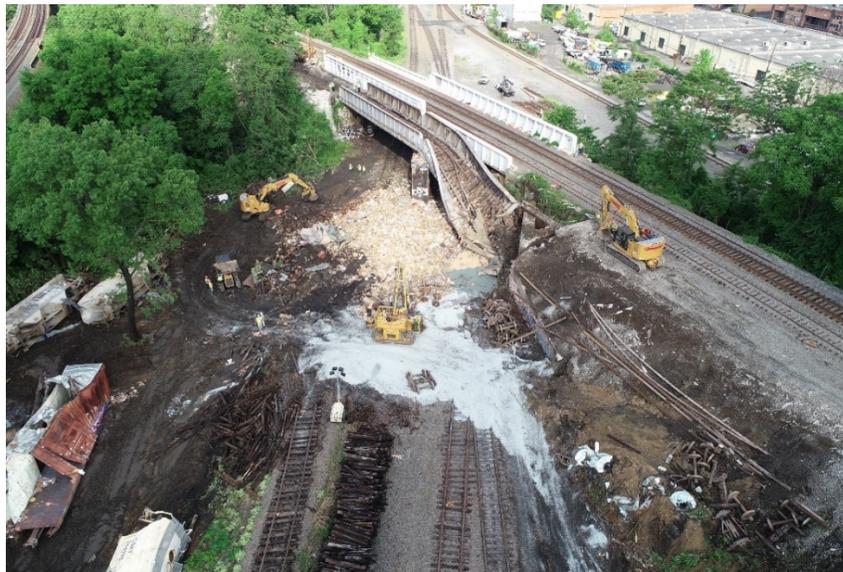
On May 19, 2018, about 7:02 a.m. eastern daylight time, southbound CSX Transportation (CSX) freight train X41518 derailed near mile post (MP) 102.9 while traveling on main track one. The derailment occurred about 500 feet north of two CSX bridges that cross over Norfolk Southern Railway (NS) tracks. A CSX bridge on main track one was extensively damaged; a CSX bridge for main tracks two and three remained in service. Some of the derailed CSX freight cars fouled the NS tracks that were below the bridge. (See figure 1.)

**Figure 1.** NTSB drone aerial photograph of damaged bridge and debris.

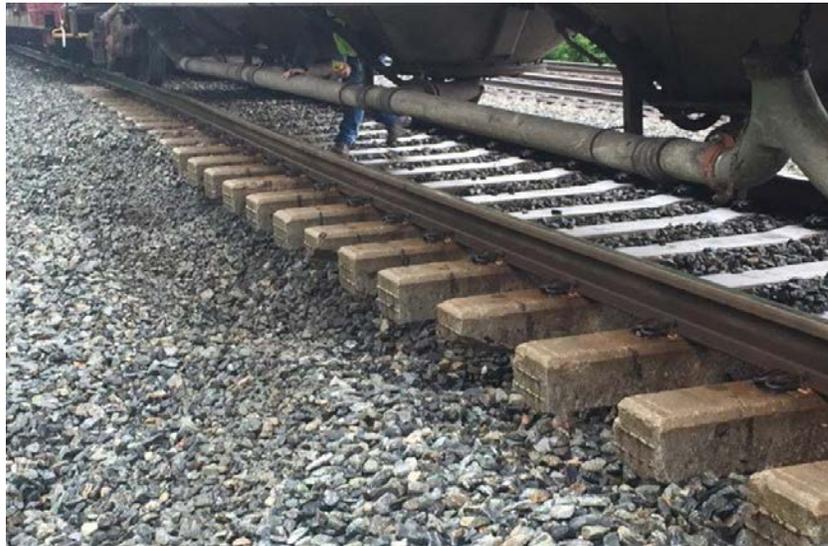
A preliminary investigation revealed an area in a curve where the subgrade fill was subsided from the track structure. The investigators found that this fill was subsided for about 26 feet (at a depth of 18 inches) at MP 102.9. (See figures 2 and 3.) The NTSB investigators also identified a flange mark traversing over the top of the rail head in the curve and the at the location of the subsided subgrade.

**Figure 2.** Ballast subsided from the outside edge of the cross-ties.

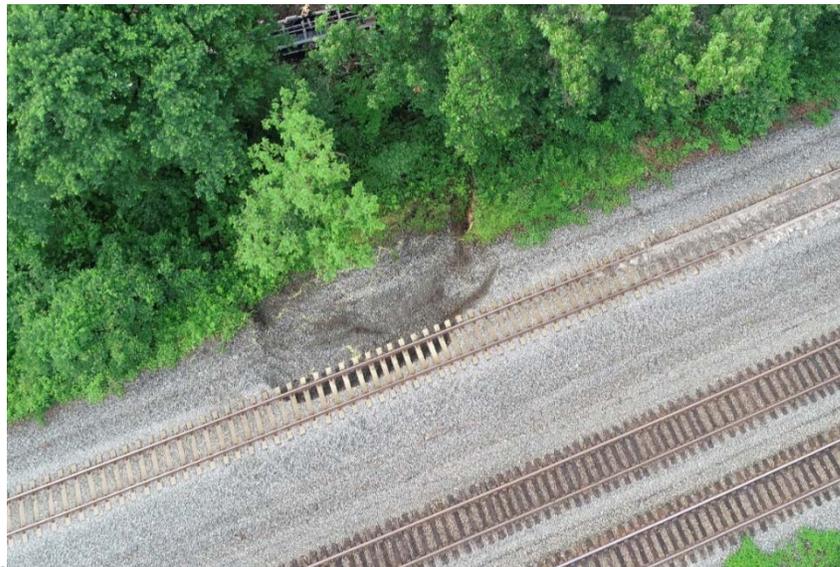
**Figure 3.** NTSB aerial drone photograph taken after freight cars were removed from main track one; ballast is subsided from outside edge of cross-ties.
